**ACTEWAGL DISTRIBUTION  
MURRUMBIDGEE ECOLOGICAL MONITORING  
PROGRAM  
FIELD OBSERVATION REPORT: SPRING 2011**

**Client:** ActewAGL Distribution  
**Project Title:** Murrumbidgee Ecological Monitoring Program  
**Report Title:** Angle Crossing assessment autumn 2011  
**Document No:** 211063-11-R7-P1  
**Document Status:** **FINAL**  
**Date of Issue:** **16/08/2011**

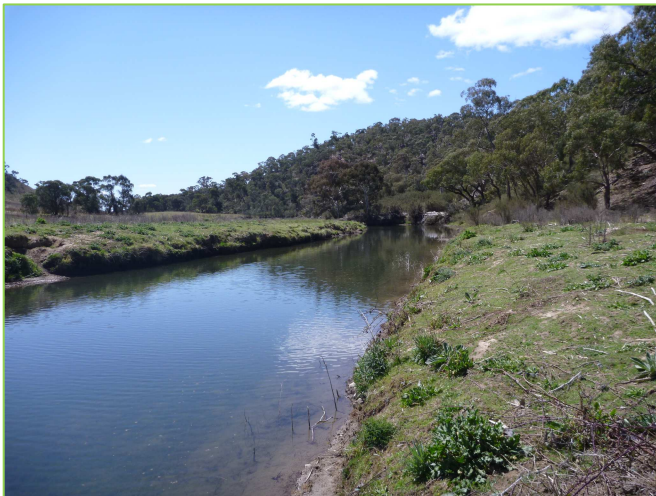
#### **Plate 1.** Bur 3 inundated by Googong Reservoir water level

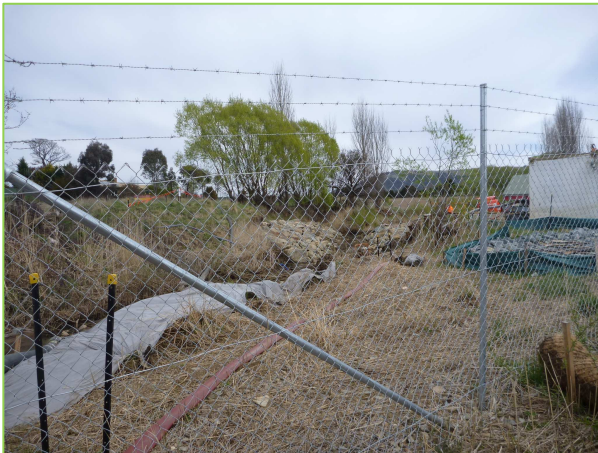
- a) the M2G construction works, upstream of Williamsdale Road bridge has intensified (Plate 2) - current work involves excavation for the pipe installation and discharge structure, which also involves diverting the upstream flow around the trench via pumping and hoses, to the downstream side to enable this work to proceed. A silt boom is in place on the downstream side (Plate 3).
- b) Flows upstream of Williamsdale Bridge were lower than autumn, evidenced by larger and more frequent patches of iron bacteria flocs along the edges at BUR 1a and BUR 1c - indicating increased ground water contribution to the base flow.

**Plate 2.** Looking just upstream of Williamsdale Bridge

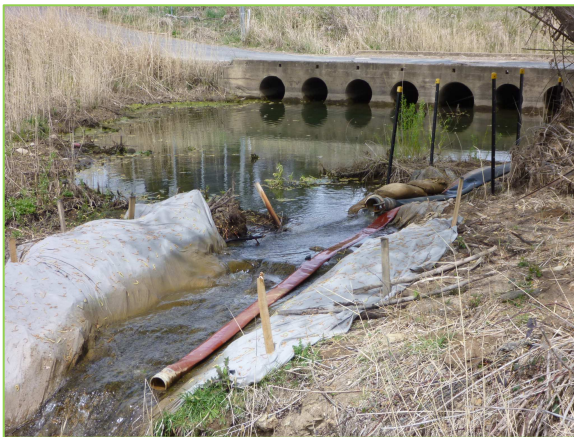
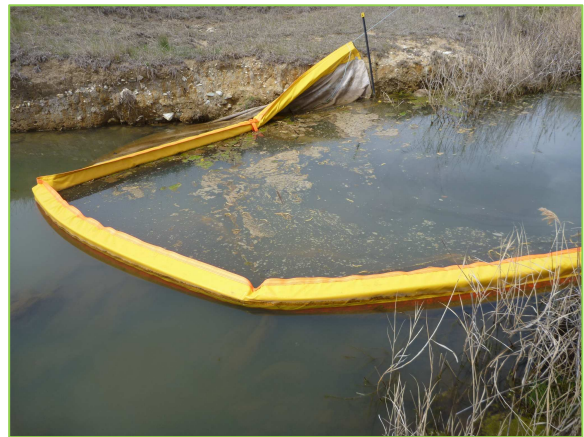
**Plate 3.** Creek water diverted to the downstream section of Burra Creek (left) and silt boom in place downstream of hose discharge

Despite the increase in construction related activity, the indication from our water samples is that water quality is currently not being compromised in the vicinity of these works. All parameters recorded in situ were within the natural range of Burra Creek water quality parameters collected to date. There were slight increases in dissolved oxygen readings at all sites compared to autumn, but this is likely due to increased photosynthetic activity as the surface temperature warms and primary production increases. Field observations throughout the length of Burra Creek indicate that algal biomass appears to have increased considerably since our last sampling run especially in the semi-isolated pools (Plate 4).

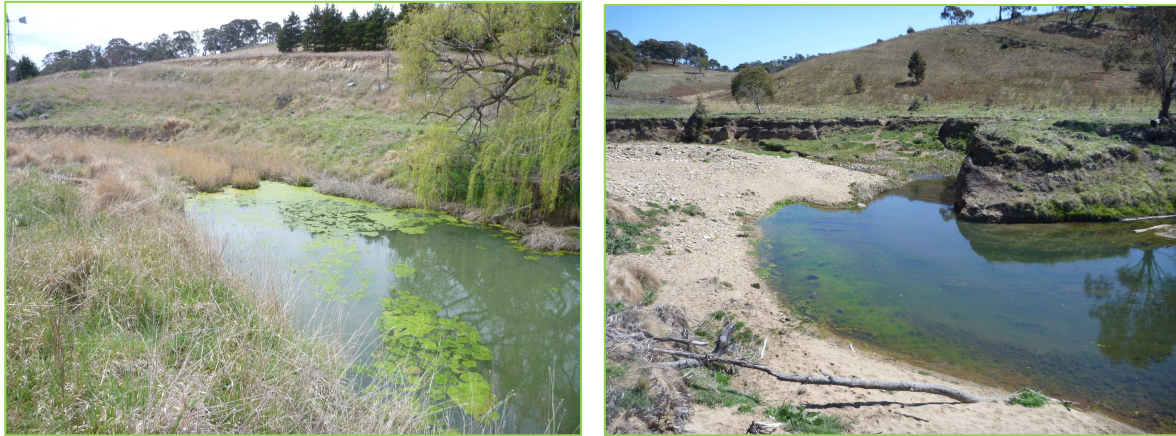
**Plate 4.** Pools downstream of Williamsdale Bridge (left) and upstream of London Bridge (right) showing increased algal growth.

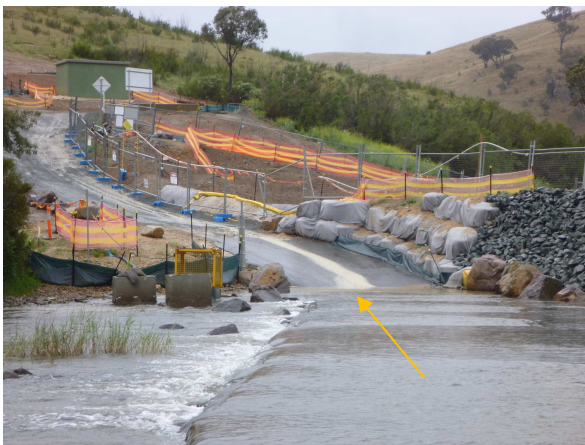
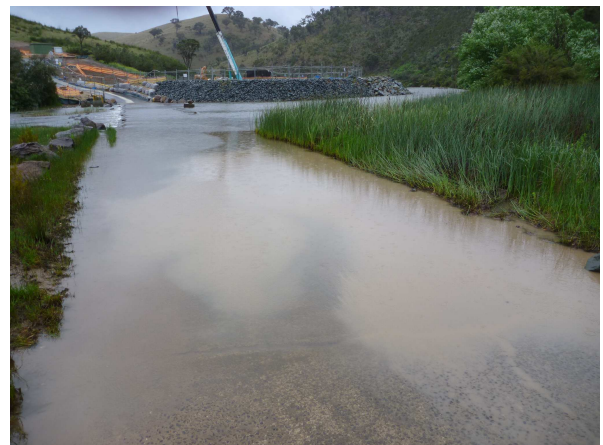
In fact, stream-side scans of the macroinvertebrate samples showed early indications of a healthy community, with a high abundance of stoneflies (Gripopterygidae) and mayflies (Leptophlebiidae) and what appears to be a diverse assemblage of other taxonomic groups. However, it was noted during rain periods at MUR 19, that turbid runoff was entering the stream on both sides of the crossing (Plate 6) which could lead to an accumulation of fines downstream.

**Plate 6.** Angle Crossing, showing turbid runoff from the right hand (indicated by the orange arrow) and from the left hand side
