BIOLOGICAL RESPONSE TO FLOWS DOWNSTREAM OF CORIN, BENDORA, COTTER, AND GOOGONG DAMS

Spring 2014

Prepared for ACTEW Water

ACTEW Water - Water Quality Monitoring Program

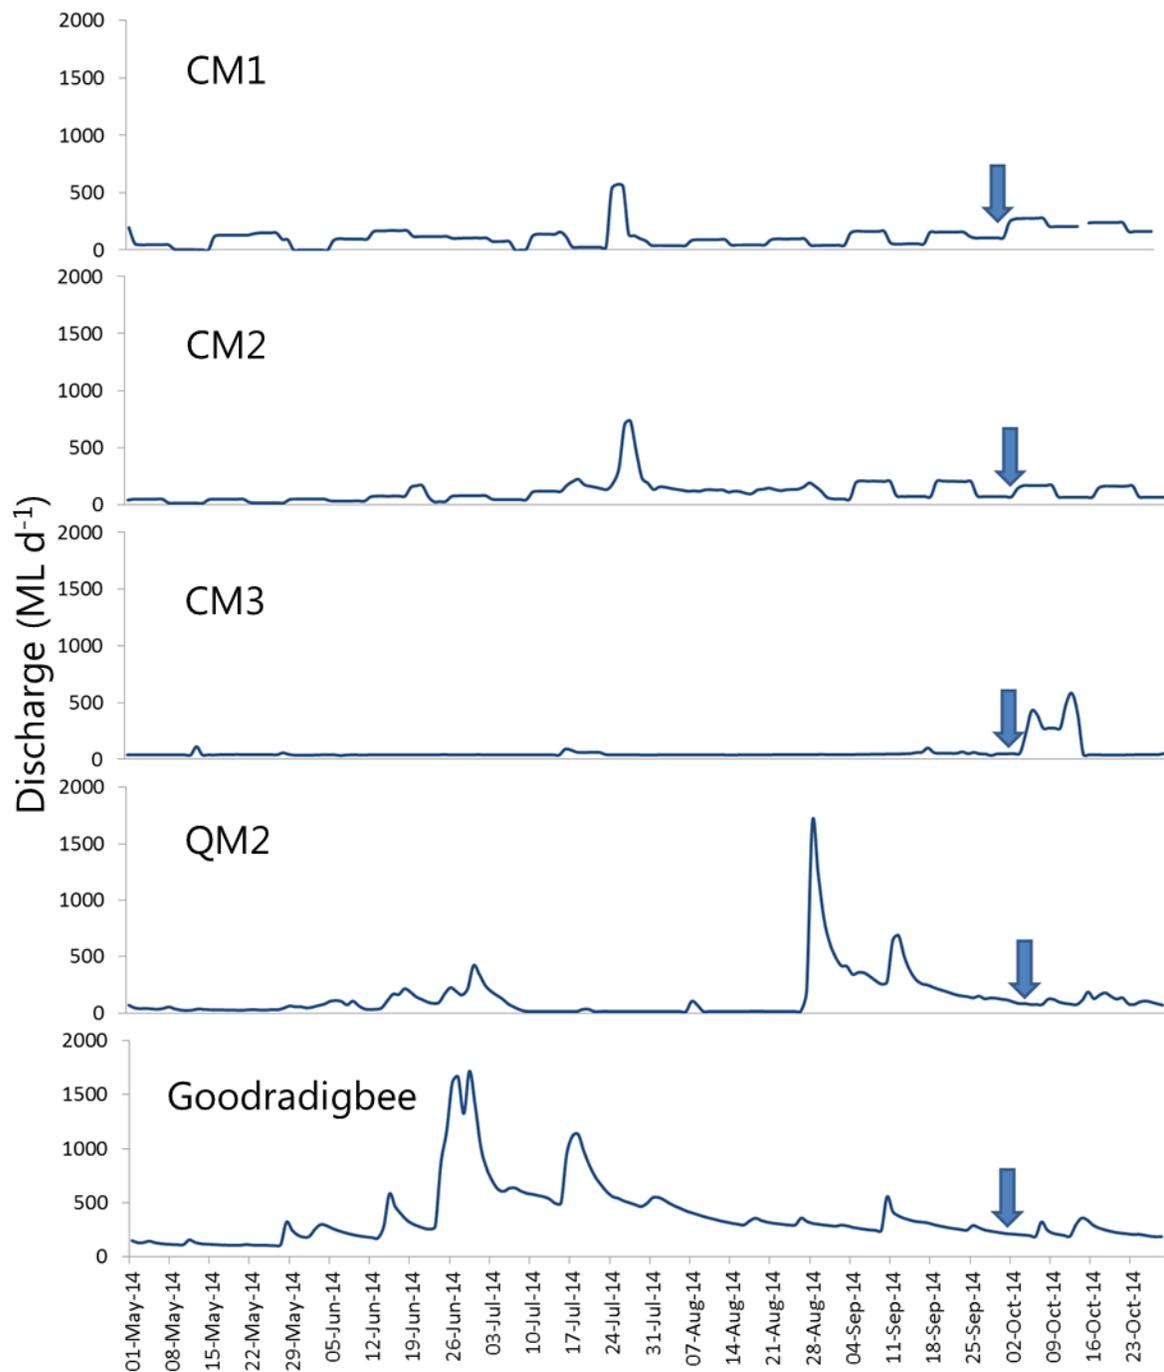
Figure 2: Mean daily discharge below Corin (CM1, station 410752), Bendora (CM2, station 410747), Cotter (CM3, station 410700) and Googong (QM2, station 410760) Dams and in the Goodradigbee River (station 410088) from 1st May 2014 to 31st October 2014. Arrows correspond to spring 2014 sampling dates.

occurred in the Queanbeyan River on the 28th August when Googong Dam spilled (Figure 2). It is likely that this disturbance would have influenced instream macroinvertebrate communities in the Queanbeyan River downstream of Googong Dam. The large proportions of filter feeding [Simuliidae](#) collected in the macroinvertebrate samples at site QM2 and QM3 are also indicative of high flow conditions and high concentrations of fine organic particulate matter being transported by high flow velocities (Figure 6). Filter feeding [Simuliidae](#) are also commonly found in greater abundance downstream of impoundments where fine particulate food sources are abundant and the downstream transport of coarser organic material has been interrupted (Ward and Stanford 1983). If higher than normal flows continue to occur downstream of Googong Dam because of spilling it is likely that sites QM2 and QM3 will remain similar to reference condition or continue on a trajectory towards reference condition.

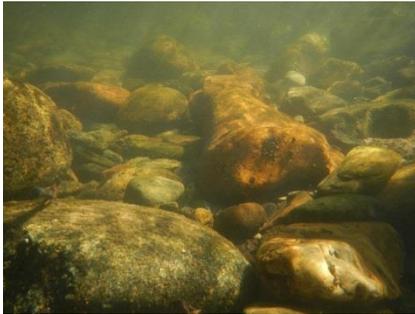
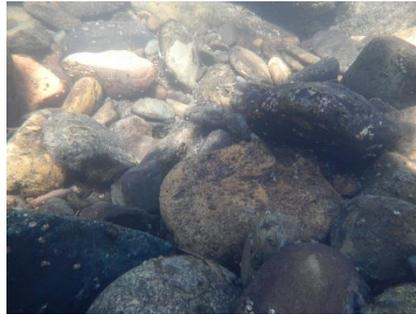
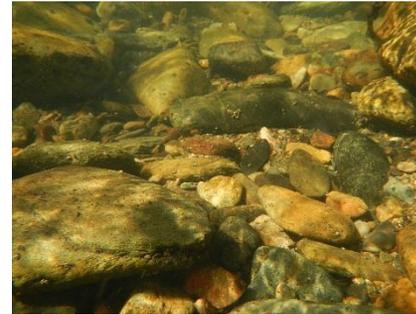
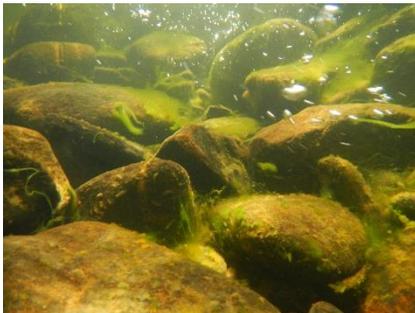
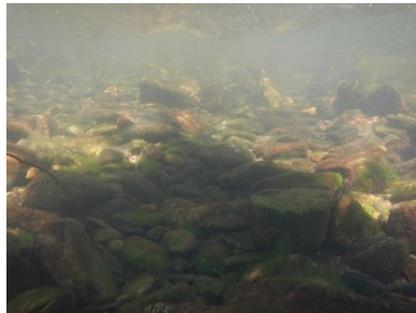
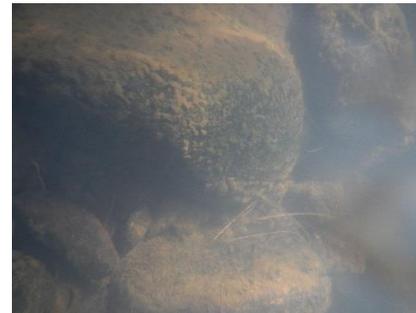
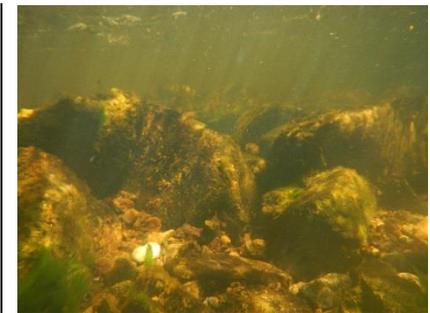
Figure 3. Filamentous algae cover of riffle bed sediments at below dam test sites and corresponding reference sites on the Goodradigbee and Queanbeyan Rivers in spring 2014.

- Only site CM1, below Corin Dam, did not meet the environmental flow ecological objective of <20% filamentous algae cover of riffle habitats. The current Corin Dam flow release strategy has proven effective in limiting filamentous algae cover in downstream riffle habitats during previous assessments. This result is likely a consequence of the phase of the flow release cycle in which spring 2014 sampling was conducted, and may not provide an accurate representation of conditions throughout the whole of spring 2014. For example, the increased filamentous algae growth downstream of Corin Dam is likely because of lower discharges before spring 2014 sampling (approx. 100-150 ML d⁻¹) than autumn 2014 sampling (200-550 ML d⁻¹), which have facilitated increased filamentous algae growth. However, compared with spring 2013 the percent cover is much lower (80% in spring 2013) where flow releases were < 100 ML d⁻¹ for ~1 month before sampling). [Click here for more information](#)

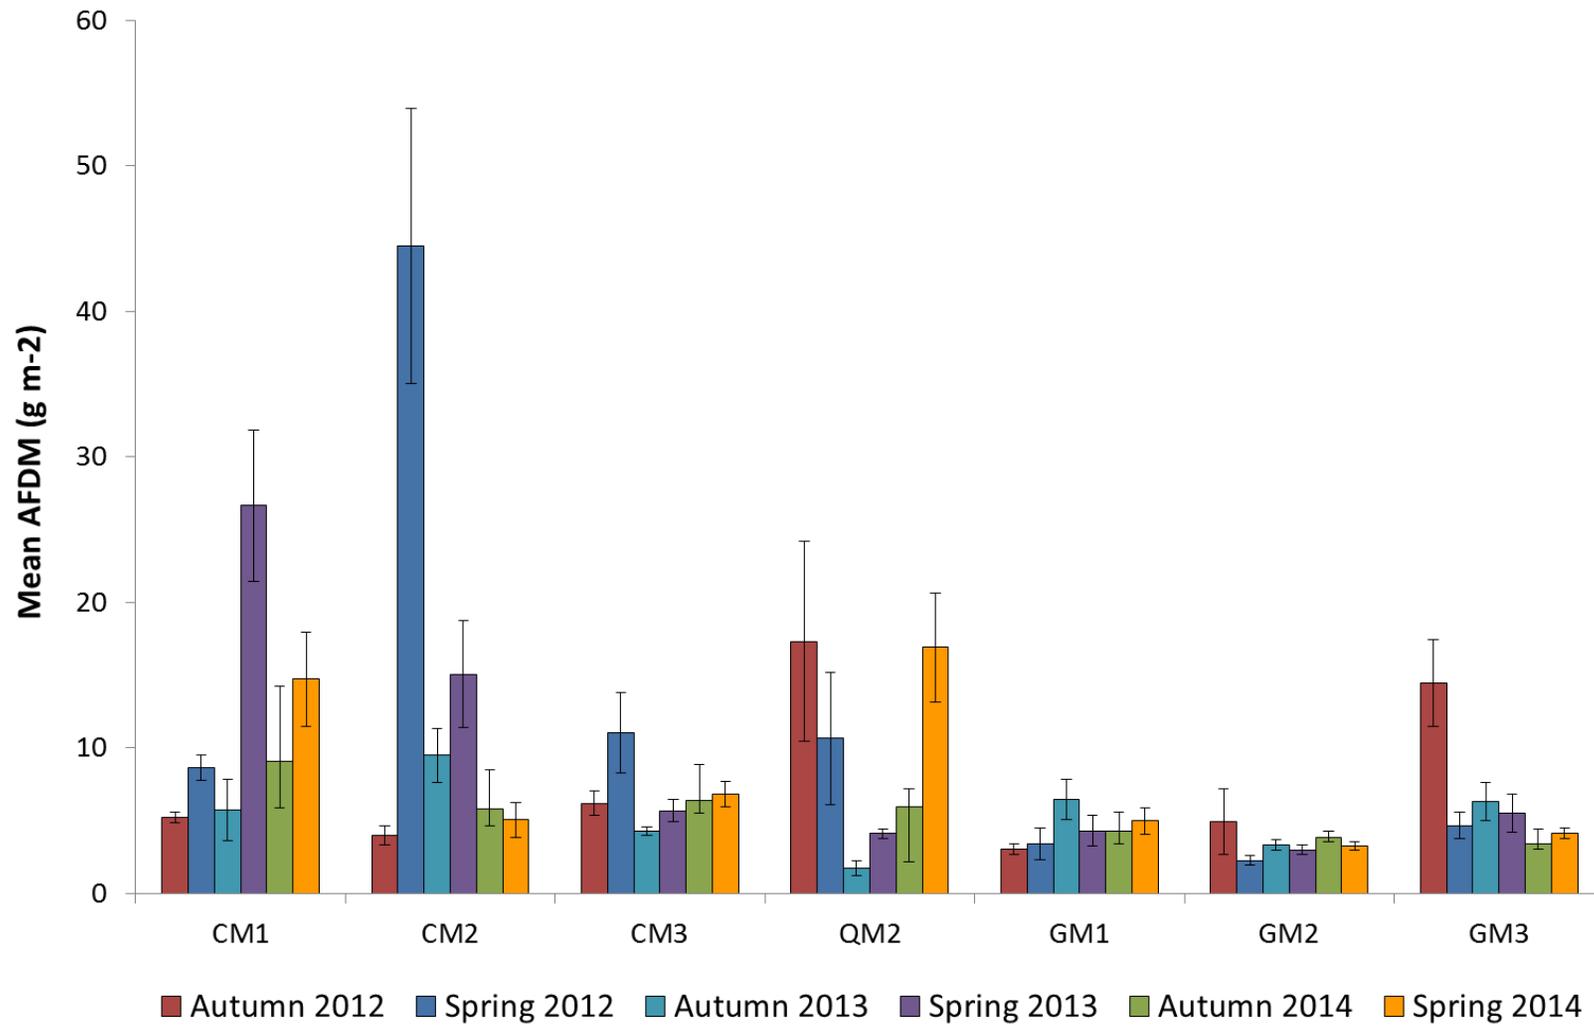
Figure 4: Mean AFDM (g m⁻²) at below dam test sites and reference sites on the Goodradigbee River from autumn 2012 to spring 2014. Error bars represent +/- 1 standard error.

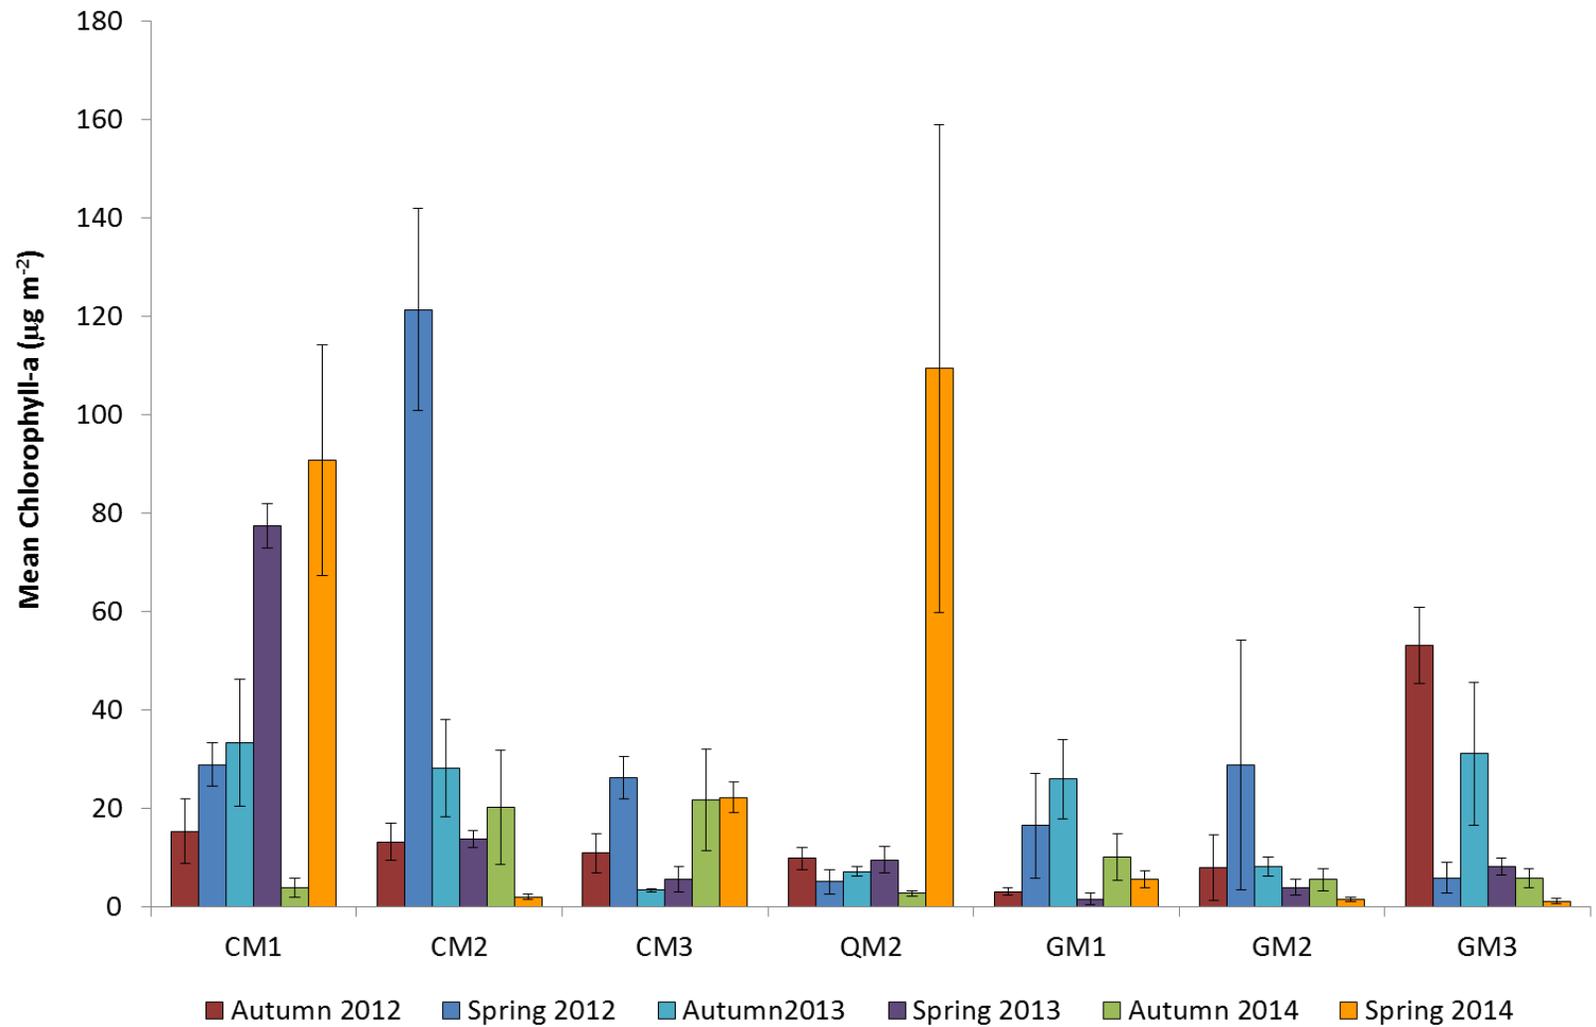
Figure 5: Mean chlorophyll-a ($\mu\text{g m}^{-2}$) at below dam test sites and reference sites on the Goodradigbee River from autumn 2012 to spring 2014. Error bars represent +/- 1 standard error.

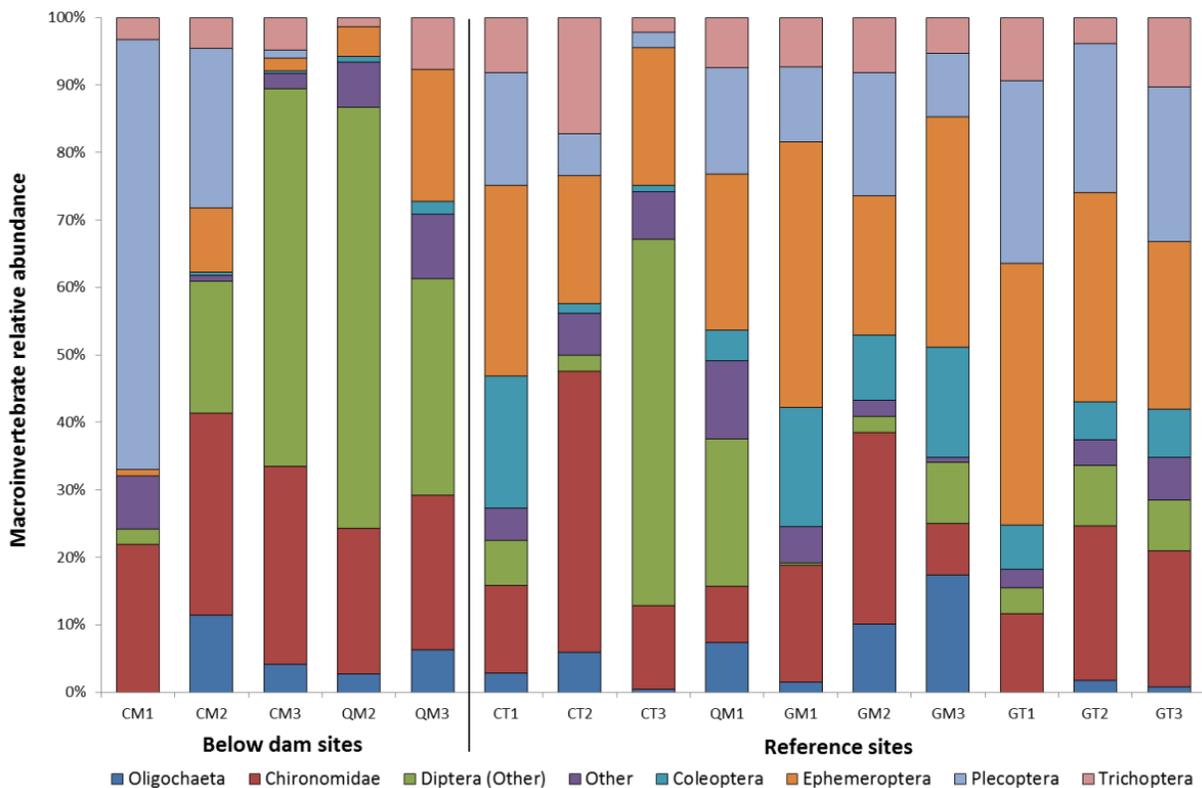
Figure 6: Relative abundance of macroinvertebrate taxonomic groups from samples collected in spring 2014.

Reference site QM1 upstream of Googong Dam had a greater relative abundance of sensitive EPT taxa and relatively fewer tolerant OC taxa compared to test sites QM2 and QM3 downstream of Googong Reservoir on the Queanbeyan River (Figure 6).

Filter feeding [Simuliidae](#) comprised 61% of the sub-sample at Queanbeyan River test site QM2 and 27% at QM3, and 56% of the sub-sample from Cotter River test site CM3 (Diptera (other) category in Figure 6 and Appendix 2). The sub-sample from Cotter River tributary site CT3 was also numerically dominated by [Simuliidae](#) (52% of the sub-sample; Diptera (other) category in Figure 6 and Appendix 2).

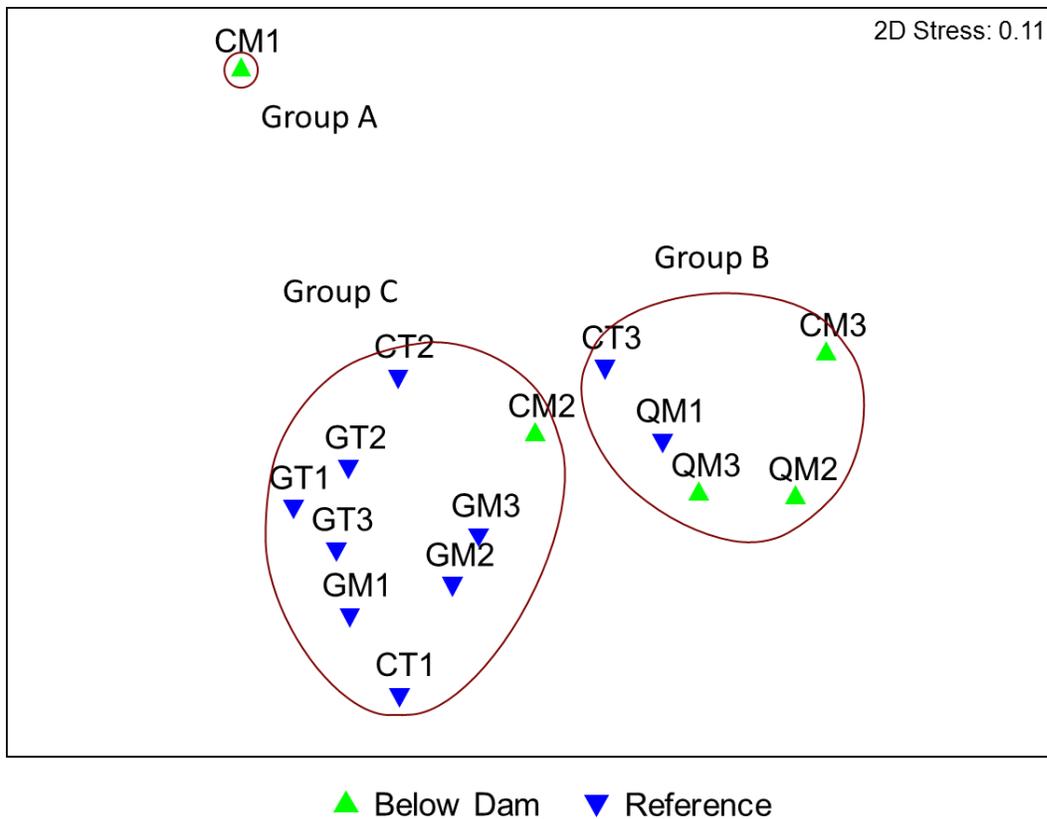
Figure 7. MDS ordination of 60% similarity between macroinvertebrate samples collected in spring 2014 for the Below Dams Assessment Program. Similarity based on macroinvertebrate relative abundance.

Cluster analysis based on the relative abundance of macroinvertebrate taxa identified three groups of sites at 60% similarity (Figure 7). Site CM1 was not similar to any of the other sites and grouped separately as Group A. Group B comprised below dam test sites (CM3, QM2, and QM3), Cotter River Tributary site CT3 and the Queanbeyan River reference site QM1 (Figure 7). Compared to other groups, group B was defined by higher abundances of Simuliidae and other disturbance tolerant taxa such as *Oligochaeta* and *Orthocladiinae* (Chironomidae sub-family) (Appendix 2). Group C contained Cotter River below dam test site CM2, all of the Goodradigbee River reference sites, and all of the Cotter and Goodradigbee River tributary sites, except for site CT3. Sites in this group were characterised by relatively high abundances of disturbance-sensitive and flow-favouring taxa such as *Leptophlebiidae*, *Philopotamidae* and *Glossosomatidae* compared to groups A and B (Appendix 2).

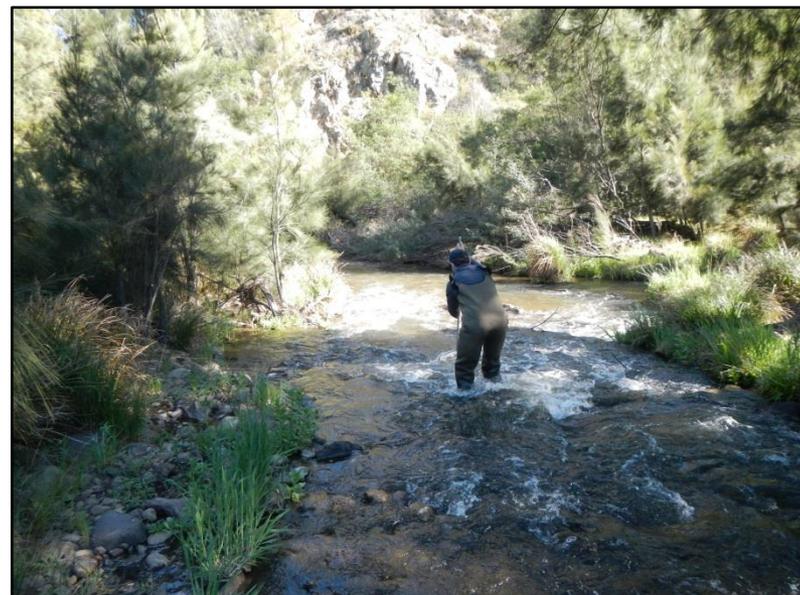
Downstream of Cotter Dam

Environmental flow ecological objective	Autumn 2014	Spring 2014	Objective met?
AUSRIVAS band A	Band B	Band B	No
<20% filamentous algae cover in riffle habitat	<10%	10%	Yes

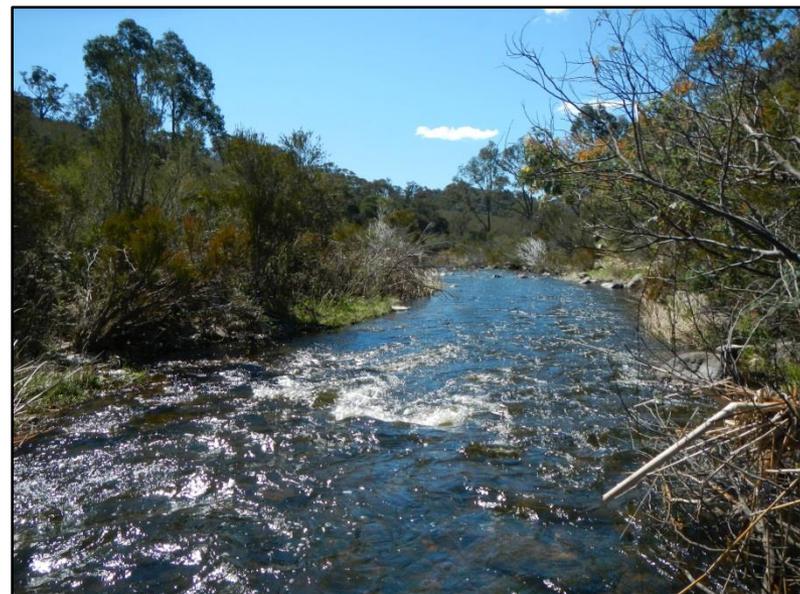
Downstream of Googong Dam

Environmental flow ecological objective	Autumn 2014	Spring 2014	Objective met?
AUSRIVAS band A	Band B	Band A	Yes
<20% filamentous algae cover in riffle habitat	<10%	10%	Yes

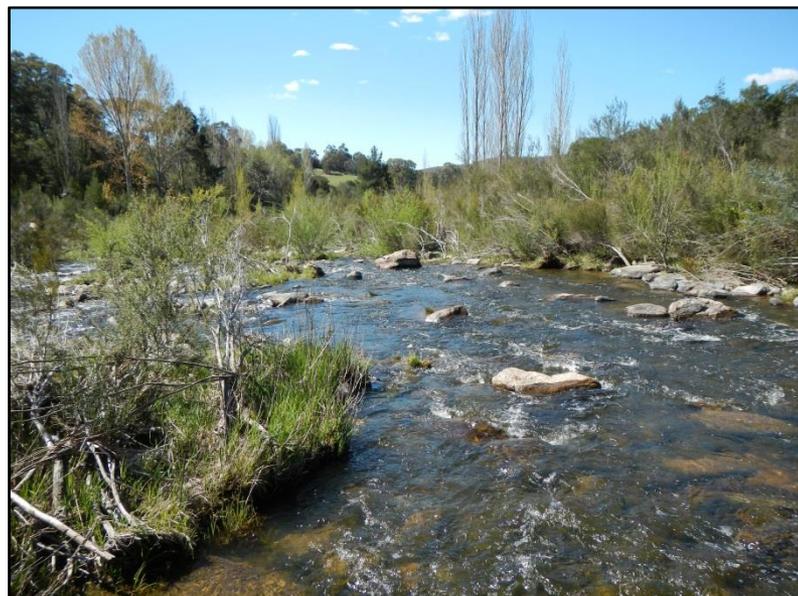
2 km Downstream of Googong Dam

Environmental flow ecological objective	Autumn 2014	Spring 2014	Objective met?
AUSRIVAS band A	Band B	Band B	No
<20% filamentous algae cover in riffle habitat	<10%	<10%	Yes

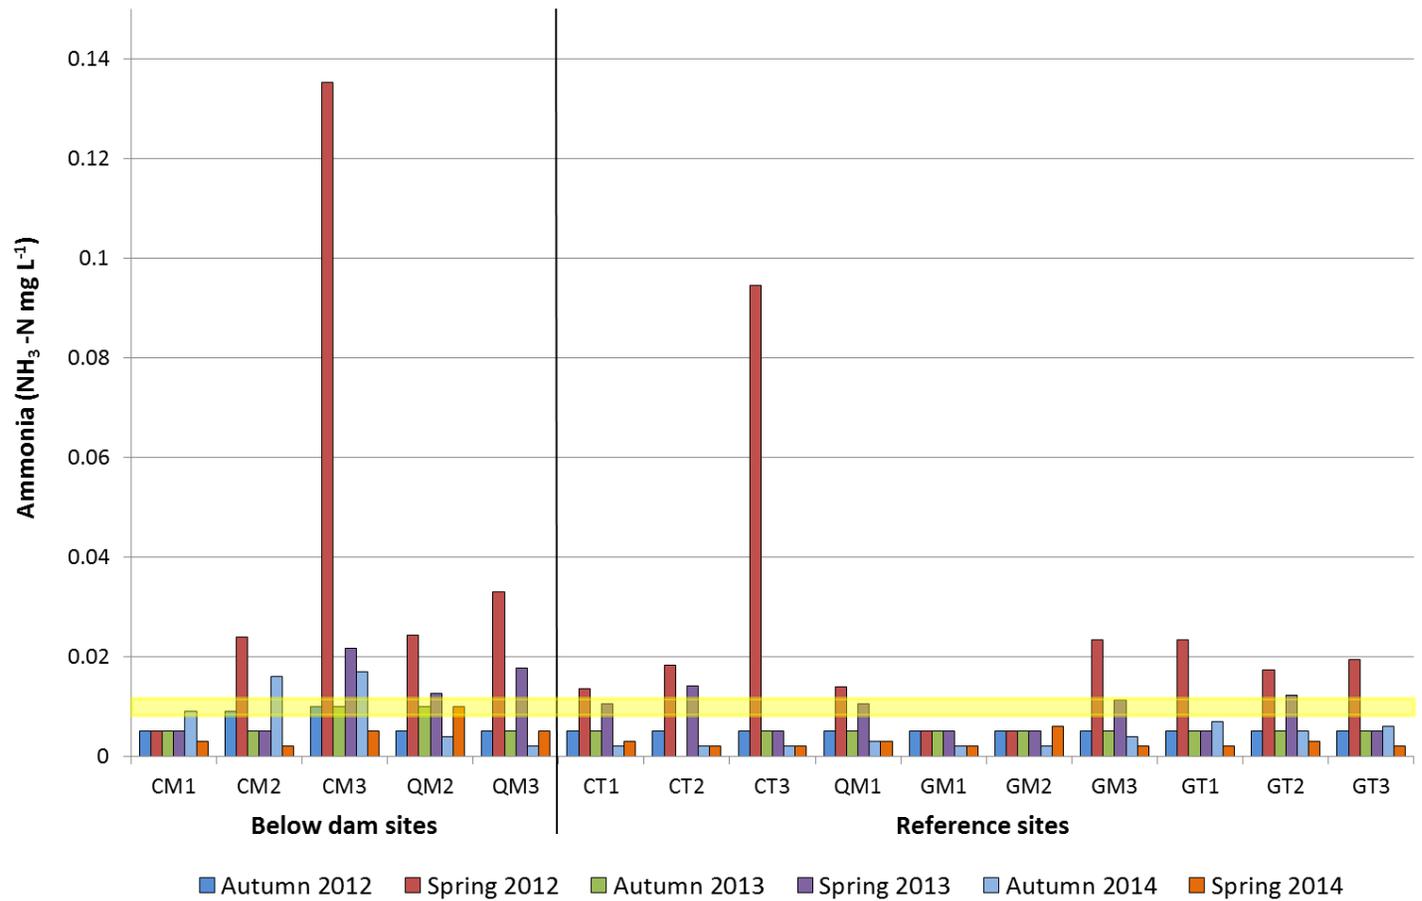
Ammonium (NH₄⁺) concentration at all sites from autumn 2012 to spring 2014. Values below the minimum detectable limit of 0.002 mg L⁻¹ are shown at 0.001 mg L⁻¹. The ANZECC/ARMCANZ (2000) guideline concentration for ammonium (NH₄⁺) is shaded yellow.

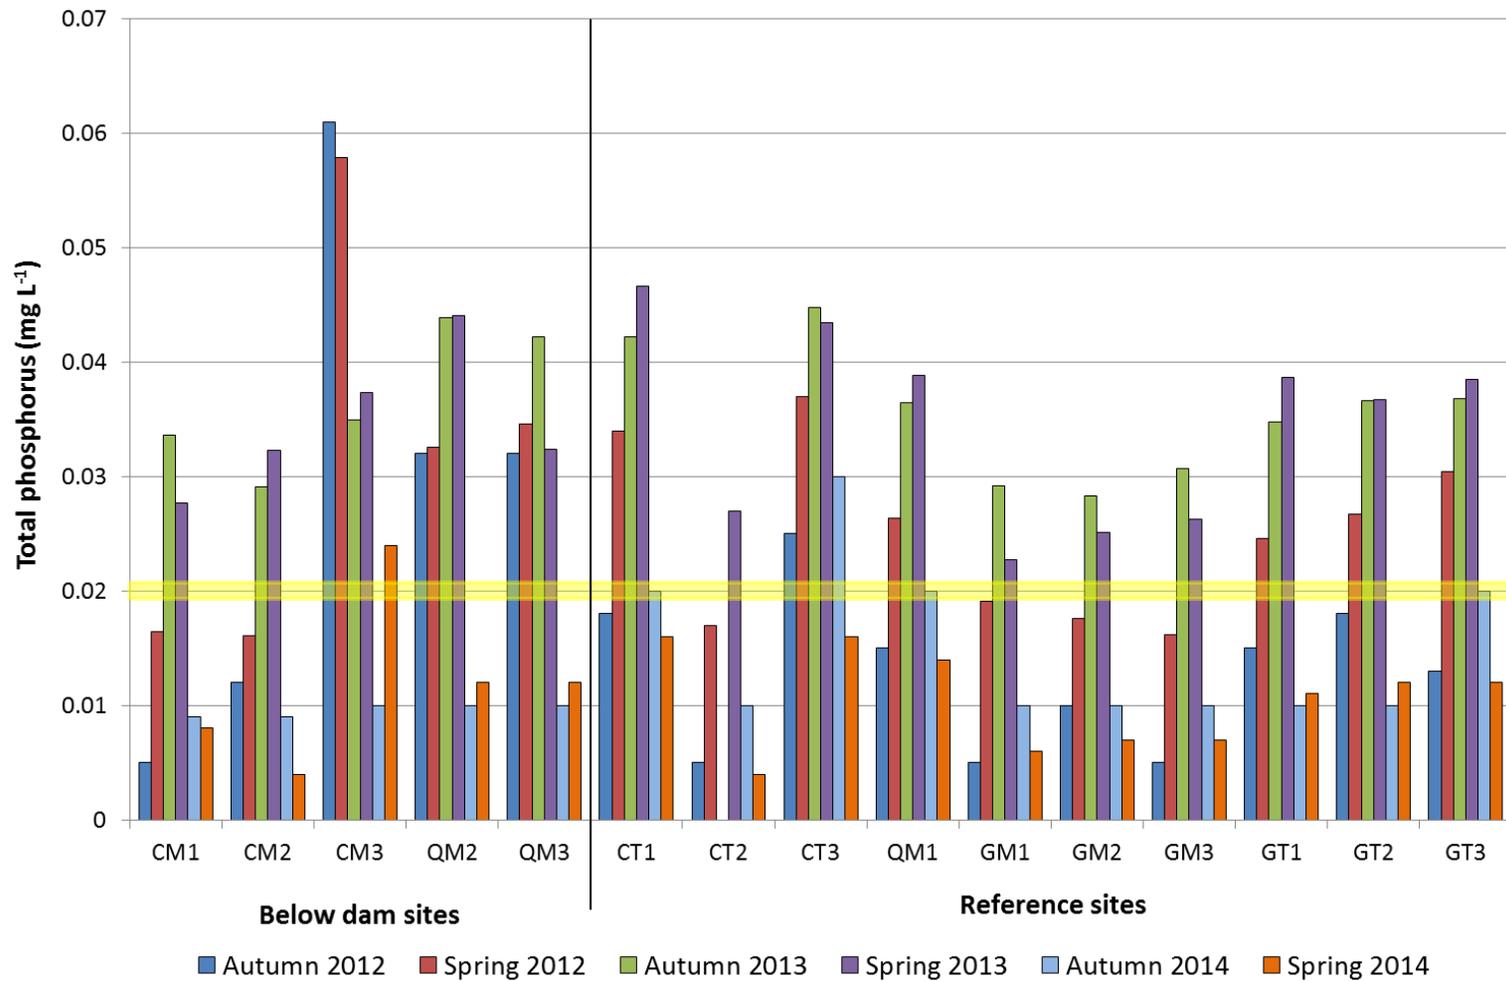
Total phosphorus concentrations at all sites from autumn 2012 to spring 2014. Values below the minimum detectable limit of 0.01 mg L⁻¹ are shown at 0.005 mg L⁻¹. The ANZECC/ARMCANZ (2000) guideline concentration for total phosphorus is shaded yellow.

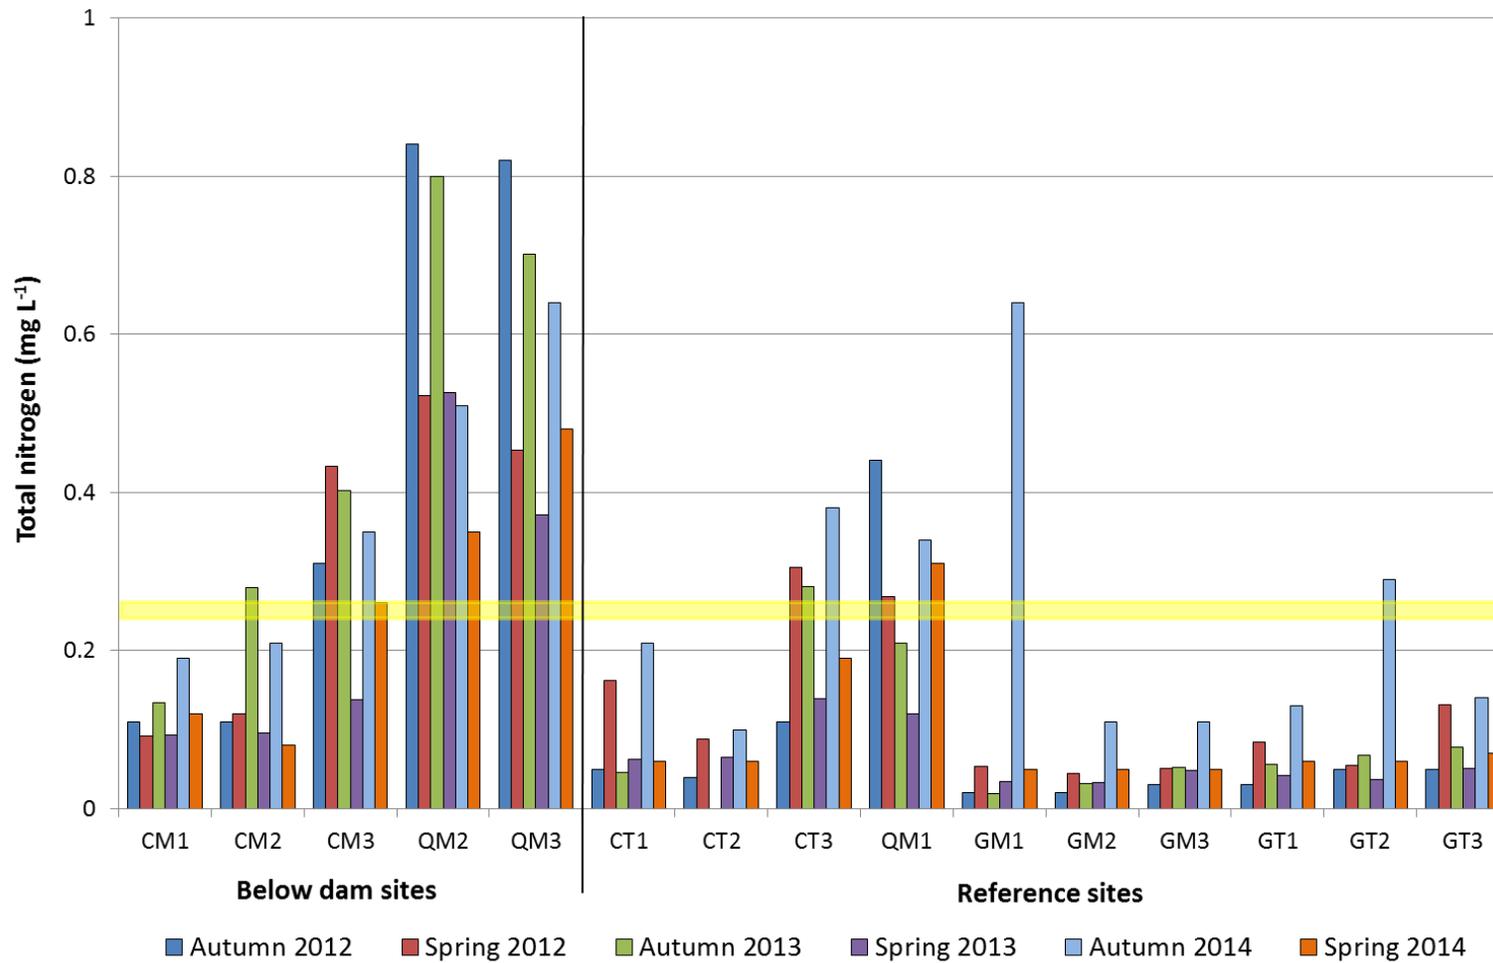
Total nitrogen concentrations at all sites from autumn 2012 to spring 2014. Values below the minimum detectable limit of 0.01 mg L⁻¹ are shown at 0.005 mg L⁻¹. The ANZECC/ARMCANZ (2000) guideline concentration for total nitrogen is shaded yellow.

Total nitrogen (TN) and nitrogen oxides (NO_x) exceeded guideline concentrations downstream of Googong Dam (site QM2 and QM3) in spring 2014 (Table 5). Only TN exceeded the guideline concentration at reference site QM1 upstream of Googong Dam (Table 5). Above guideline NO_x and TN concentrations downstream of Googong Dam are likely to be the result of water quality conditions in Googong Dam and inflows from the upstream catchment (e.g. above guideline TN concentrations at site QM1 – Table 5). Historically, NO_x and TN concentrations have been above guideline levels downstream of Googong Dam, because of increased concentrations from inflow into Googong Dam during the 2010 and 2012 floods.

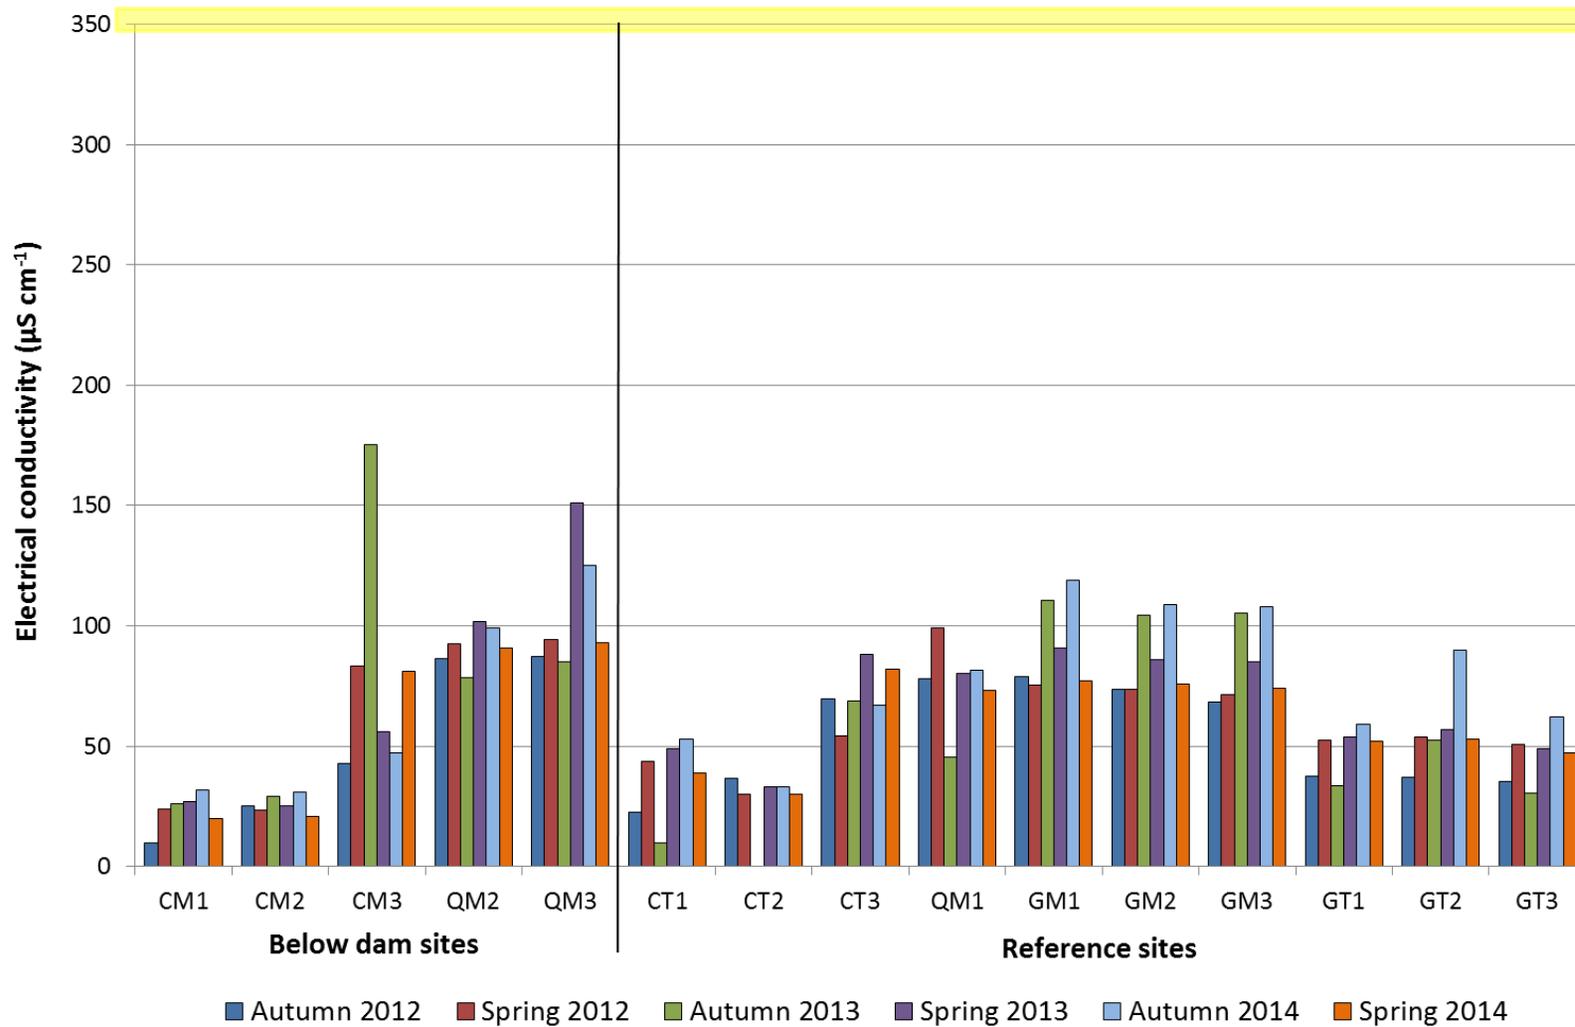
Electrical conductivity at all sites from autumn 2012 to spring 2014. The ANZECC/ARMCANZ (2000) guideline for electrical conductivity is shaded yellow.

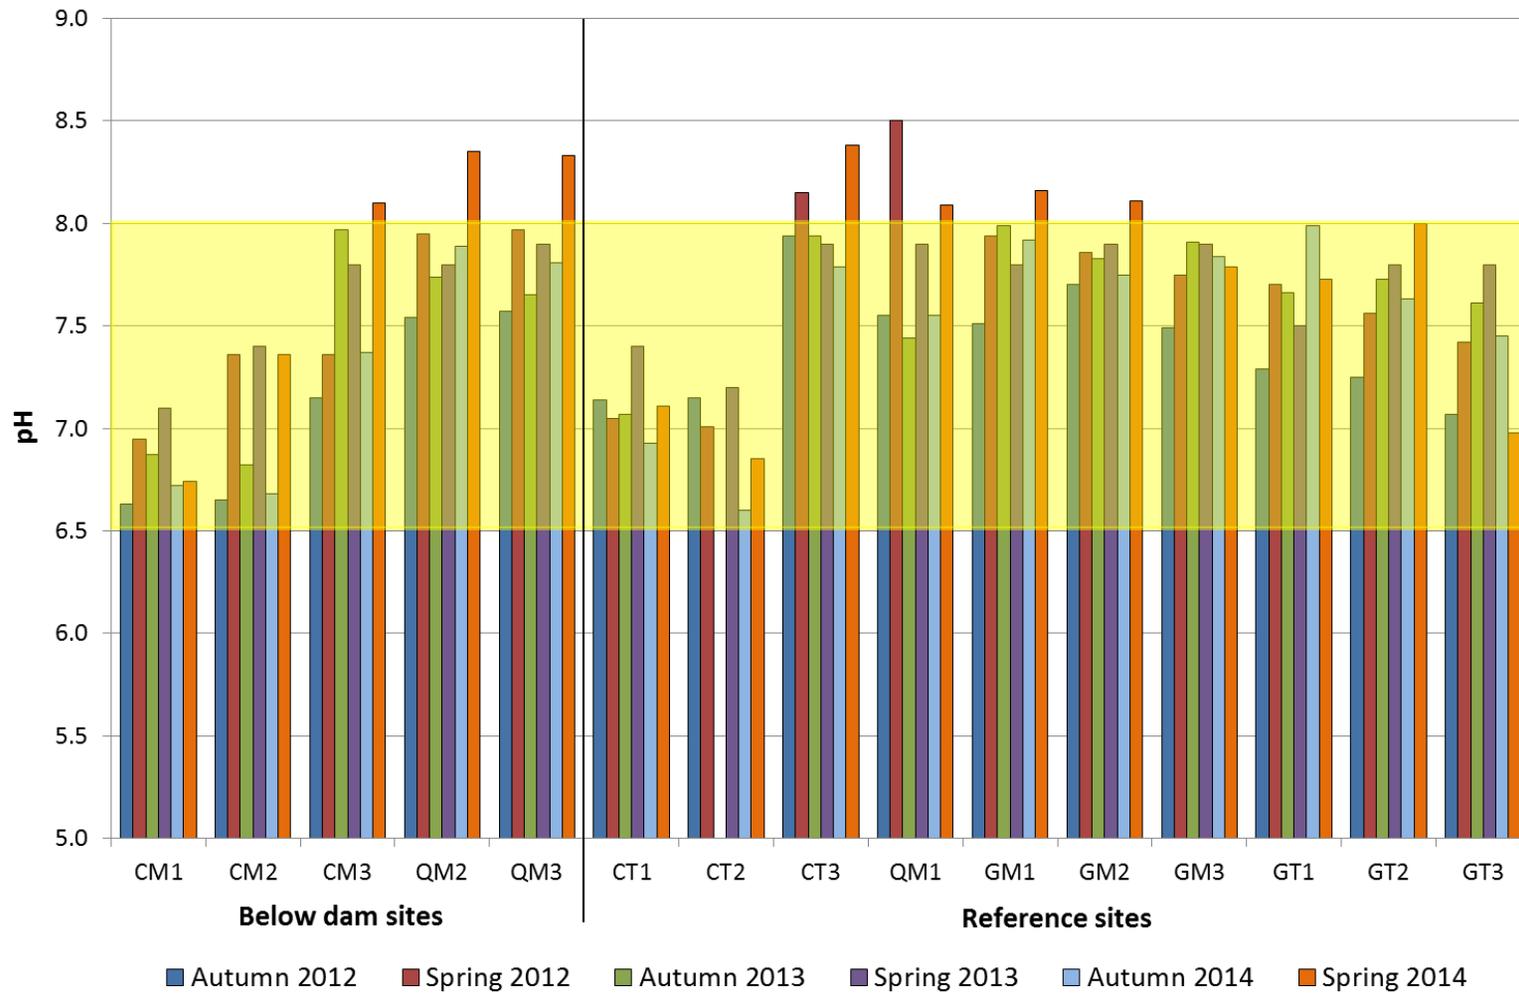
pH at all sites from autumn 2012 to spring 2014. The ANZECC/ARMCANZ (2000) guideline for pH is shaded yellow.

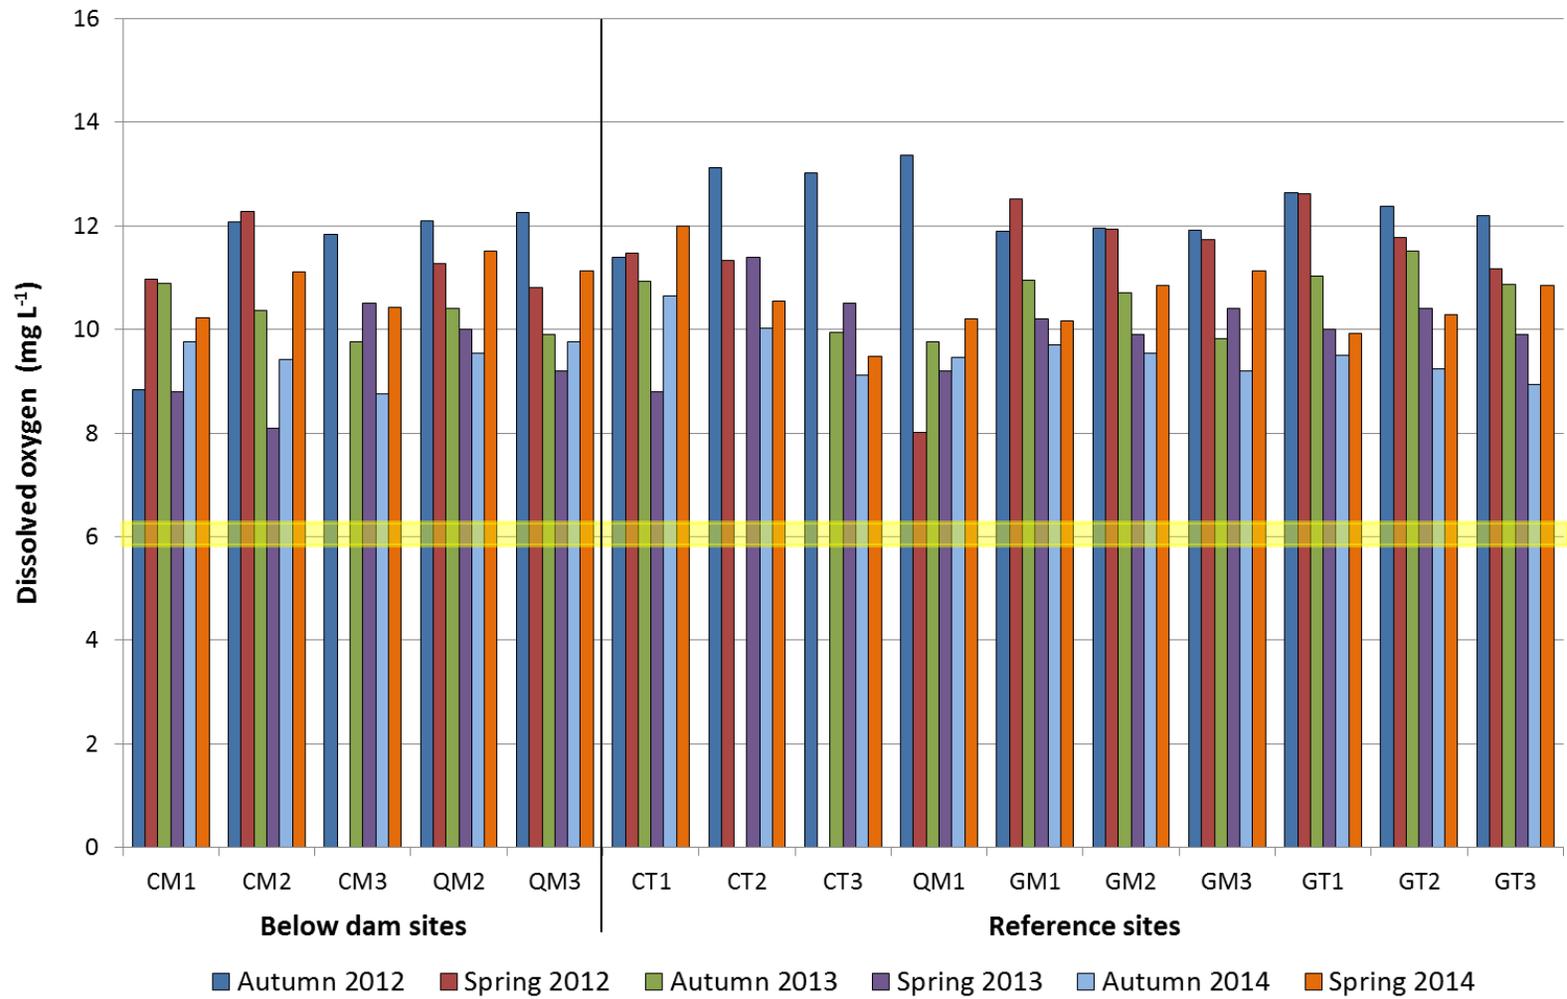
Dissolved oxygen concentration at all sites from autumn 2012 to spring 2014. The minimum guideline for electrical conductivity is shaded yellow (Environment Protection Regulation SL2005-38).

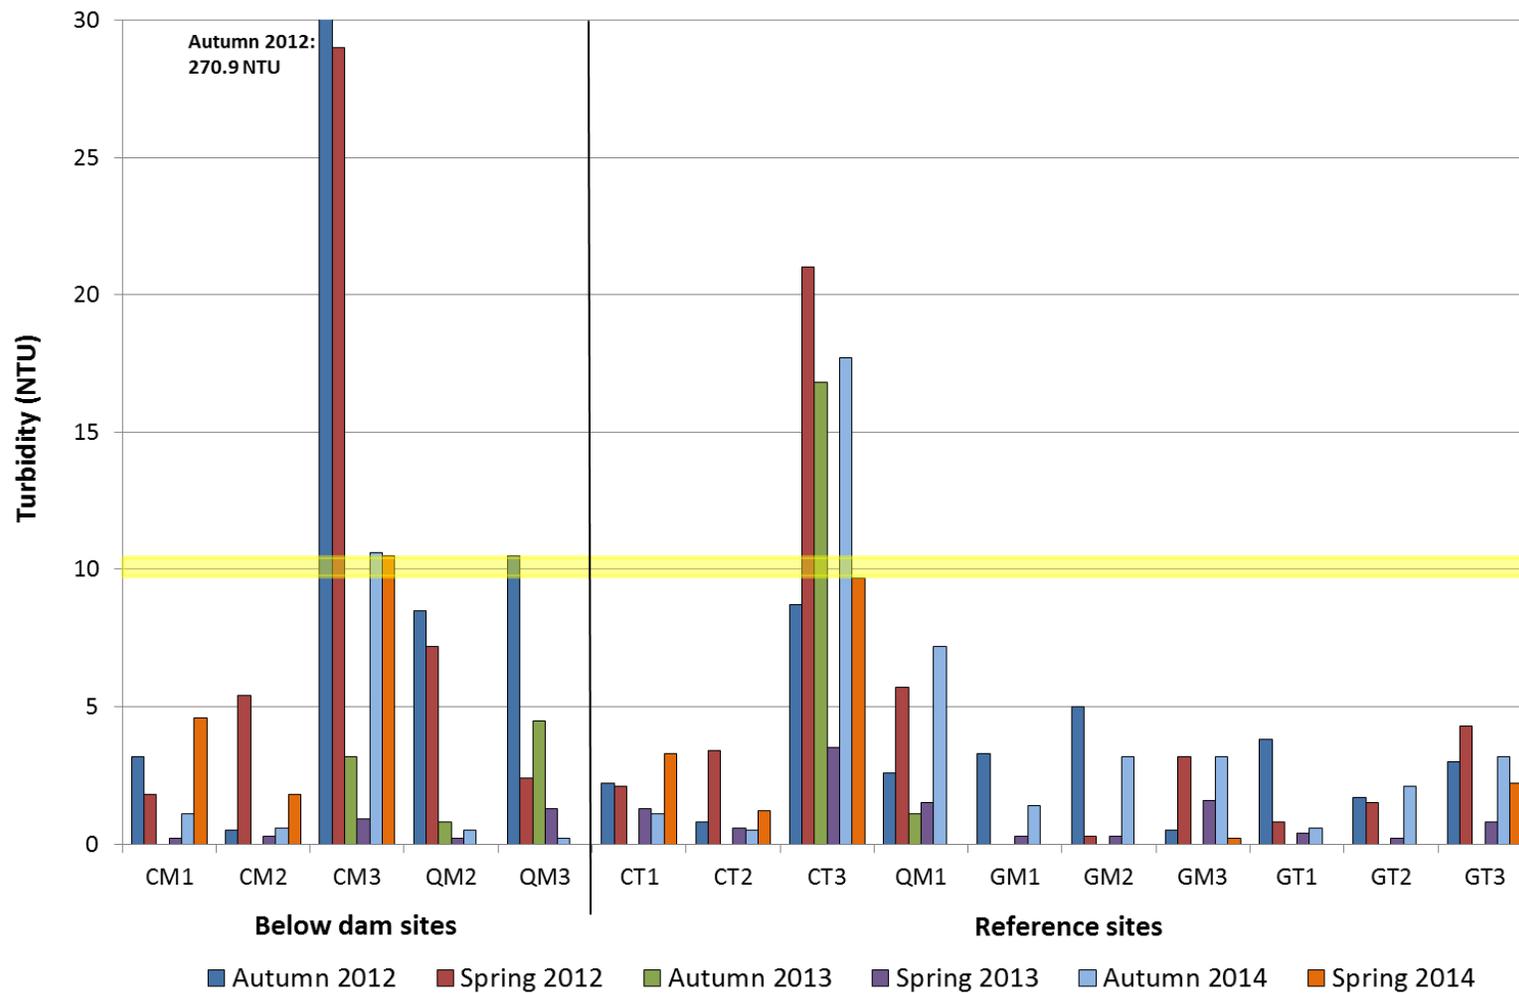
Turbidity at all sites from autumn 2012 to spring 2014. The guideline for turbidity is shaded yellow (Environment Protection Regulation SL2005-38).
