M2G Offset Property Monitoring Report

Autumn 2013

Prepared for
ACTEW Water

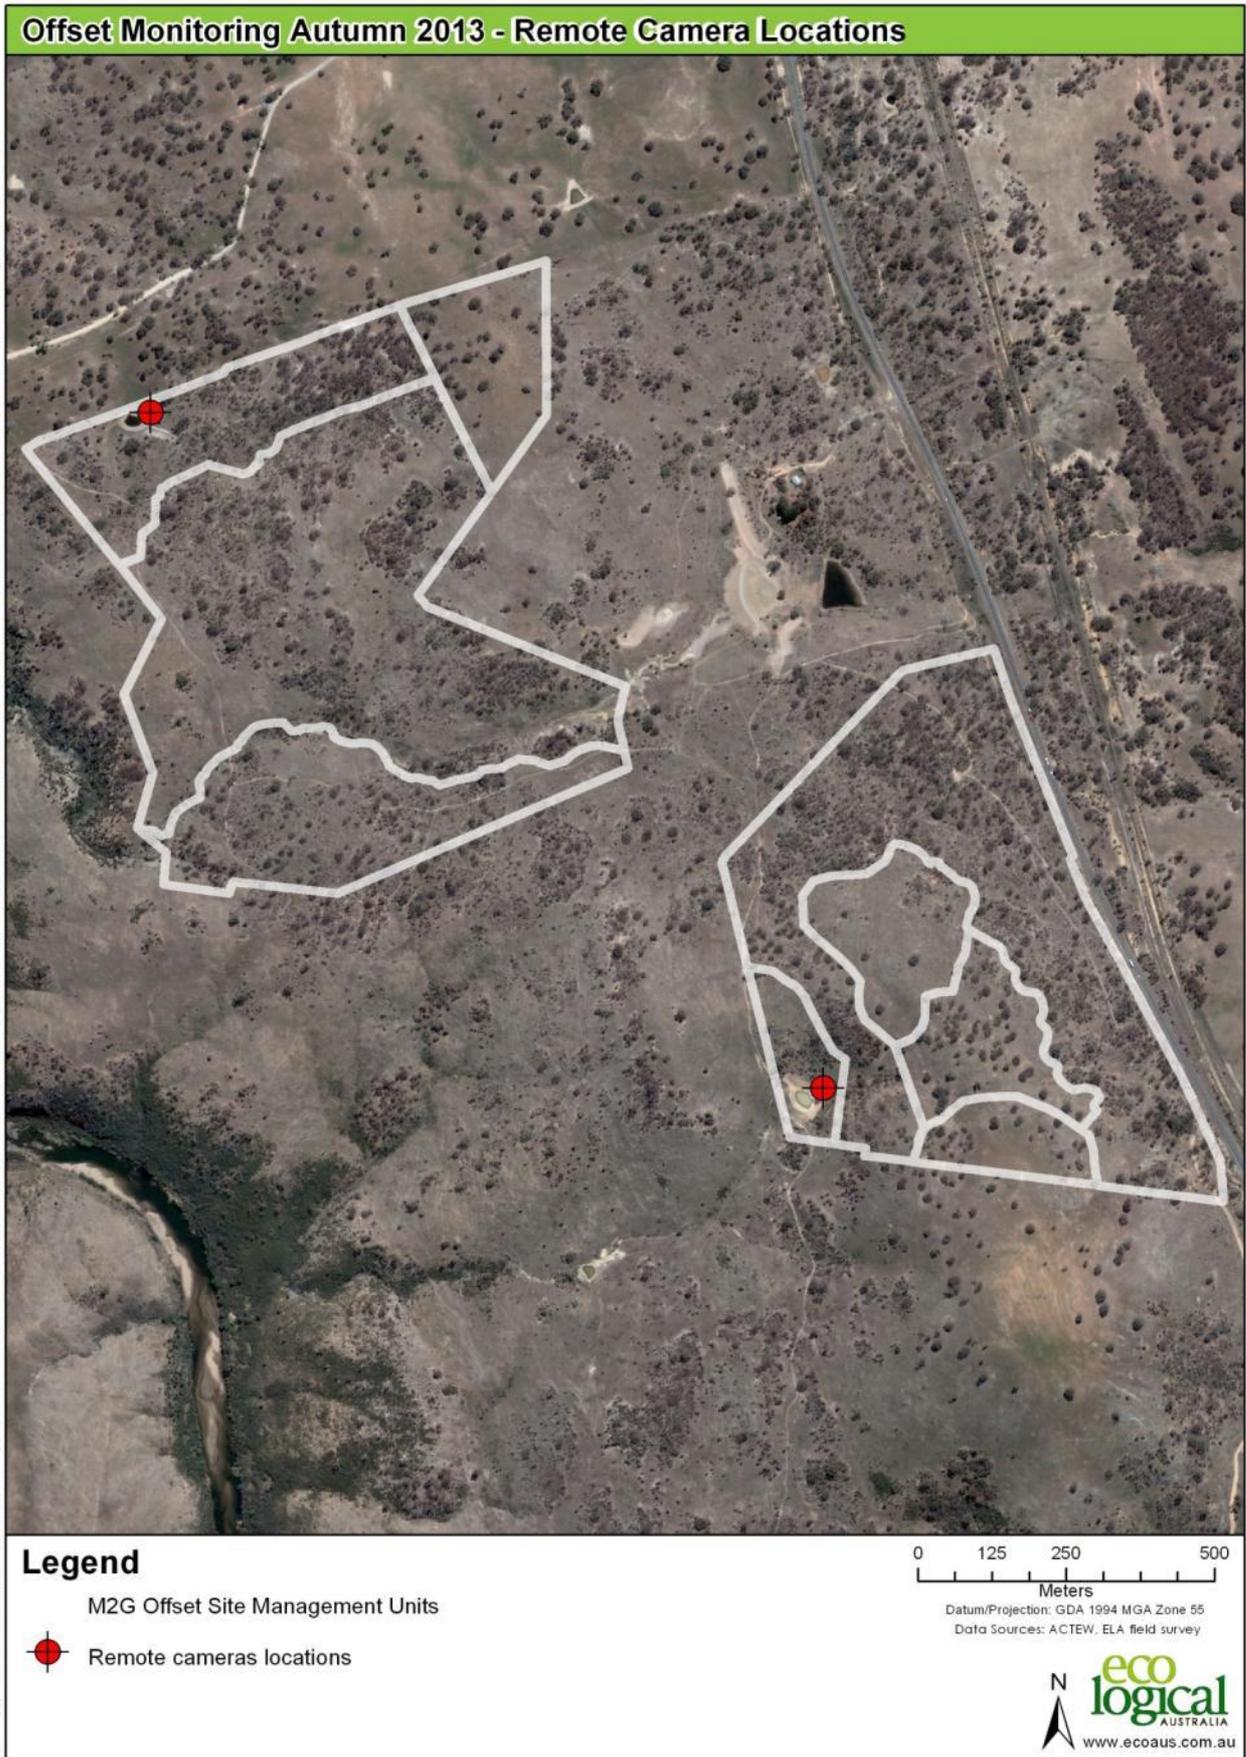
Figure 3: Management Units and monitoring plot and infra-red camera locations

The locations of the infra-red cameras are shown in **Figure 3**.

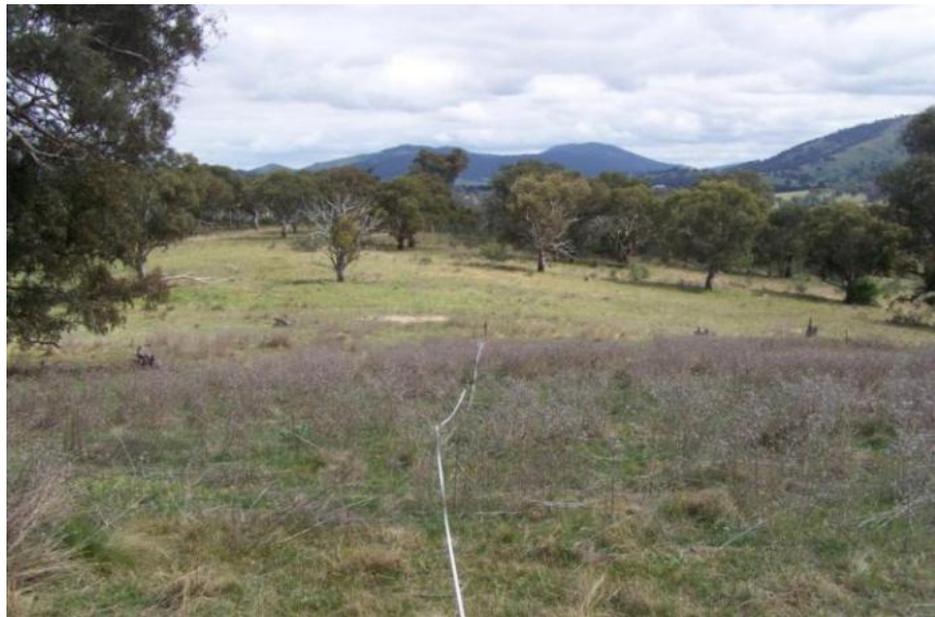
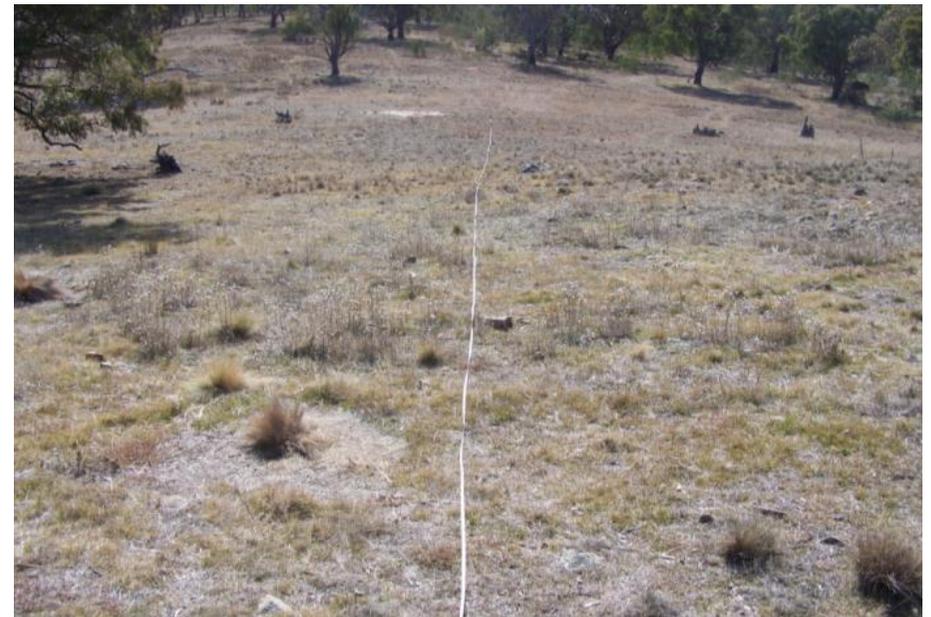
Figure 4: Monitoring Plot 1. (Left: Baseline monitoring photo, March 2012. Right: Monitoring photo May 2013)

Monitoring plot 1 is located within MU1 on the southern offset. The monitoring plot is composed of relatively lower condition Box-Gum Woodland. Natural regeneration of the overstorey was present with a low number of saplings observed within the monitoring plot. This is in comparison to no regeneration recorded during the baseline surveys. Native species diversity was low (10 species) which is probably a reflection of the time of year as well as the climatic conditions experienced over the previous months. Despite low native diversity, the plot was still dominated by native species. The dominant species included *Austrostipa* spp., *Microlaena stipoides* (Weeping Grass) and *Carex inversa* (Common Sedge). It was noted that several Serrated Tussock (*Nassella trichotoma*) individuals sprouted following weed control works within and adjacent to the plot.

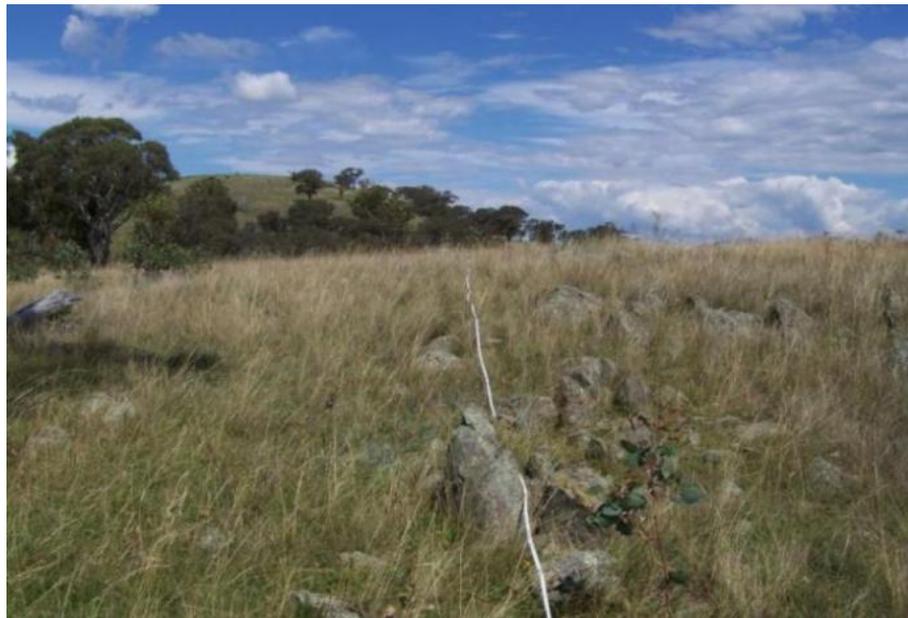
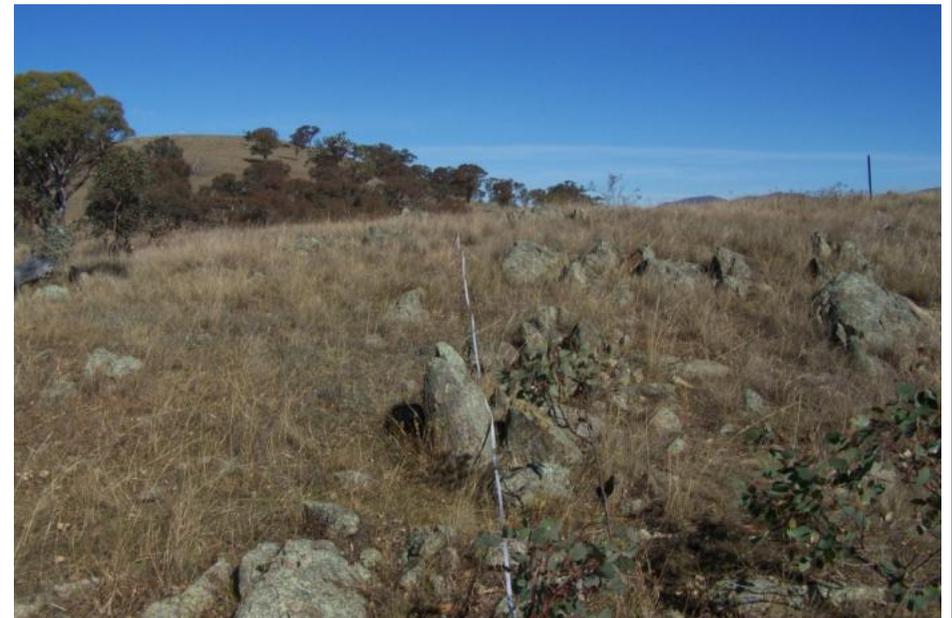
Figure 5: Monitoring Plot 2. (Left: Baseline monitoring photo, March 2012. Right: Monitoring photo May 2013)

Monitoring plot 2 is located within MU2 within the southern offset. It is situated on a rocky hill containing Pink-tailed Worm Lizard habitat. It contains relatively good condition mature Box-Gum Woodland with limited regeneration present. It contains a moderate to high diversity of native understorey species and is generally devoid of exotic grasses. The groundlayer is dominated by *Austroanthonia* spp., *Austrostipa* spp. and *Chrysocephalum apiculatum* (common everlasting). The autumn 2013 monitoring surveys recorded 31 native species.

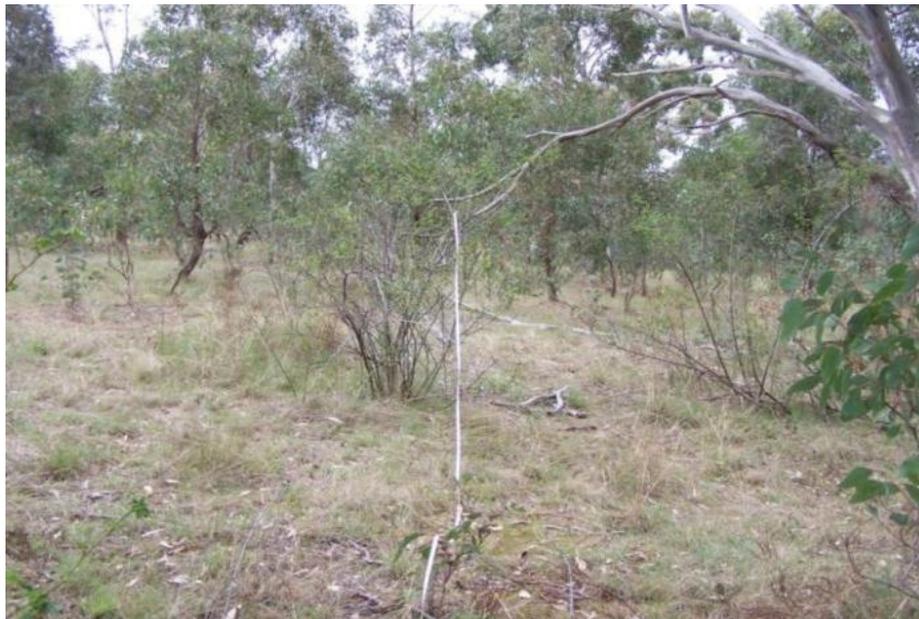
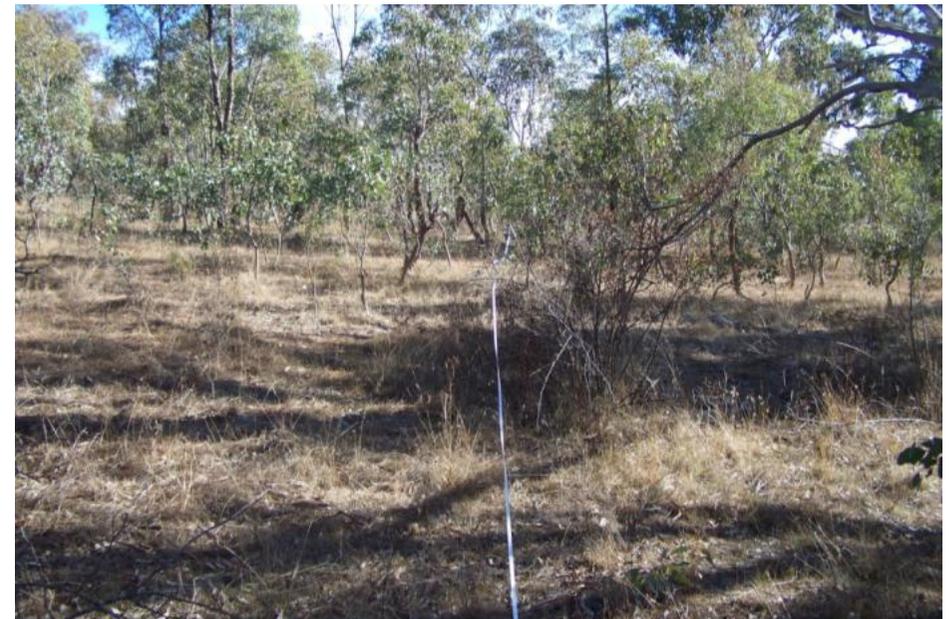
Figure 6: Monitoring Plot 3. (Left: Baseline monitoring photo, March 2012. Right: Monitoring photo May 2013)

Monitoring plot 3 is located within MU3. The plot is located in moderate to good quality Box-Gum Woodland. The plot is dominated by mature *E. blakelyi* and a significant amount of natural regeneration is present. A diverse understorey exists with dominant species including *Themeda australis* (Kangaroo Grass), *Austrodanthonia* spp. (Wallaby Grasses) and *Bothriochloa macra* (Red-leg Grass). The understorey has a high diversity of native species (30) which is an increase compared to the baseline monitoring diversity (26). Seasonal variation in the understorey can be seen in the photos below. Weed control activities undertaken in 2012 targeted Sweet Briar and appear to have been successful at this stage.

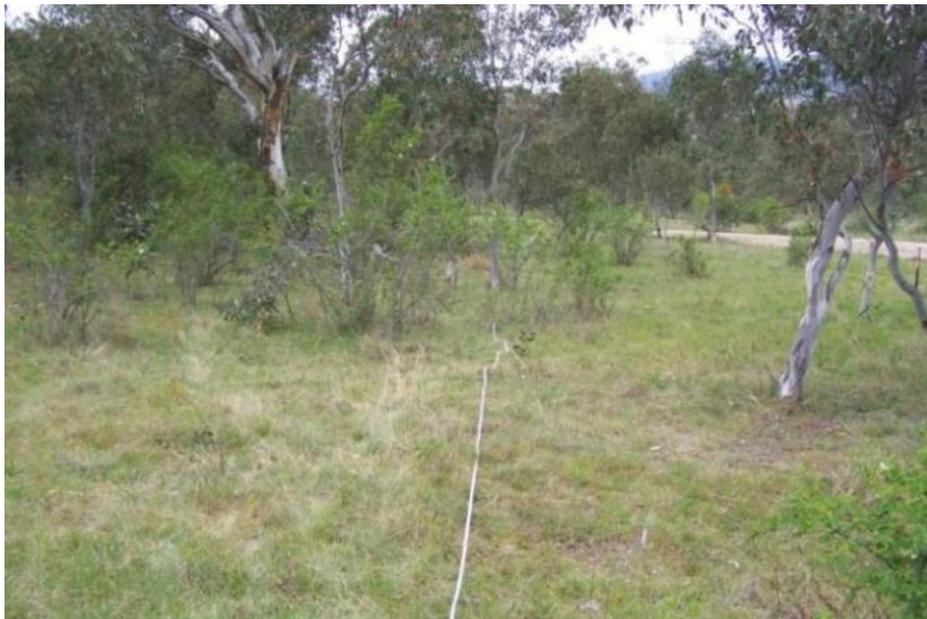
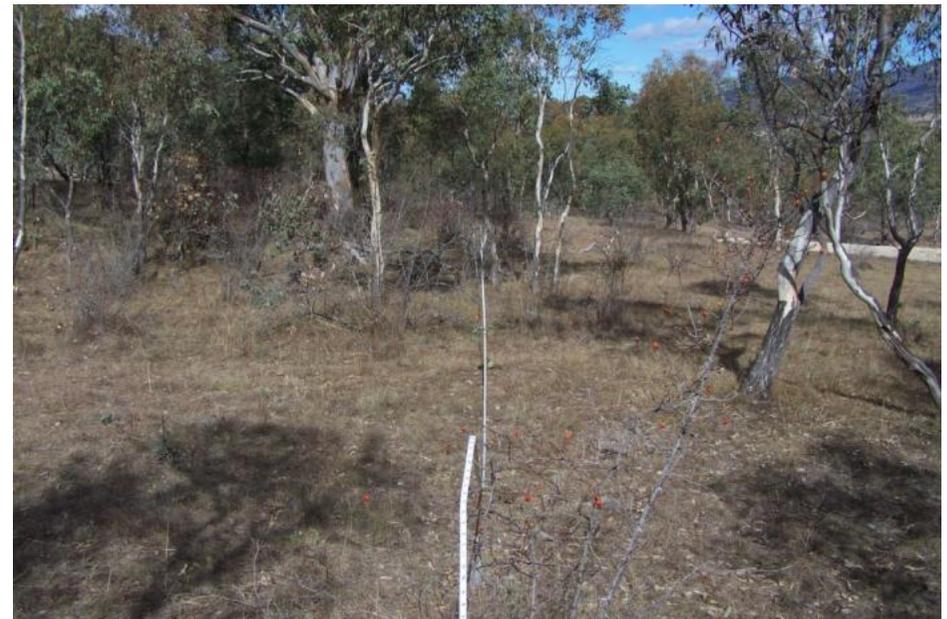
Figure 7: Monitoring Plot 1. (Left: Baseline monitoring photo, March 2012. Right: Monitoring photo May 2013)

Monitoring plot 4 is located in the northern offset in MU4. The plot is located in moderate to good quality Box-Gum Woodland dominated by *E. blakelyi*. The plot supports a highly diverse understorey composed of 34 native species compared to 26 recorded in the baseline surveys. The dominant species are *Themeda australis*, *Schoenus apogon* and *Haloragis heterophylla*. The woody weed, *R. rubiginosa* comprise the majority of the mid-storey and was targeted in the weed control activities undertaken in 2012. At the time of monitoring, control appeared successful. A moderate to strong level of regeneration exists within the MU with a qualitative assessment indicating an increase in regeneration (*Eucalyptus* spp., *Dodonaea viscosa*) compared to the baseline monitoring (prior to grazing exclusion).

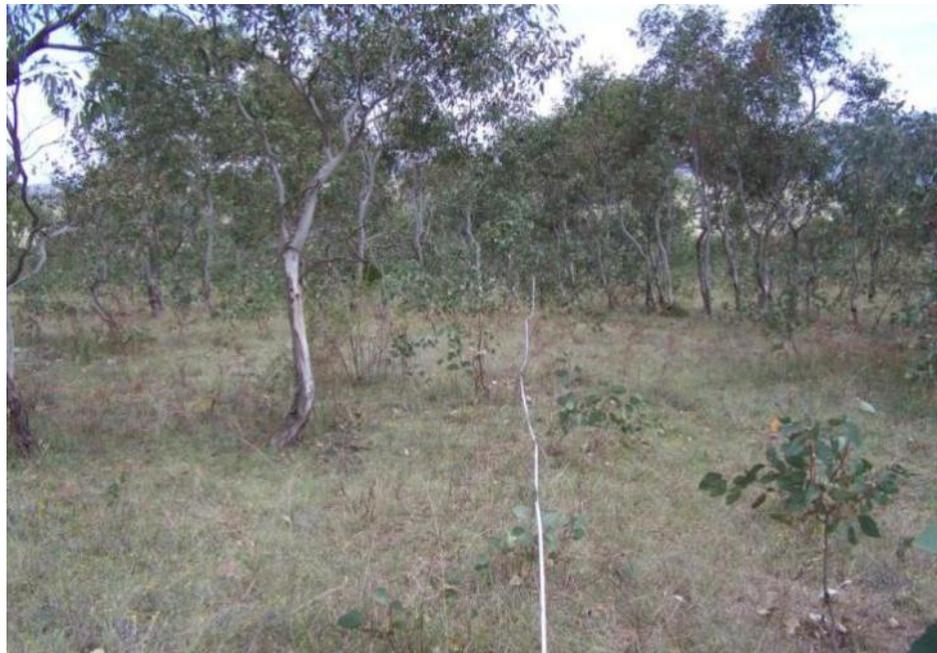
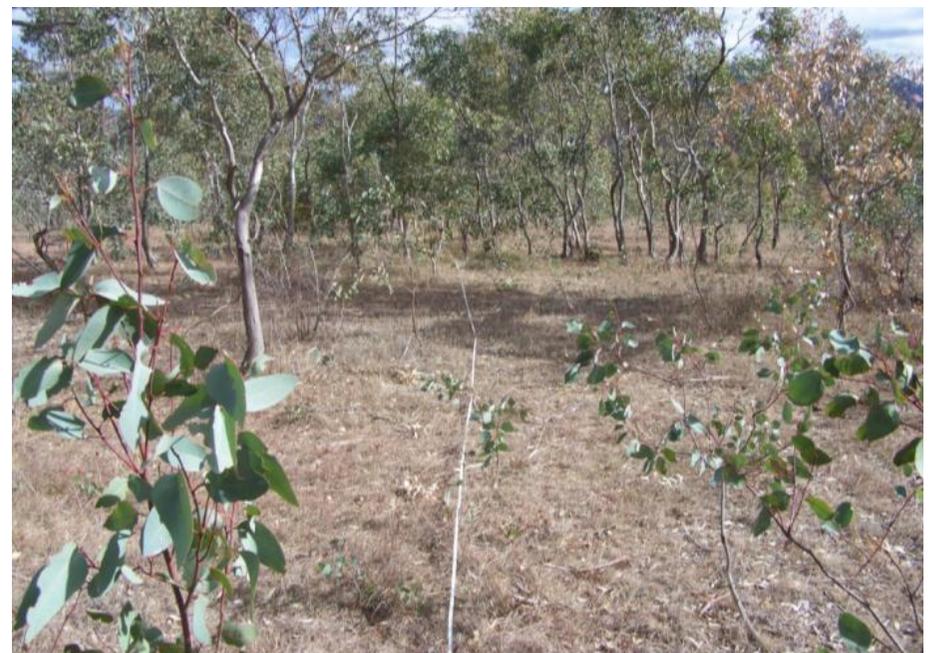
Figure 8: Monitoring Plot 1. (Left: Baseline monitoring photo, March 2012. Right: Monitoring photo May 2013)

Monitoring plot 5 is a control plot located in MU5. No management actions will occur within the bounds of the monitoring plot. Plot 5 is located in moderate-good quality Box-Gum Woodland dominated by *E. blakelyi* with a significant amount of natural regeneration present. The monitoring plot supports a highly diverse understorey of grasses, herbs and forbs with 60 native species recorded in spring 2012. However, only 27 species were recorded in autumn 2013. This is likely a result of natural seasonal variation as well as the lower rainfall recorded in the first quarter of 2013. The understorey is known to support a high diversity of forbs including typically grazing intolerant species, such as *Swainsona sericea*, *Microseris lanceolata*, *Arthropodium minus* and *Microtis unifolia* (recorded spring 2012).

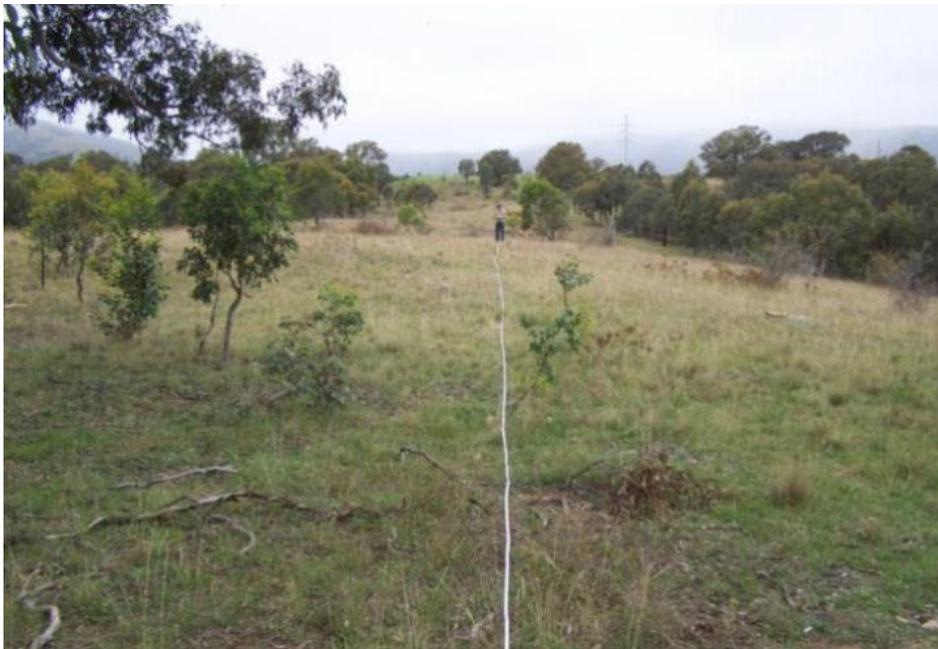
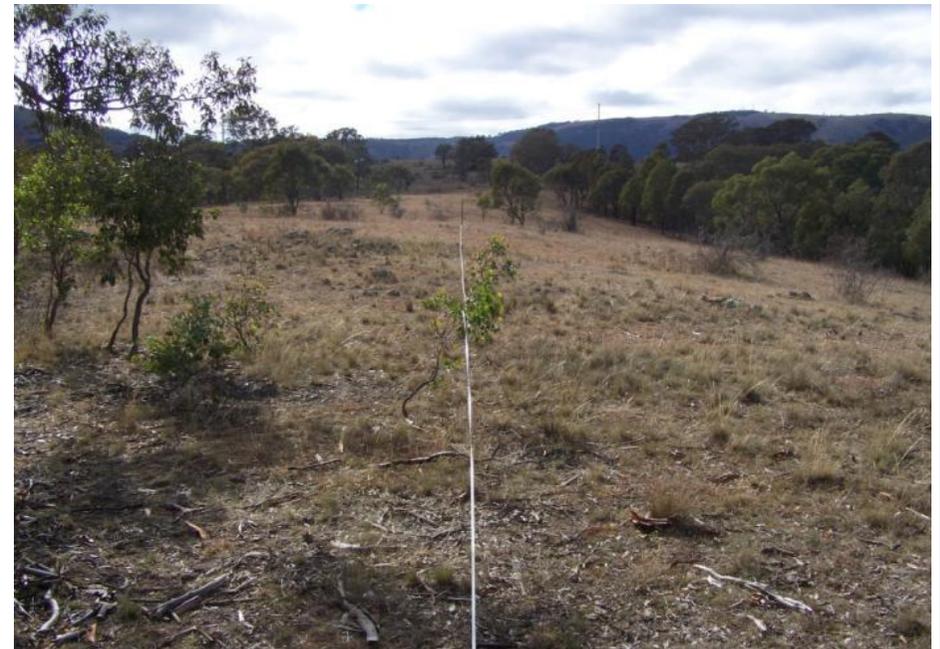
Figure 9: Monitoring Plot 1. (Left: Baseline monitoring photo, March 2012. Right: Monitoring photo May 2013)

Monitoring plot 6 is located in MU6 along the central ridge line, in moderate-good quality Box-Gum Woodland dominated by *E. blakelyi*. The plot supports a diverse under storey of grasses, herbs and forbs with 45 native species recorded in spring 2012. However, only 21 native species were recorded in autumn 2013, which is likely to reflect natural seasonal variation as well as climatic conditions. The understorey was dominated by native perennial tussock grasses including *Austrostipa* spp. Sweet Briar (*R. rubiginosa*) was present at low abundance in the plot and observed more broadly in the MU, however, weed control undertaken in 2012 appears to have been moderately successful in controlling this species.

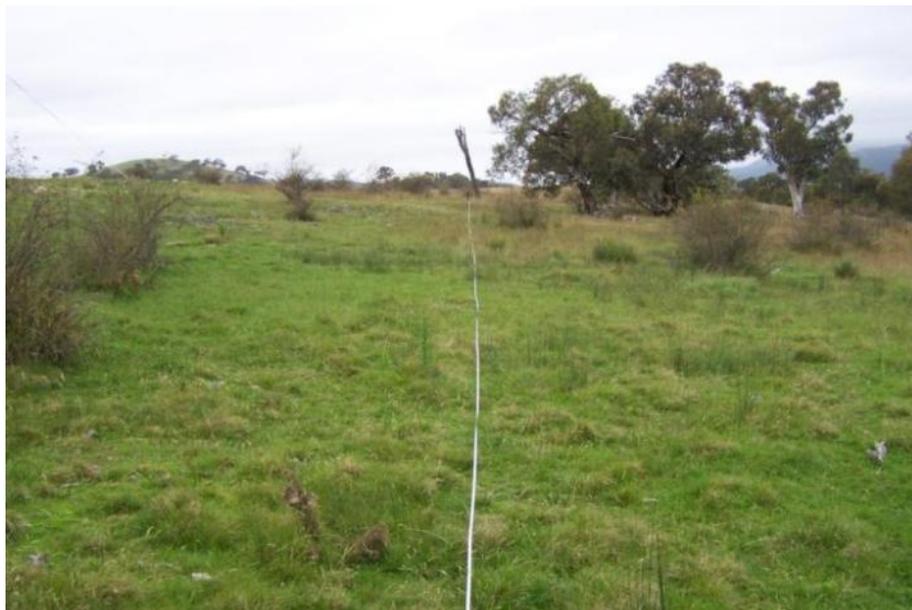
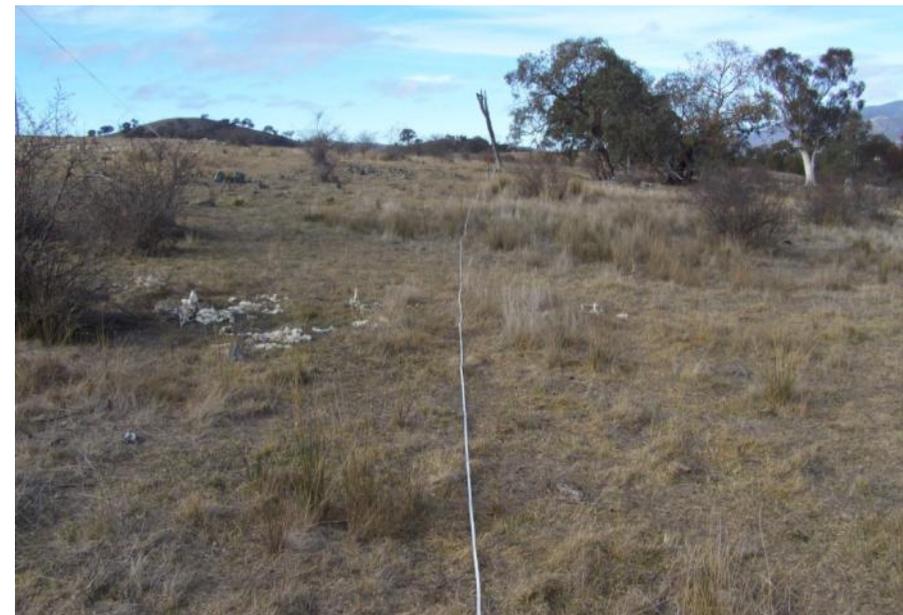
Figure 10: Monitoring Plot 1. (Left: Baseline monitoring photo, March 2012. Right: Monitoring photo May 2013)

Monitoring plot 7 is located within MU7 in the northern offset. The MU is composed of degraded Box-Gum Woodland dominated by *E. blakelyi*. However, no native overstorey or mid-storey was recorded within the plot. Native species diversity was low (10 species) in comparison with other monitoring plots with little change compared to the baseline surveys (13 native species). The plot is dominated by native species (predominantly sedges and rushes); however, evidence of the significant exotic annual cover recorded in spring 2012 still occurs on site. Sheep were observed grazing within MU7 over the monitoring period and have had a considerable impact on the vegetation within the management unit.

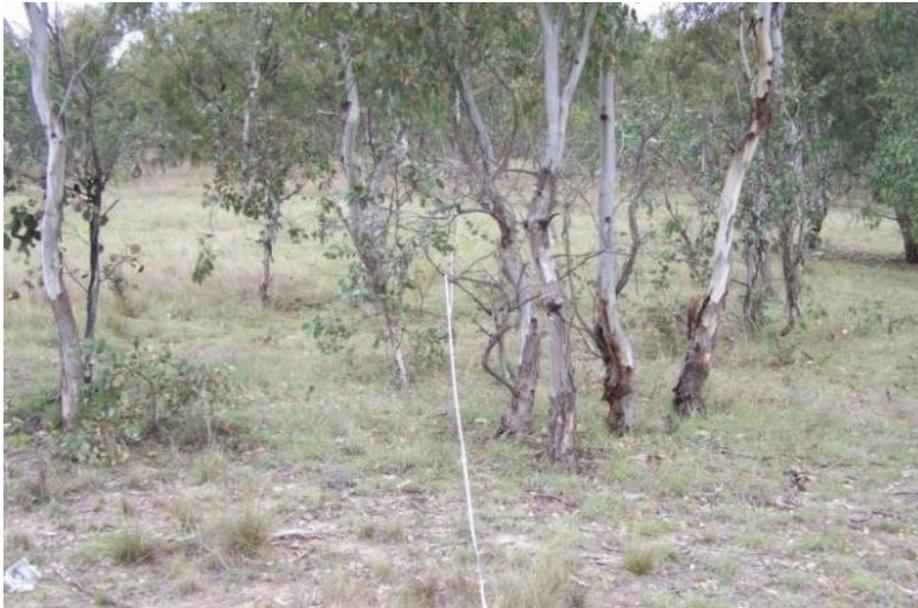
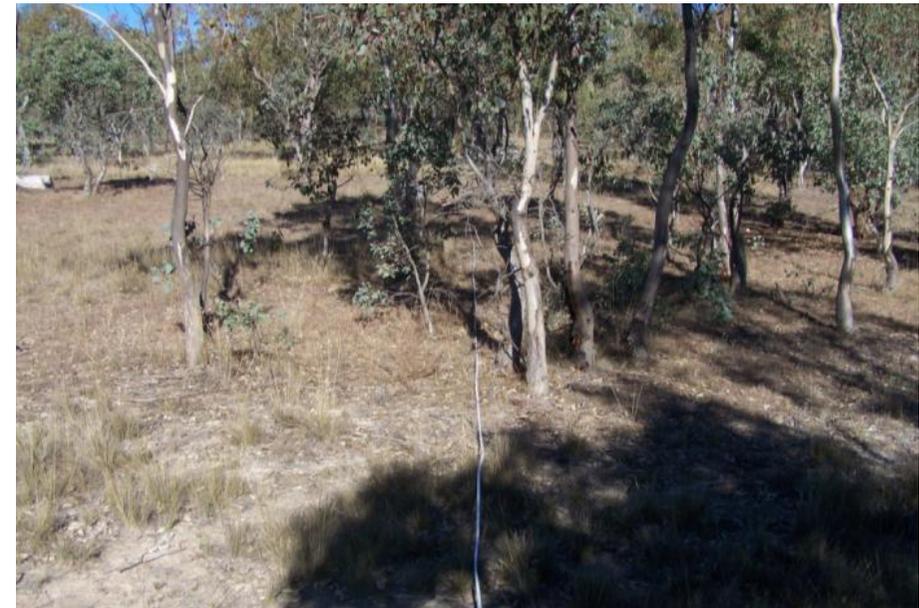
Figure 11: Monitoring Plot 1. (Left: Baseline monitoring photo, March 2012. Right: Monitoring photo May 2013)

Monitoring plot 8 (3b) is a control plot located in MU3. No management actions are proposed to occur within the bounds of the plot. The plot is located in good quality Box-Gum Woodland dominated by *E. blakelyi*. The plot supports a diverse understorey of grasses, herbs and forbs with 41 native species recorded in spring 2012. Of those, 26 native species were recorded in autumn 2013, which is likely to reflect natural seasonal variation as well as climatic conditions. The dominant understorey species included *Themeda australis*, *Austrodanthonia* spp. and *Chrysocephalum apiculatum*. Photo comparison shows a healthy understorey dominated by native species with good inter-tussock spacing.

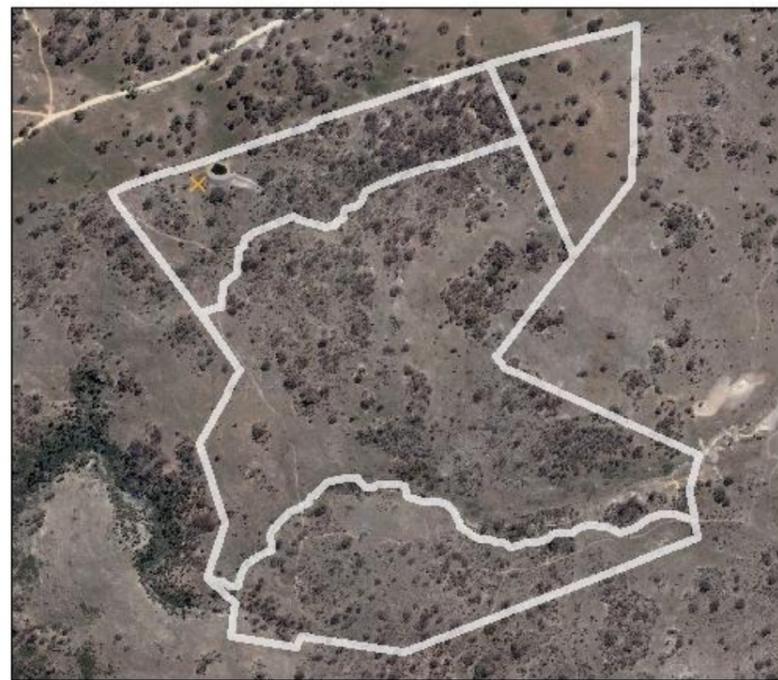
Figure 12: relative weed distribution, northern offset

The relative distribution of key weed species across the offset site has been mapped in **Figure 12** and **Figure 13**.

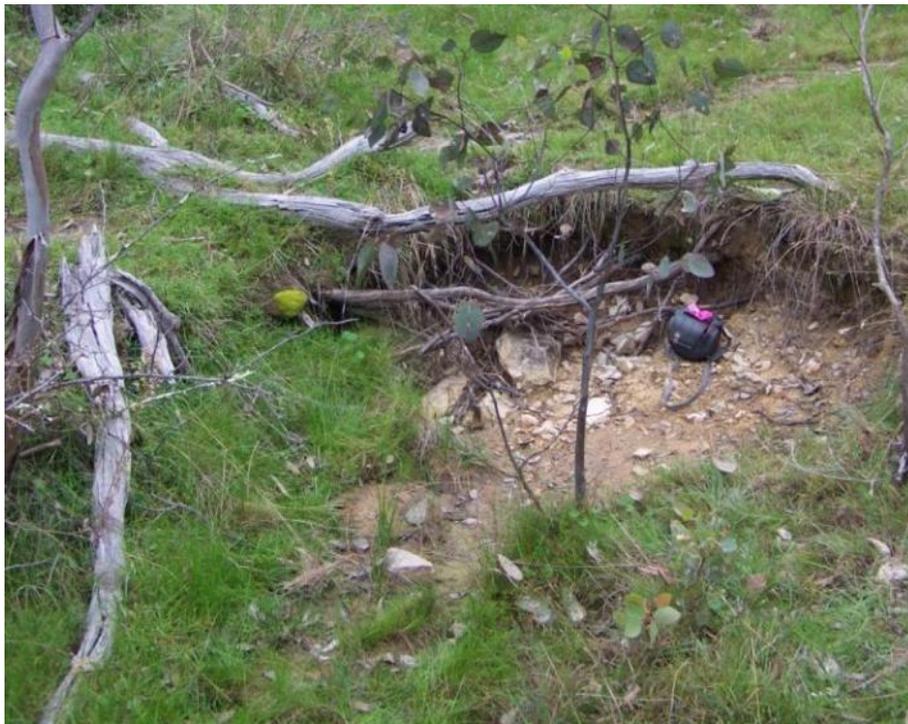
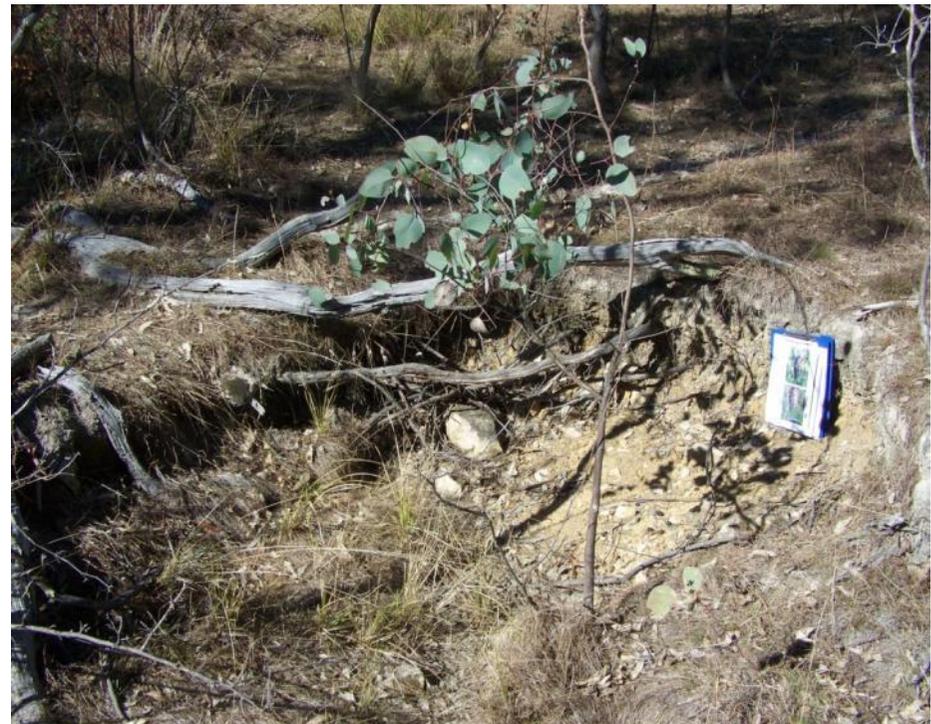
Change: No significant change observed compared to baseline monitoring.

Action required: No ground works required at this stage. Continue bi-annual monitoring.

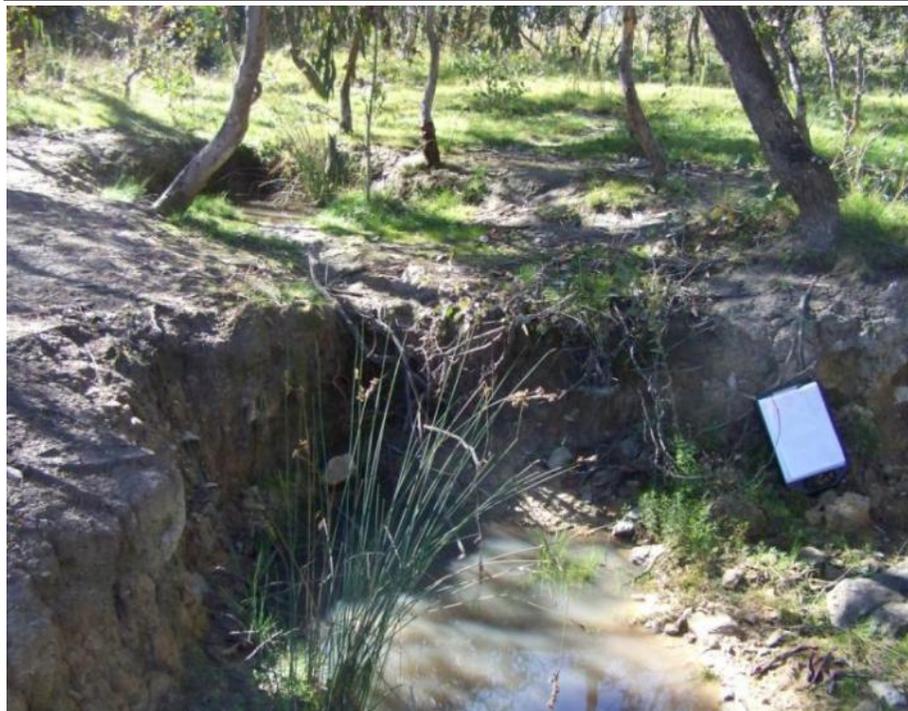
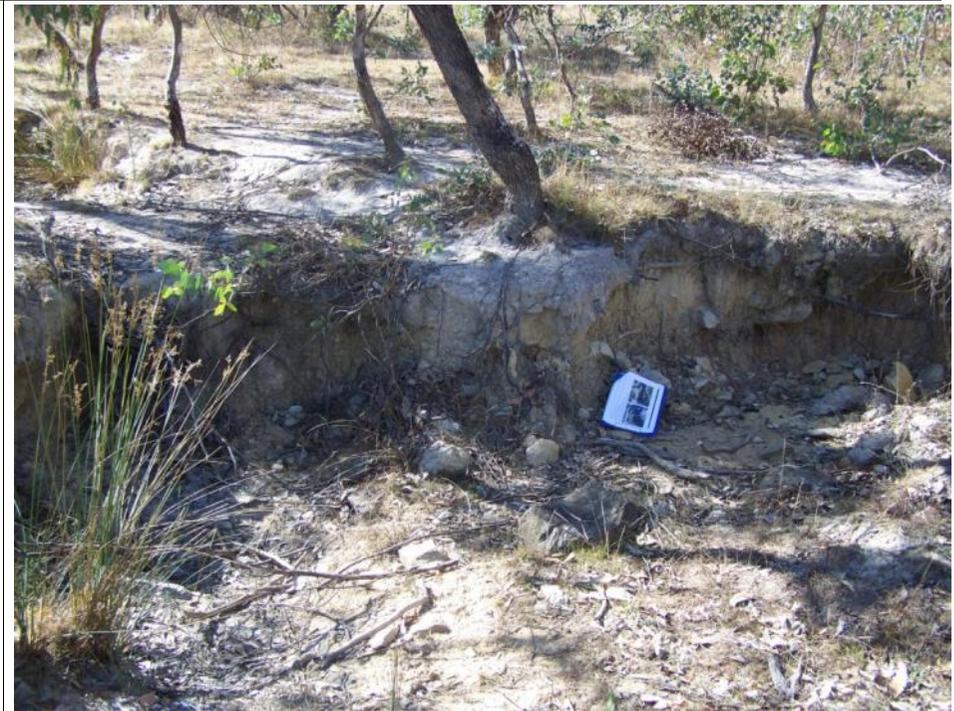
Erosion Point 2:

Change: No significant change observed since baseline monitoring survey.

Note: Autumn 2013 monitoring photo incorporates more of the erosion point on right hand-side of the photo.

Action required: No works required at this stage. Continue bi-annual monitoring.

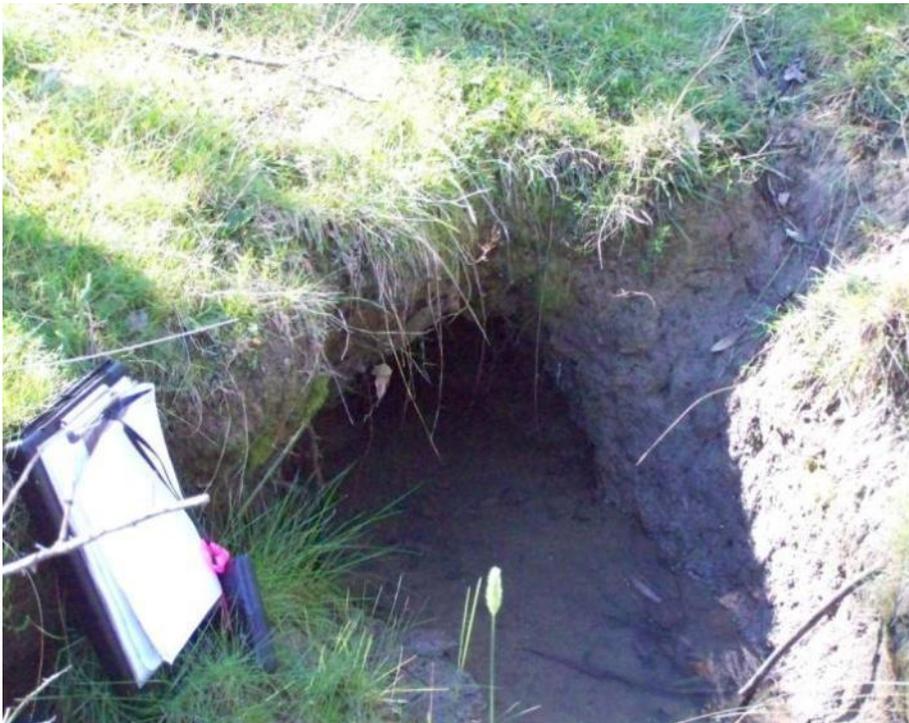
Erosion Point 3:

Change: No significant change observed since baseline monitoring survey.

This erosion point has been re-assessed and is recommended to be removed from future monitoring. The site is a slow moving ephemeral drainage line where a number of other points are being used to monitoring the occurrence of erosion.

Action required: No works required at this stage. Recommended to cease bi-annual monitoring.

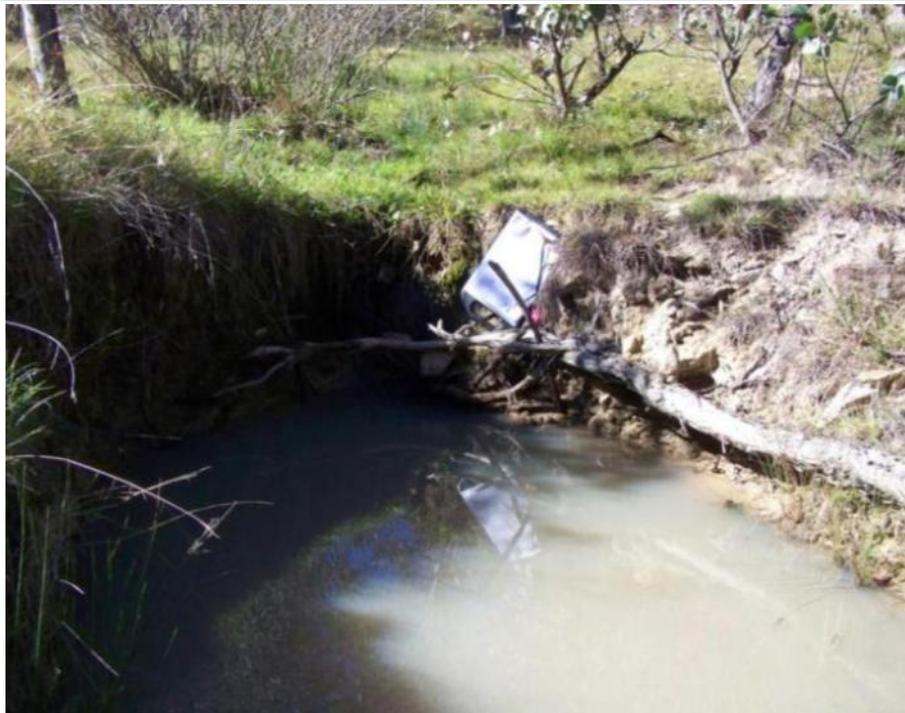
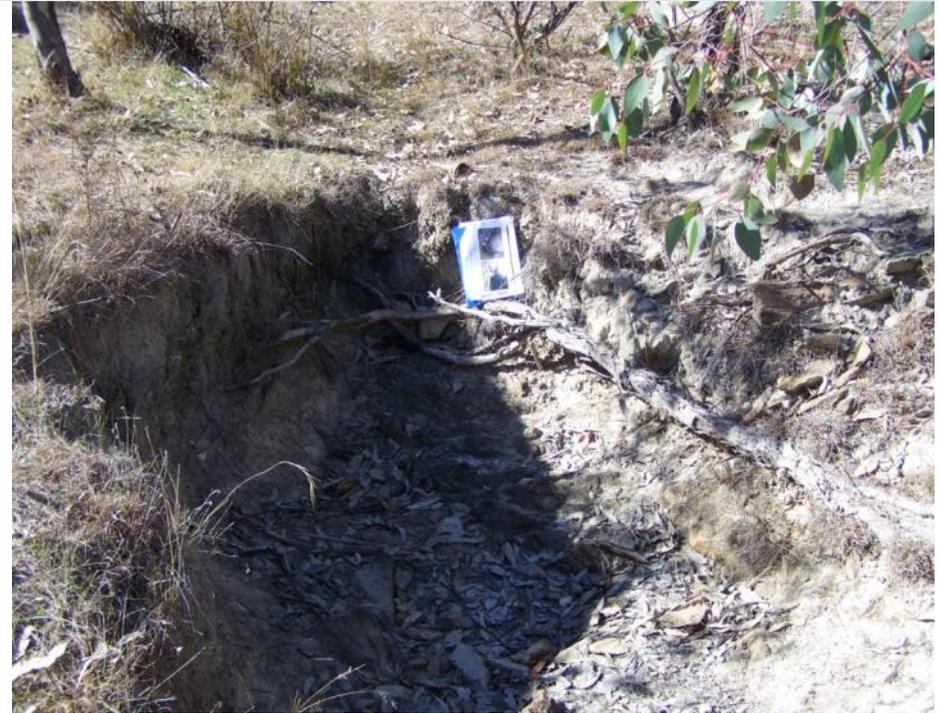
Change: No significant change observed since baseline monitoring survey.

Action required: No works required at this stage. Continue bi-annual monitoring.

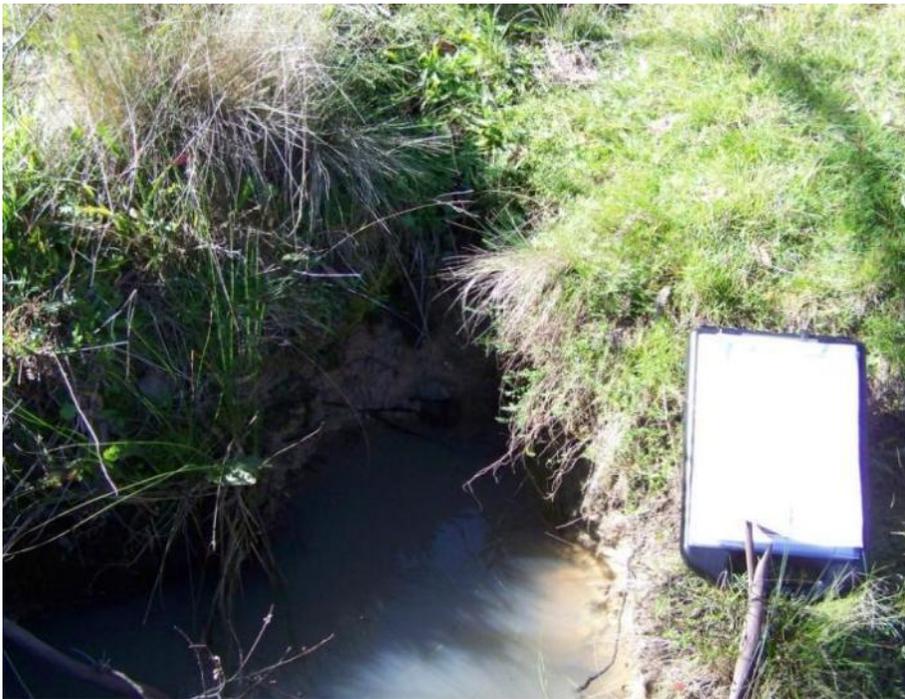
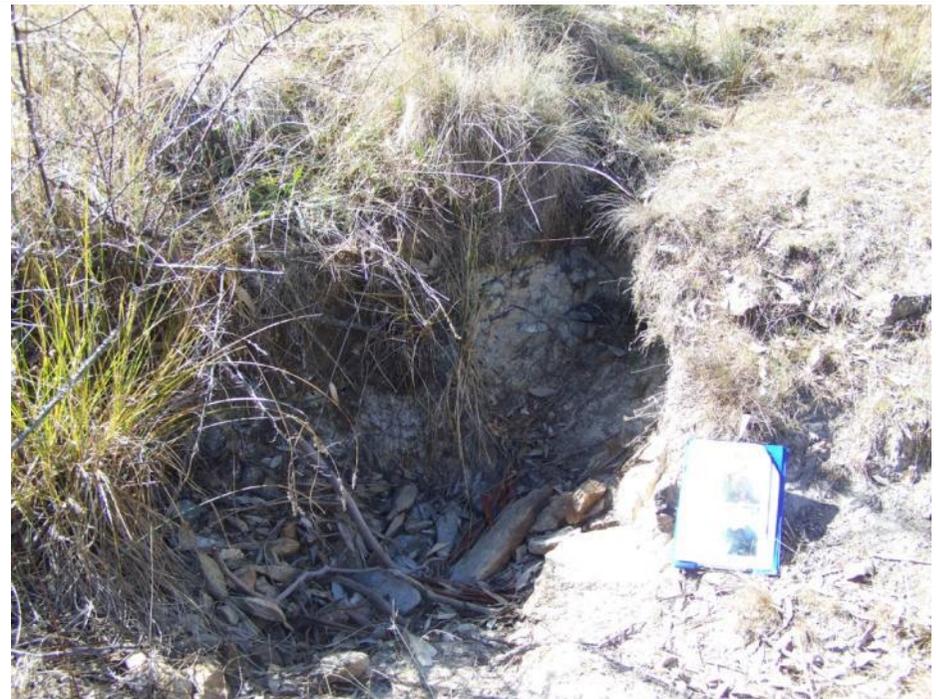
Erosion Point 5:

Note: There is a difference in the scale of the 2 photos. The right photo is zoomed out to incorporate a broader picture of the erosion point.

Action required: No works required at this stage. Continue bi-annual monitoring.

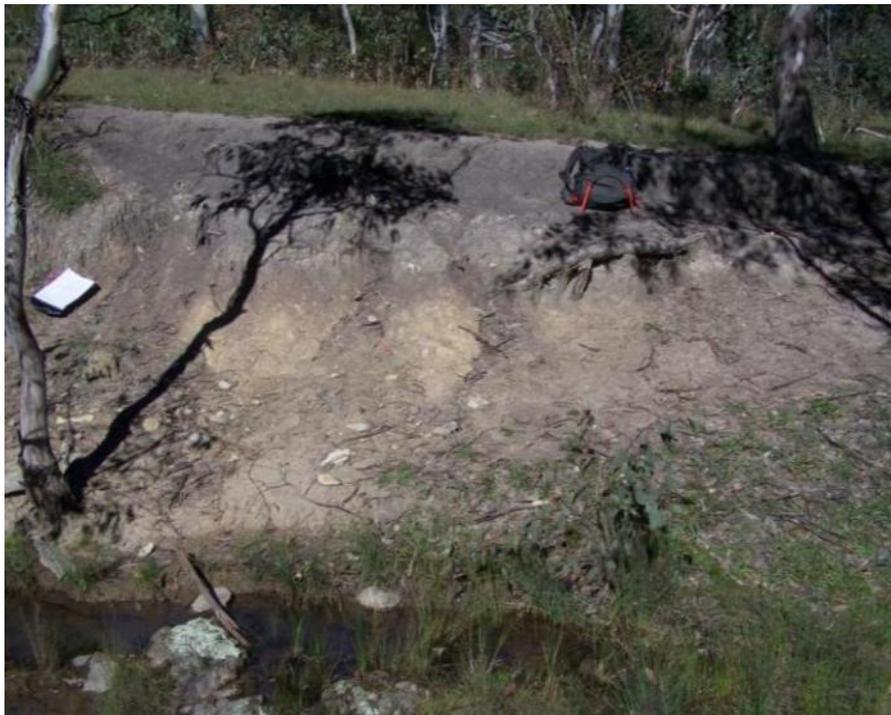
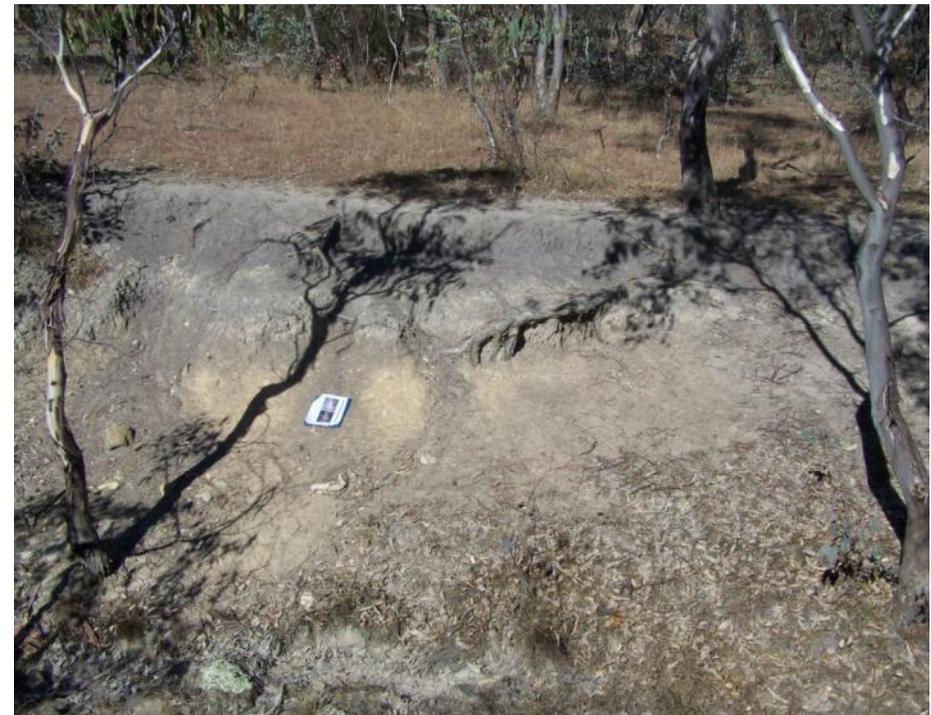
Erosion Point 6:

Change: No significant change observed since baseline monitoring survey.

Action required: Continued bi-annual monitoring and targeted monitoring following heavy rains.

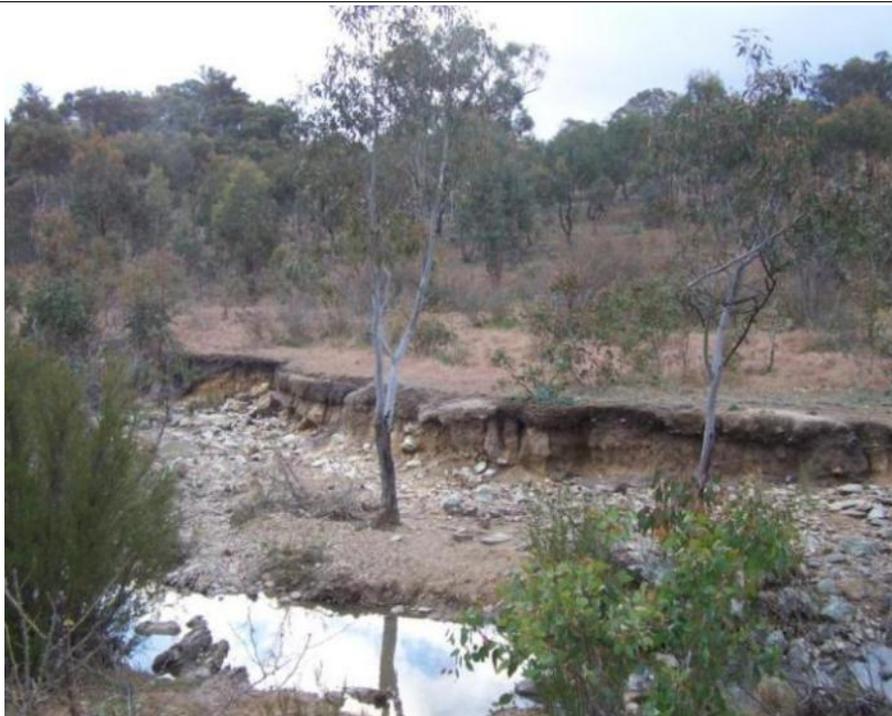
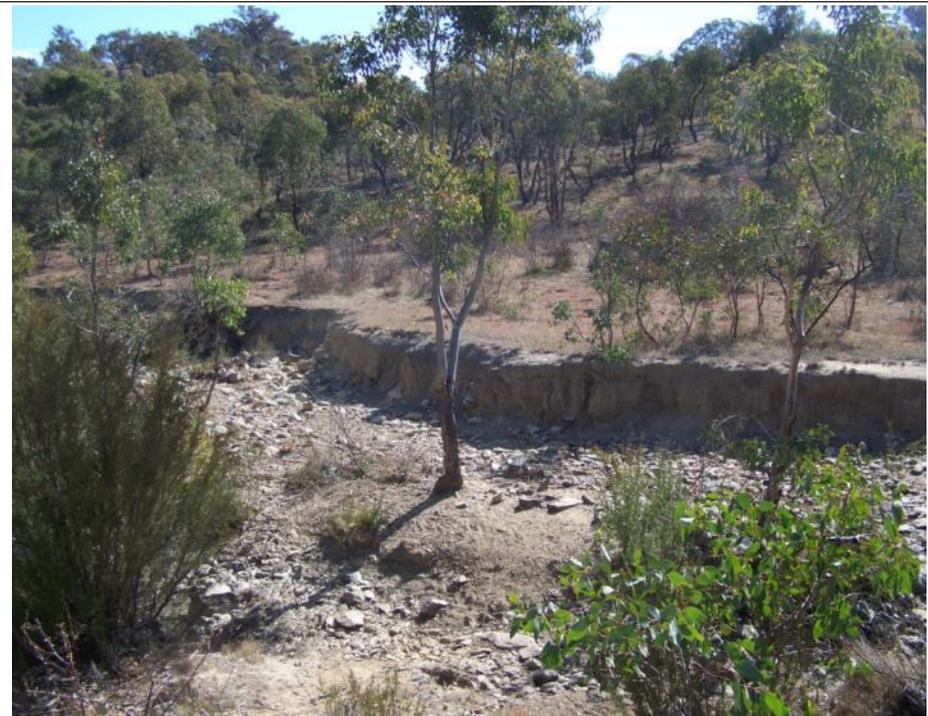
Erosion Point 7:

Change: No significant change observed since baseline monitoring period.

Action required: Targeted monitoring at photo point following heavy rain and continue bi-annual monitoring.
