M2G Offset Property Monitoring Report

Autumn 2013

Prepared for
ACTEW Water

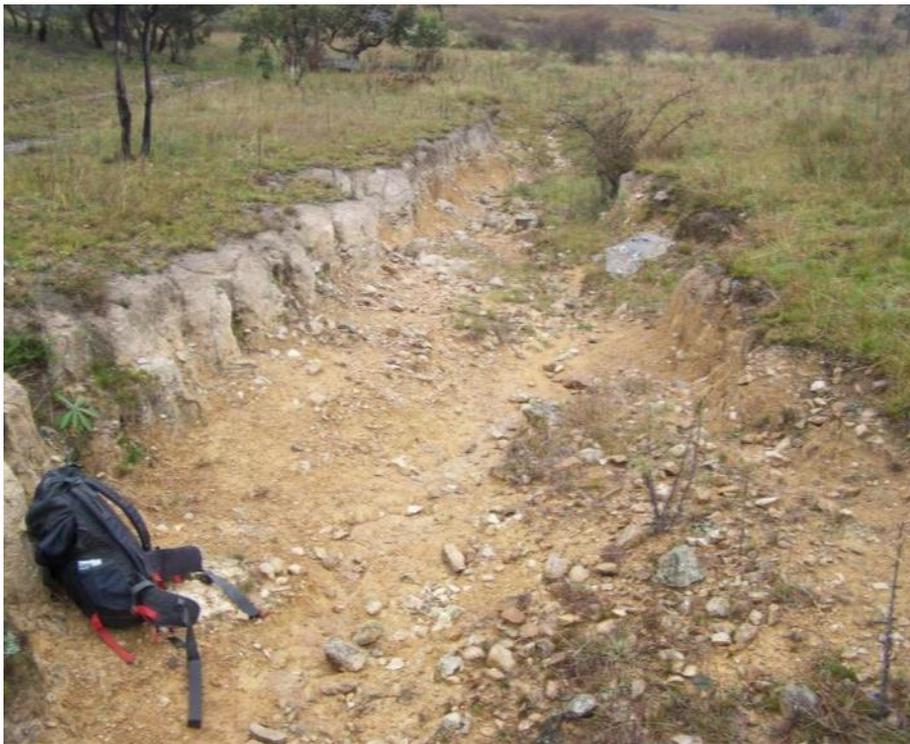
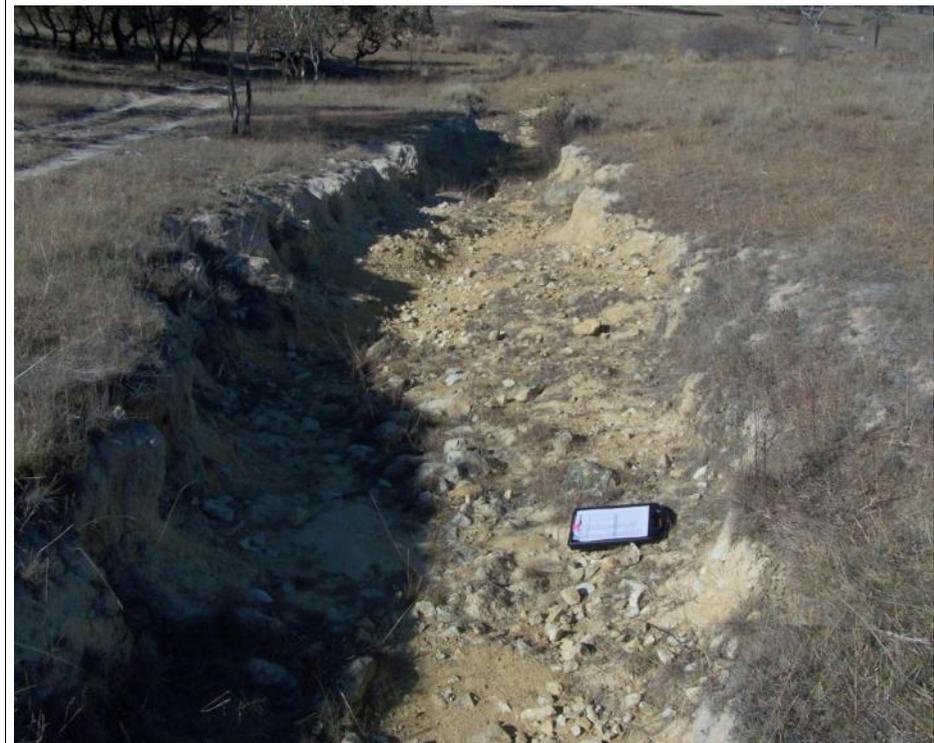
Change: No significant change observed since baseline monitoring survey. Minor changes were observed including slight deepening exposing smaller rocks on the left hand side of the channel. Minor slumping may have occurred on the left as well.

Action required: Continued bi-annual monitoring and targeted monitoring following heavy rains.

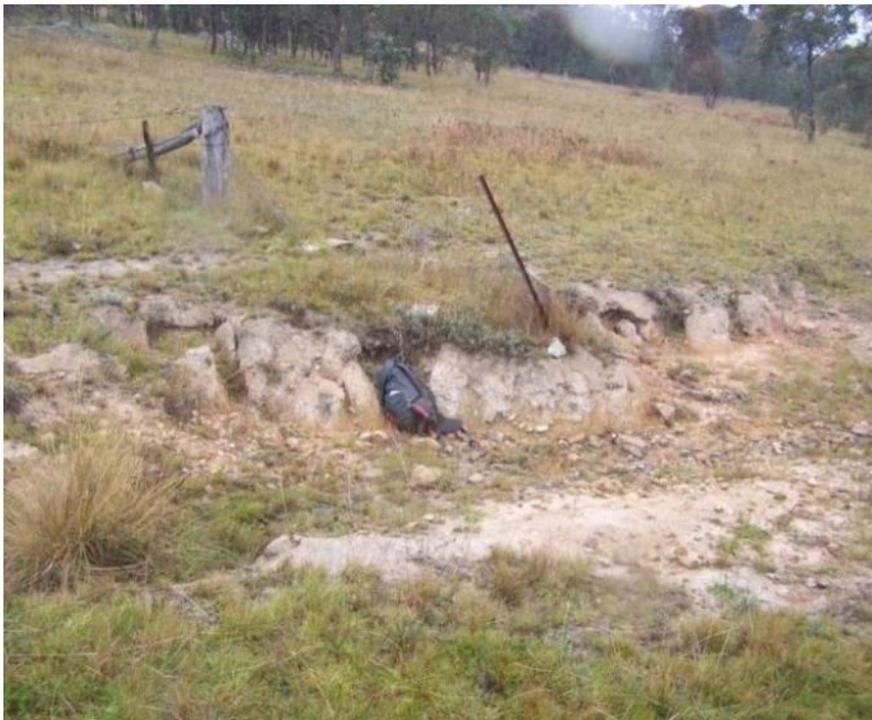
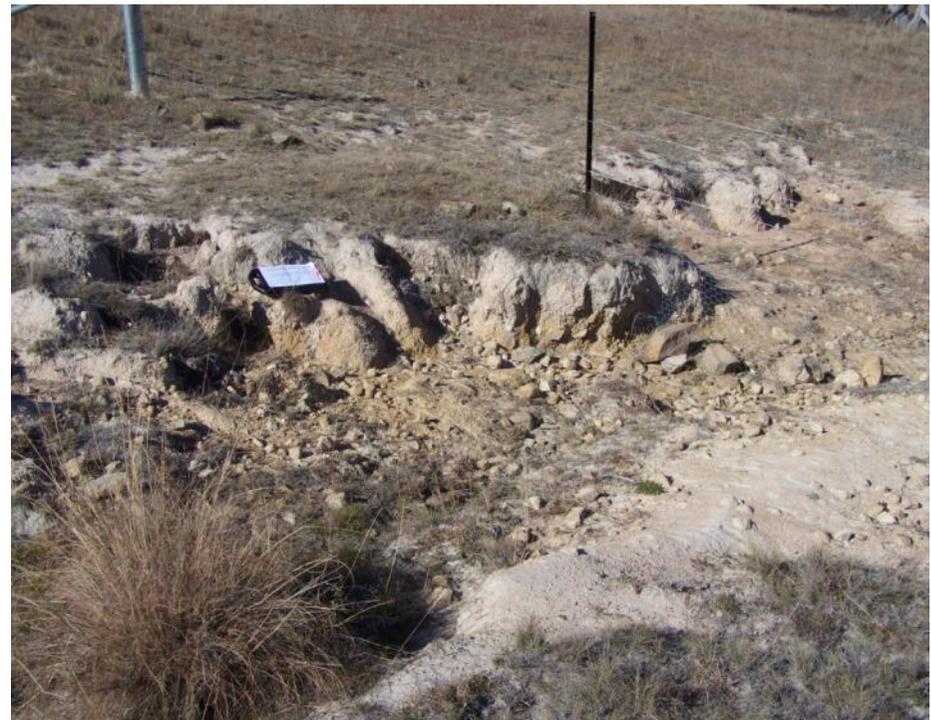
Change: Some minor erosion has occurred adjacent to the new fence line (this is within the neighbouring property to the south of the offset site). No change since Spring 2012.

Action required: No immediate action required. Continued bi-annual monitoring and targeted monitoring following heavy rains.

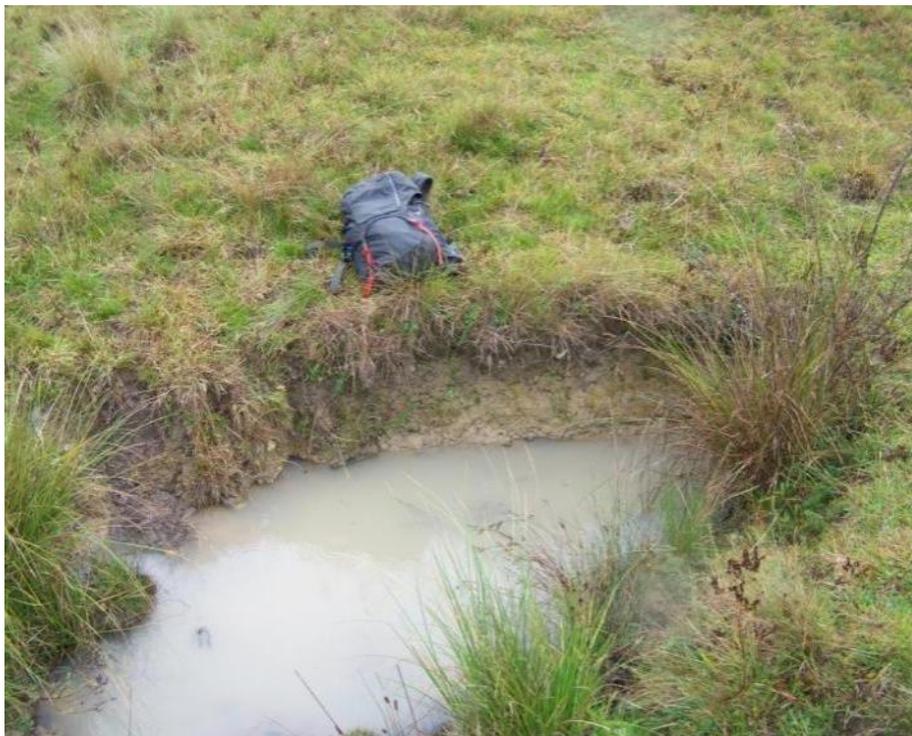
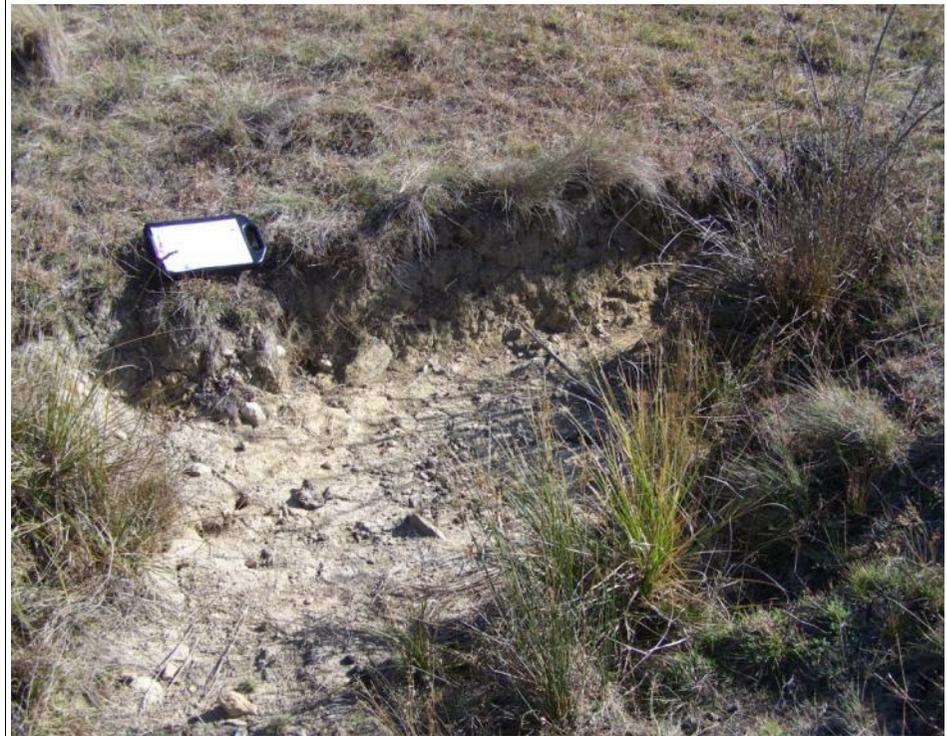
Change: No significant erosion has occurred since the baseline monitoring period.

Action required: Continued bi-annual monitoring and targeted monitoring following heavy rains.

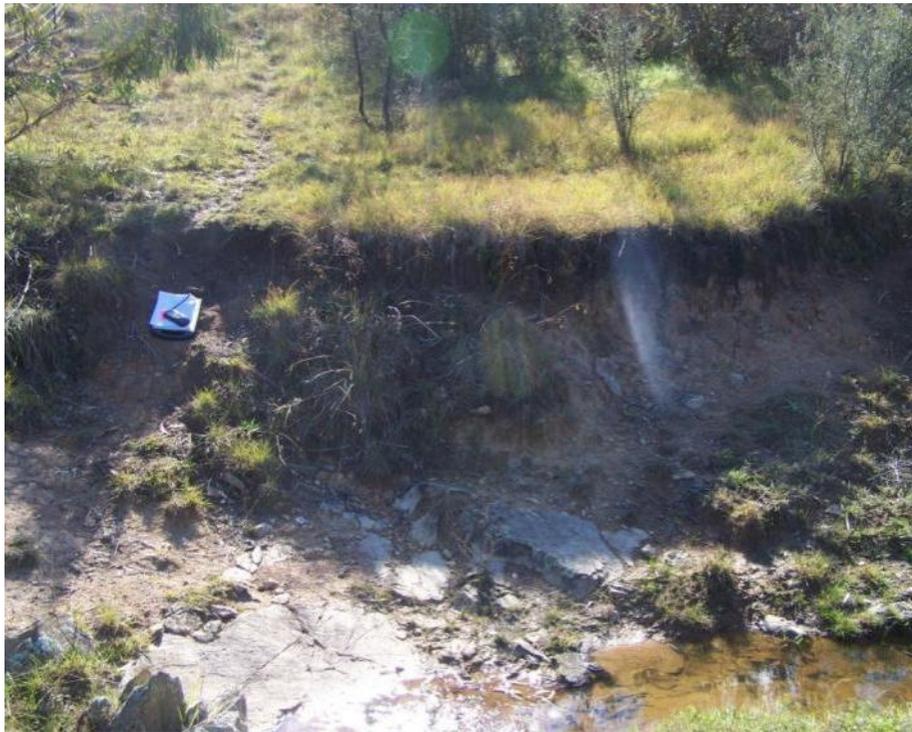
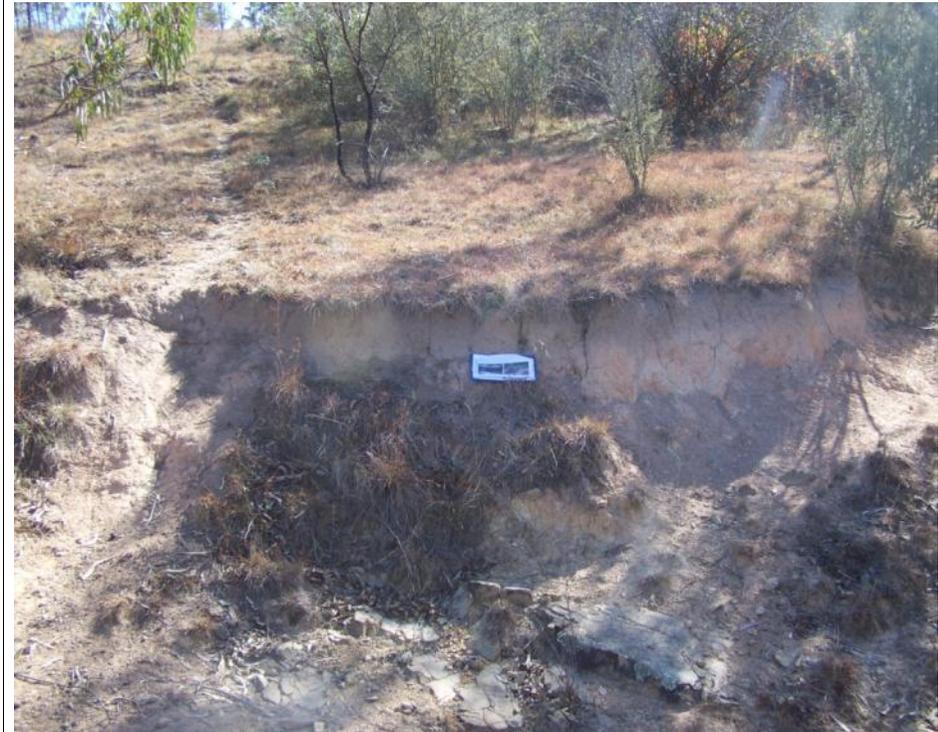
Change: No significant erosion has occurred since the baseline monitoring period.

Action required: Continued bi-annual monitoring and targeted monitoring following heavy rains.

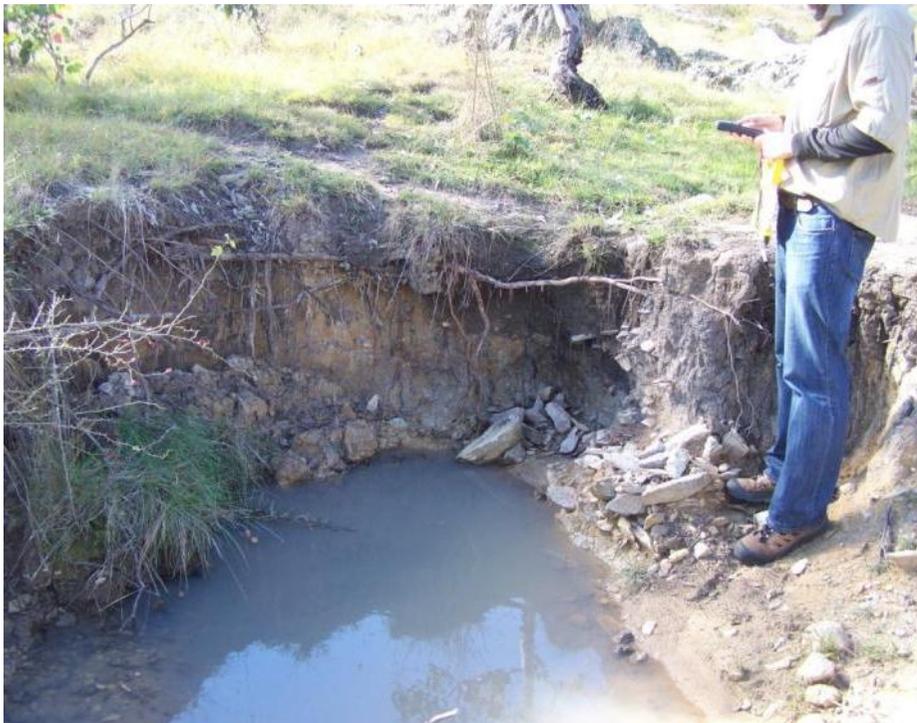
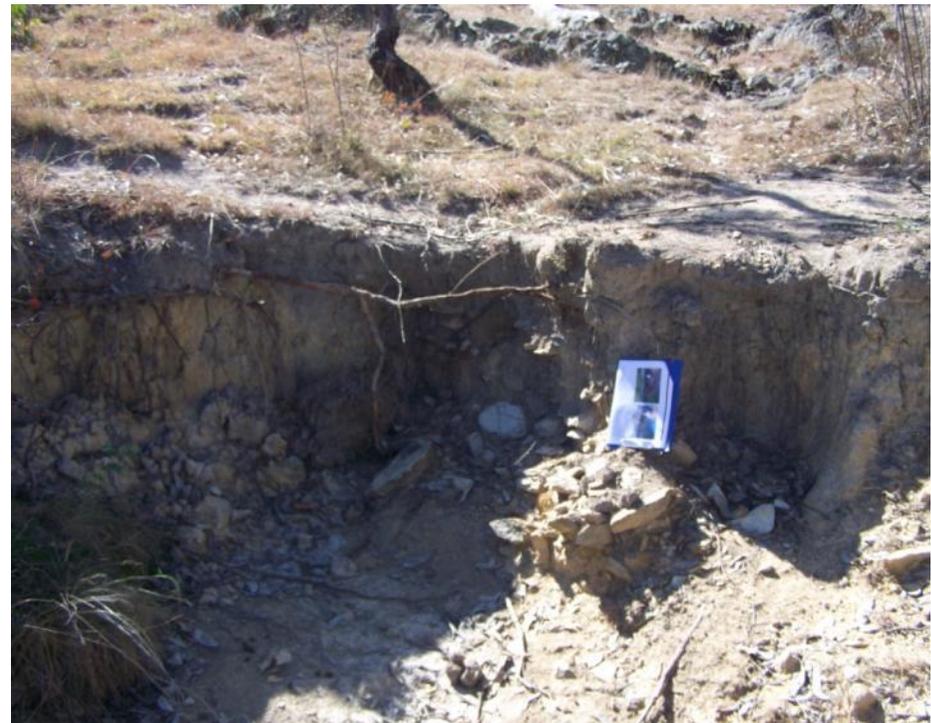
Change: Some minor slumping previously occurred. No change since spring 2012.

Action required: No immediate action required. Continue to monitor.

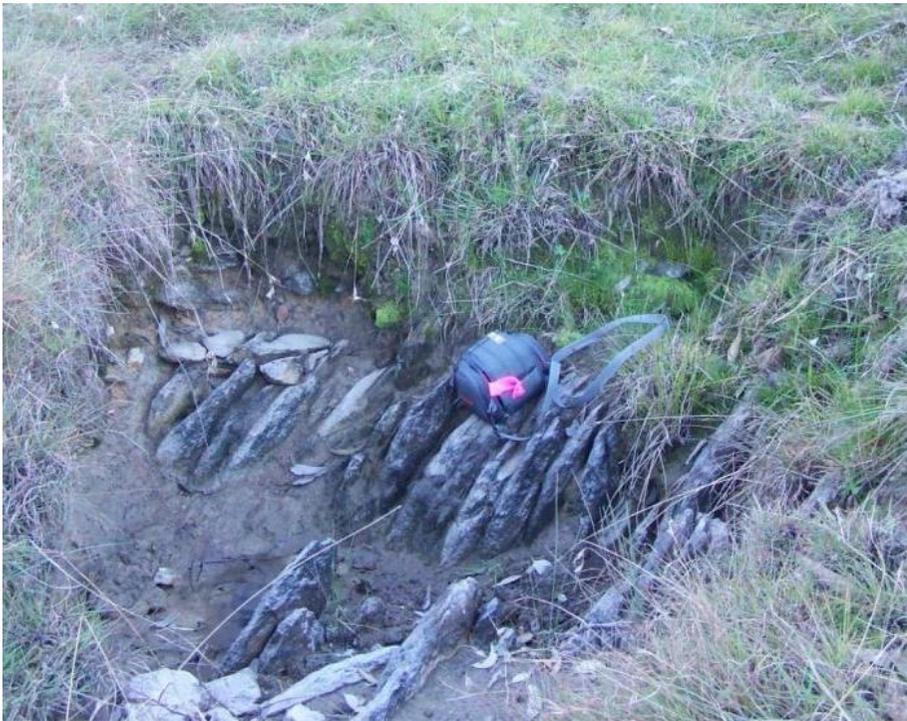
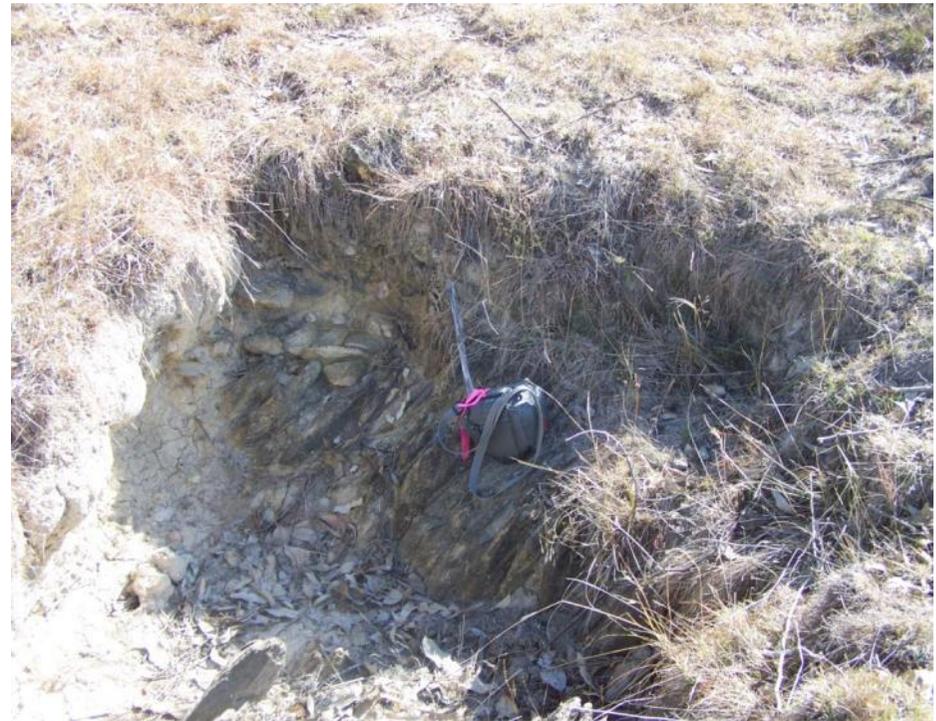
Change: No significant erosion has occurred since the baseline monitoring period.

Action required: Continued bi-annual monitoring and targeted monitoring following heavy rains.

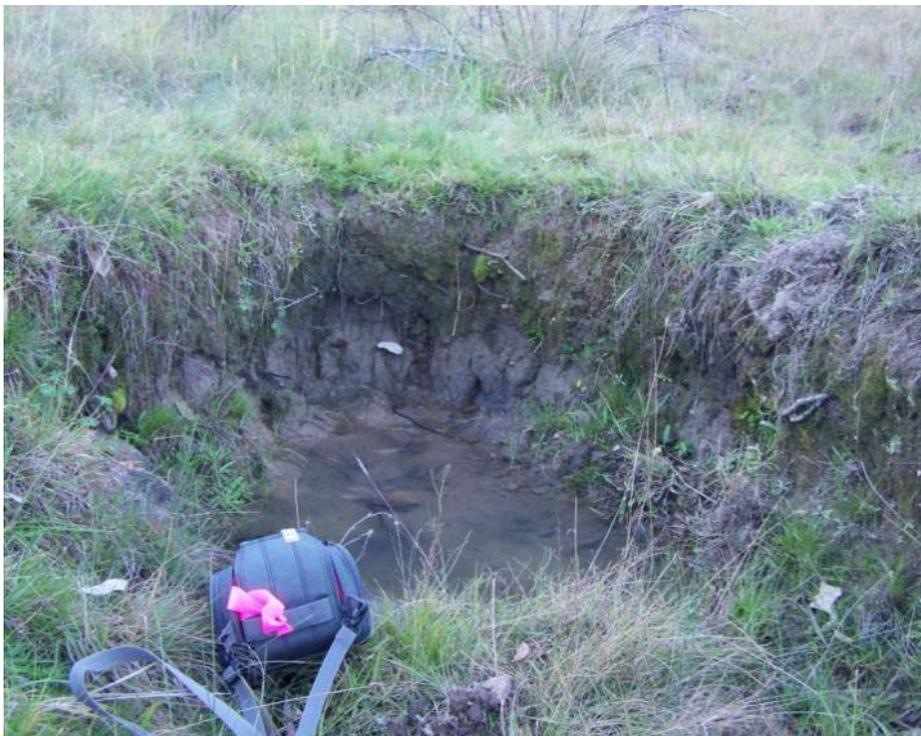
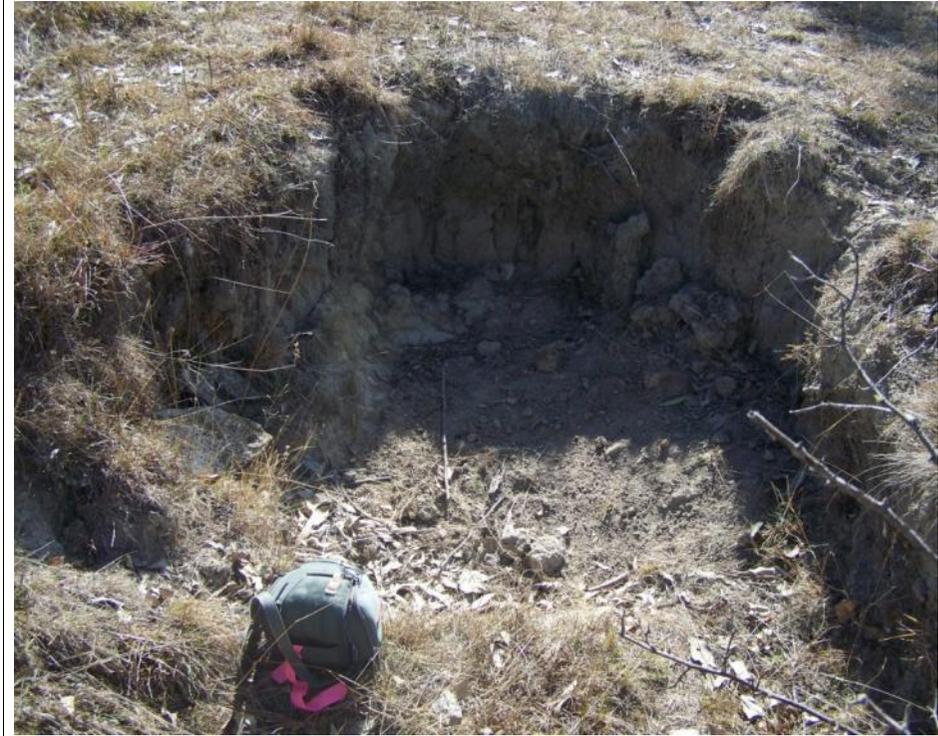
Change: No significant erosion has occurred since the baseline monitoring period.

Action required: No ground works required at this stage.

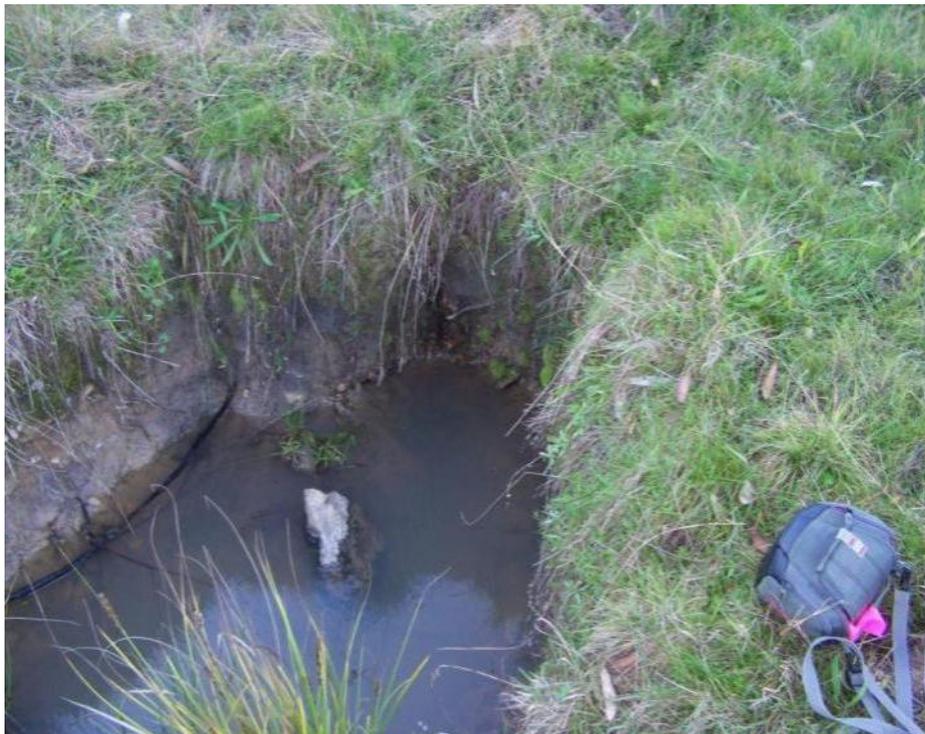
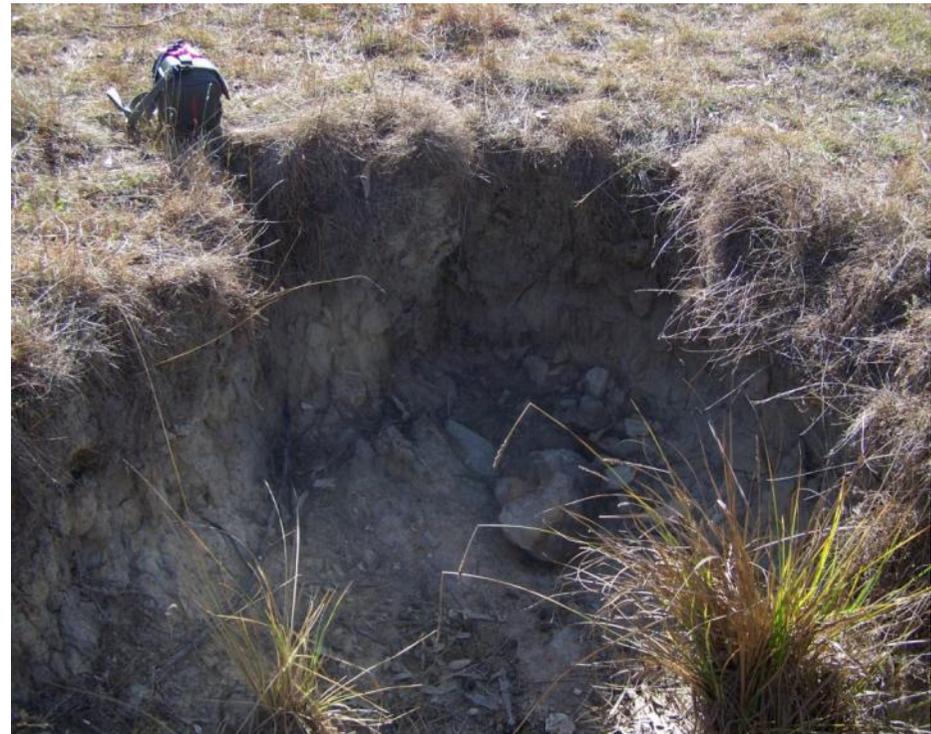
Change: Some slight erosion is occurred at the head cut previously. No significant erosion has occurred since the previous monitoring period.

Action required: No ground works required at this stage.

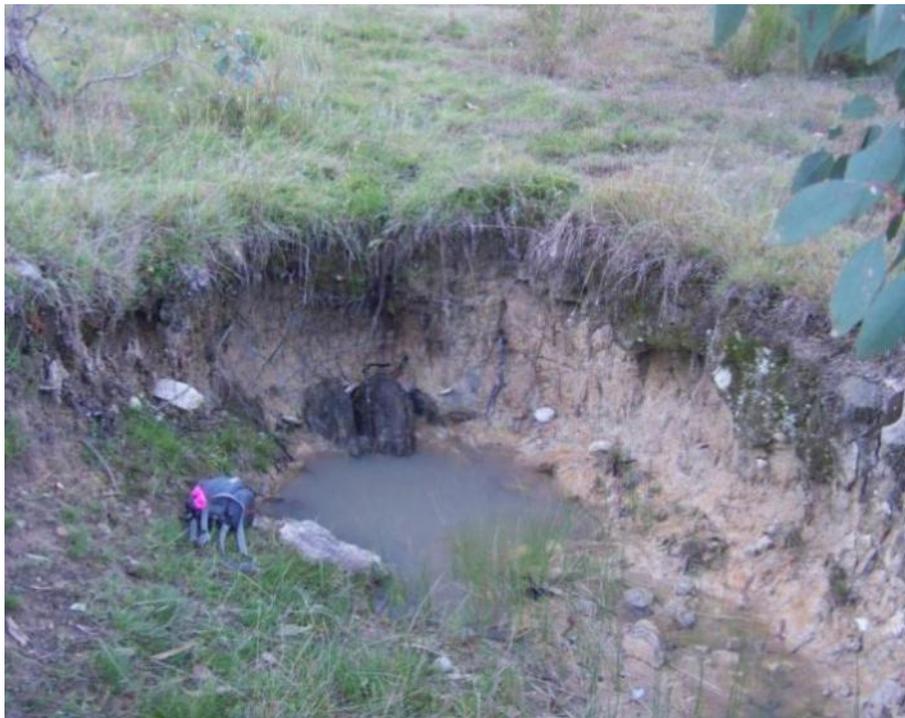
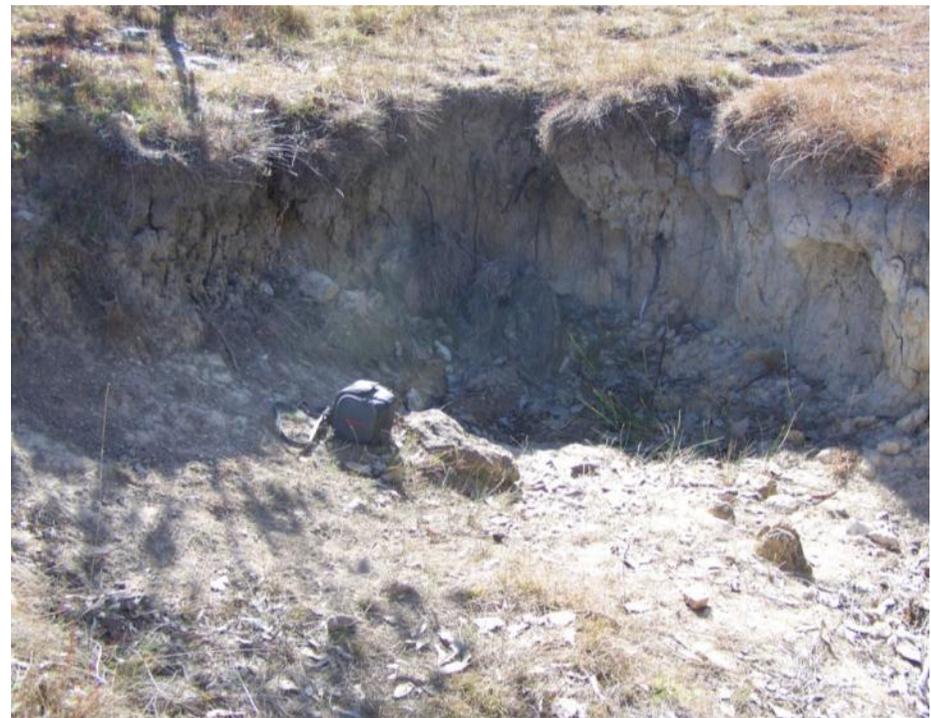
Change: No change has occurred since the previous monitoring period.

Action required: No ground works required at this stage. Continue to monitor.

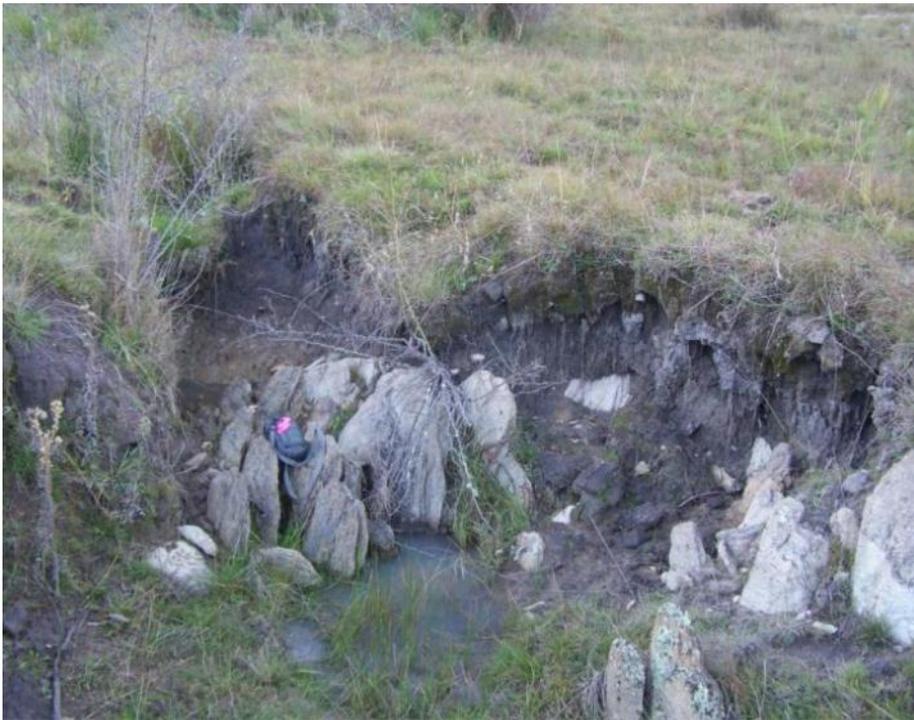
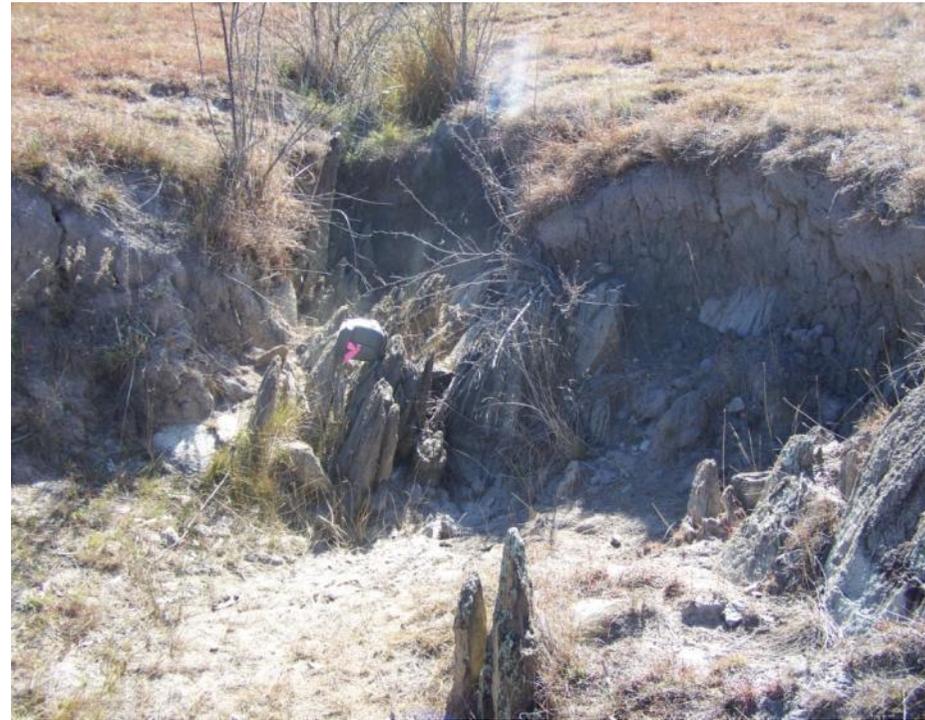
Change: No significant erosion has occurred since the baseline monitoring period.

Action required: No ground works required at this stage.

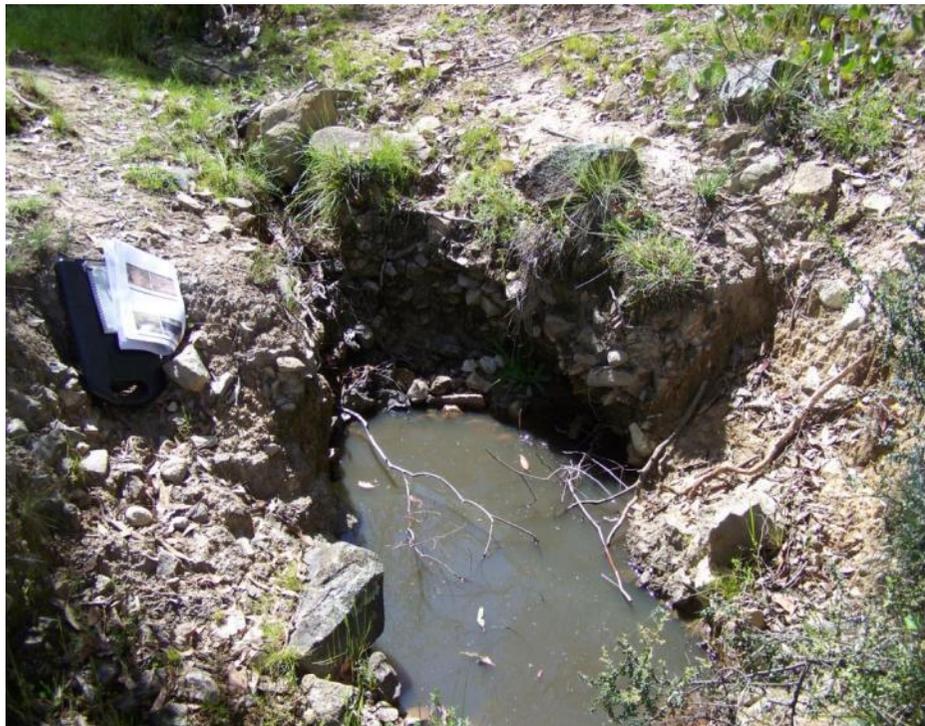
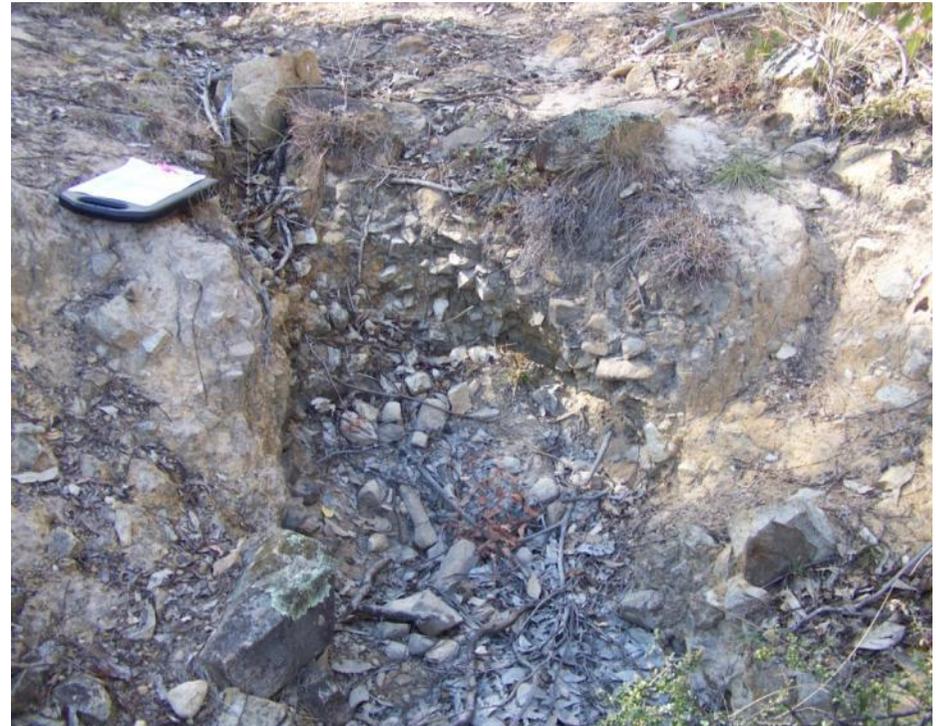
Change: No change since previous monitoring.

Action required: No action is required at this stage.

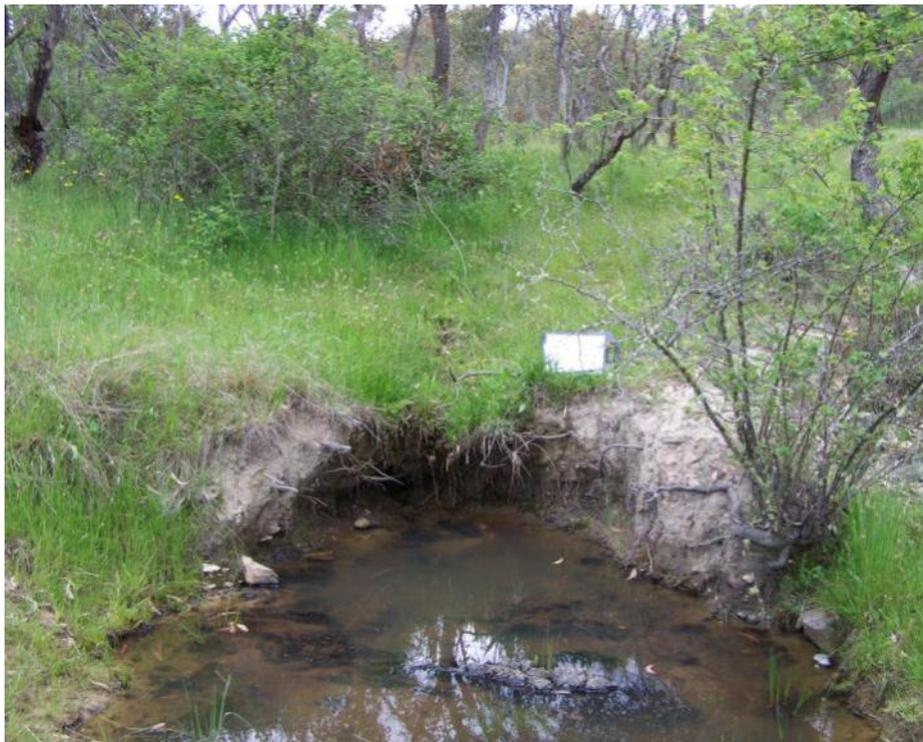
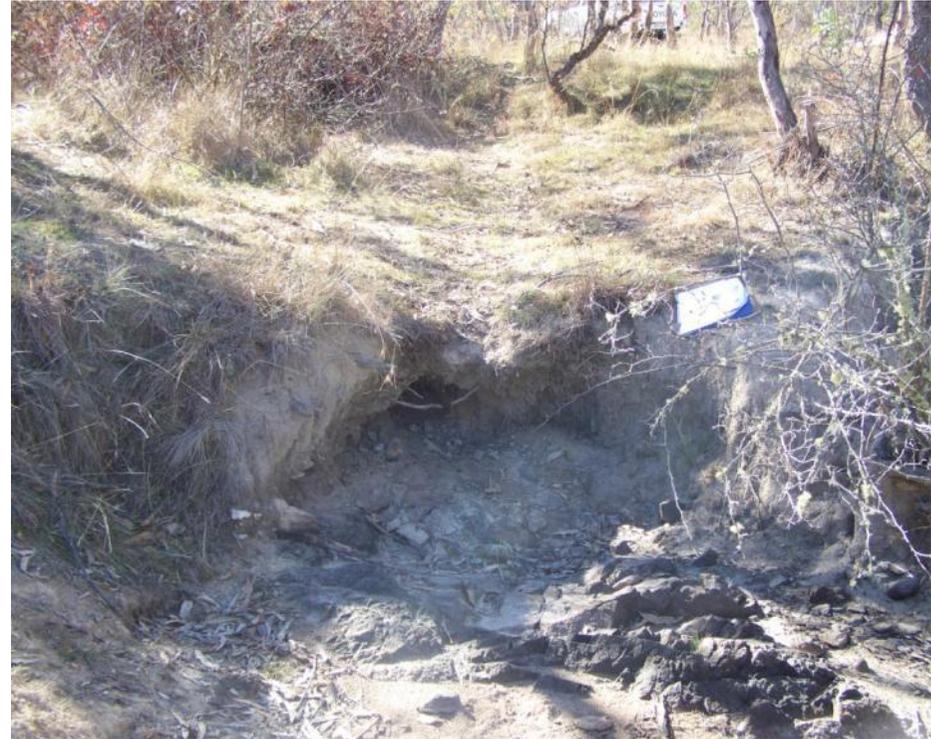
Change: No change since previous survey.

Action required: No action is required at this stage.

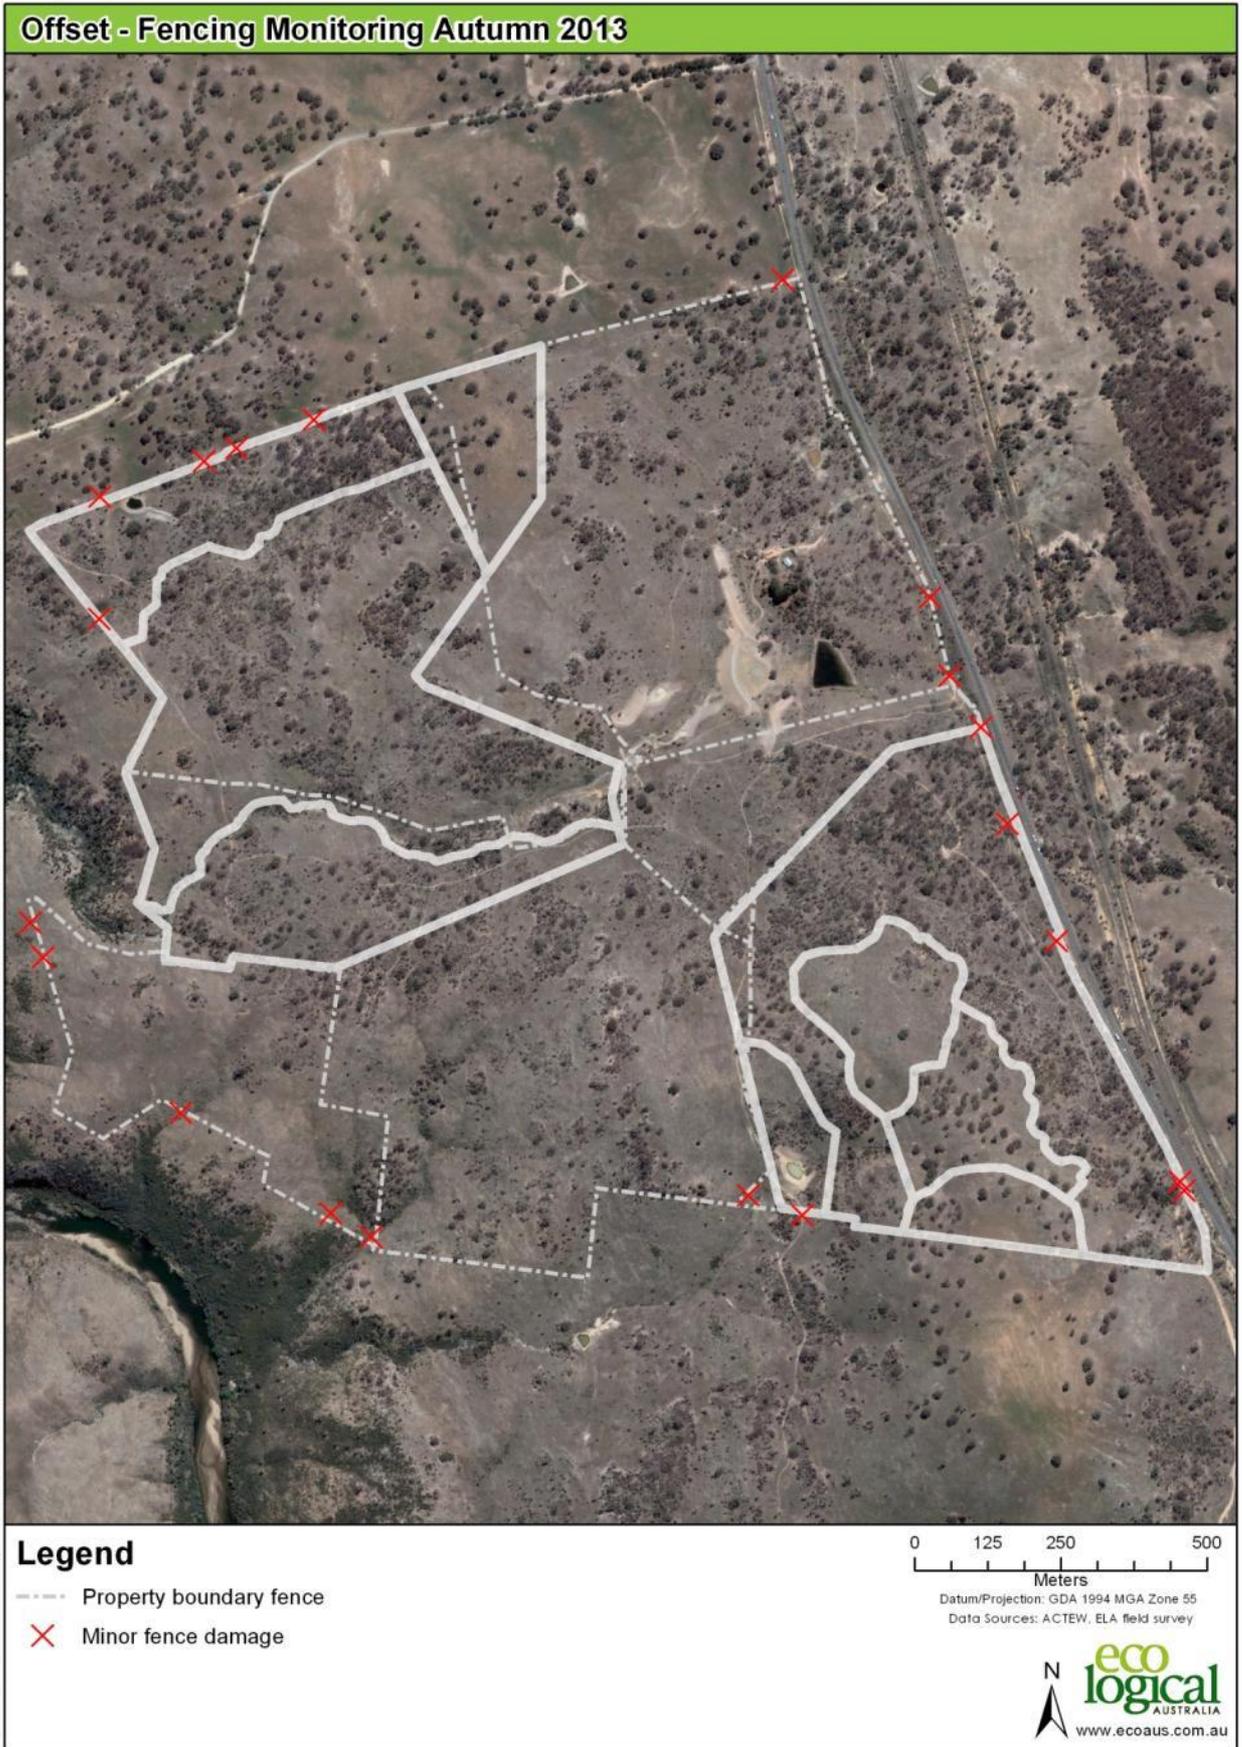
Figure 16: Williamsdale property fence with points recommended for repair

Fence monitoring was undertaken by traversing the Williamsdale property border fence line and assessing the condition of the fence. Any areas observed along the fence line that required attention were noted and a GPS point taken.

The removal of the internal fences would enhance the wildlife friendly nature of the offset site and be consistent with the biodiversity conservation ideals of the ODP and associated sub-plans.
