# Planting Monitoring Report M2G Construction Corridor (Late Spring 2012)

Tom O'Sullivan  
March 2013

Ref: 1305

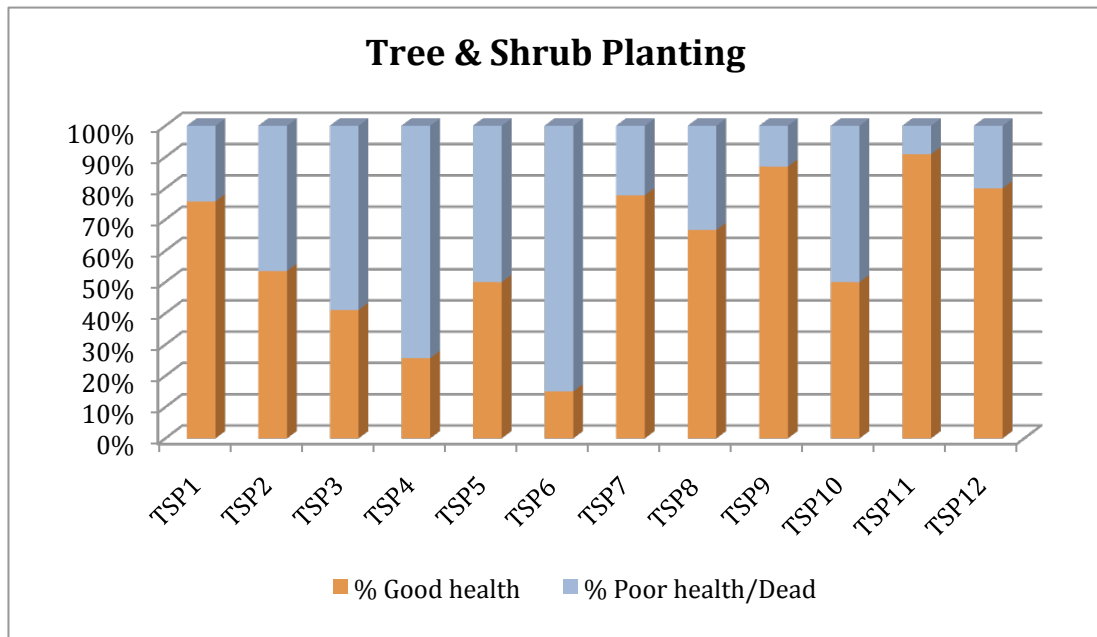
Chart 1: Proportions of specimens in good or poor/dead health at each monitoring site.

On the strength of these results the performance target of 90% success rate was not met.

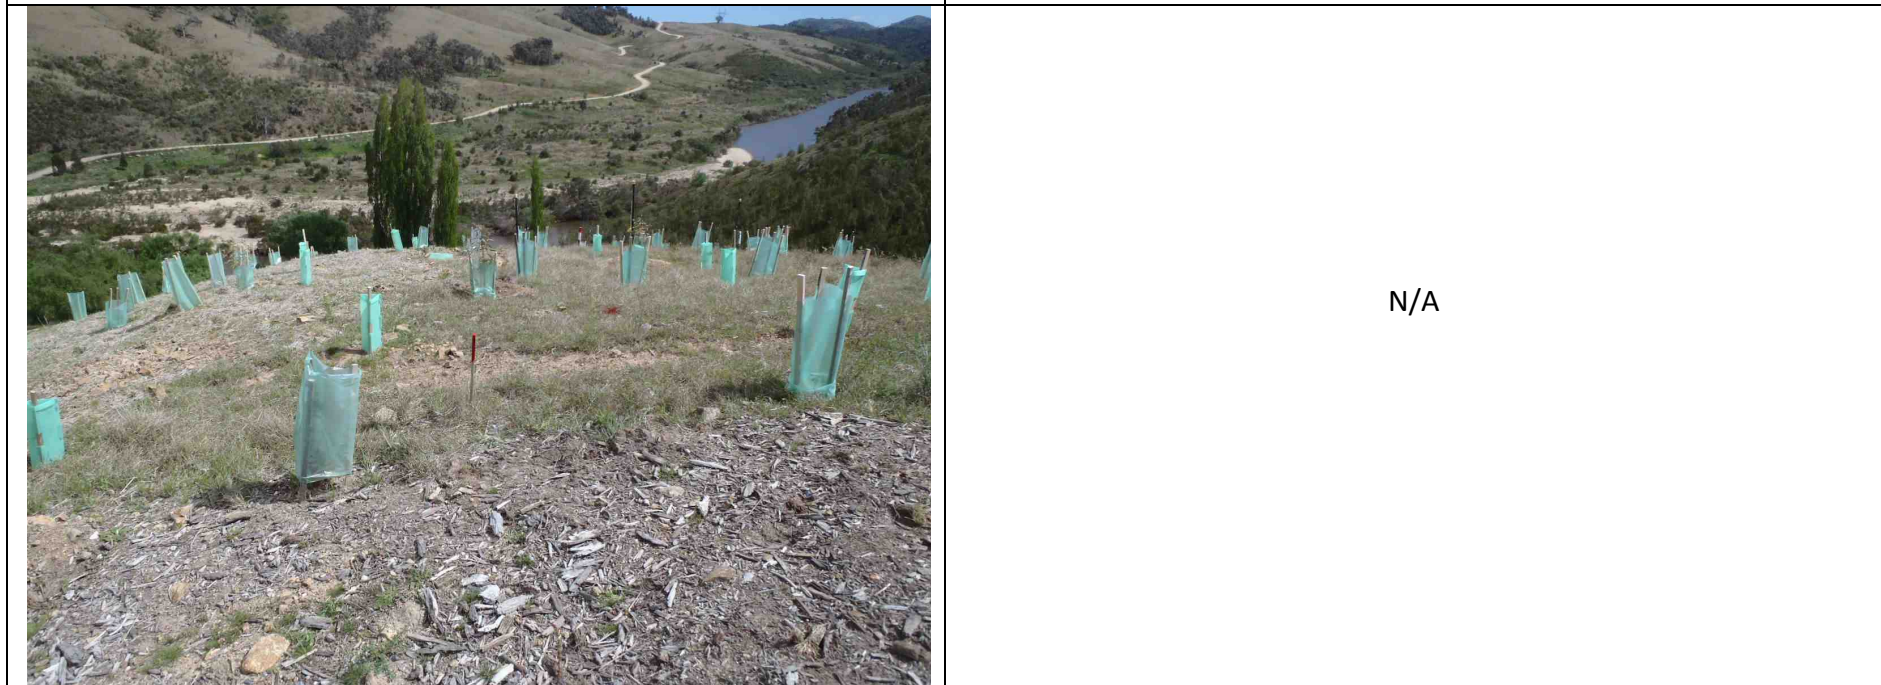
Plate 1: Monitoring Site TSP1

<b>Jurisdiction</b>	<b>ACT</b>	<p><b>TSP1</b> located W and NW of the HLPS about 250 m from the LLPS, within the Murrumbidgee River Corridor.</p> <p>NOTE: About 40% of herbaceous plantings along the N batter of the HLPS had been either eaten or removed by herbivores.</p>
Co-ordinates	691345 - 6060236	
<b>No. of tree &amp; shrub species</b>	<b>7</b>	
<b>Seedling Health</b>		
Good	69	
Poor	15	
Dead	7	
<b>Total plantings</b>	<b>91</b>

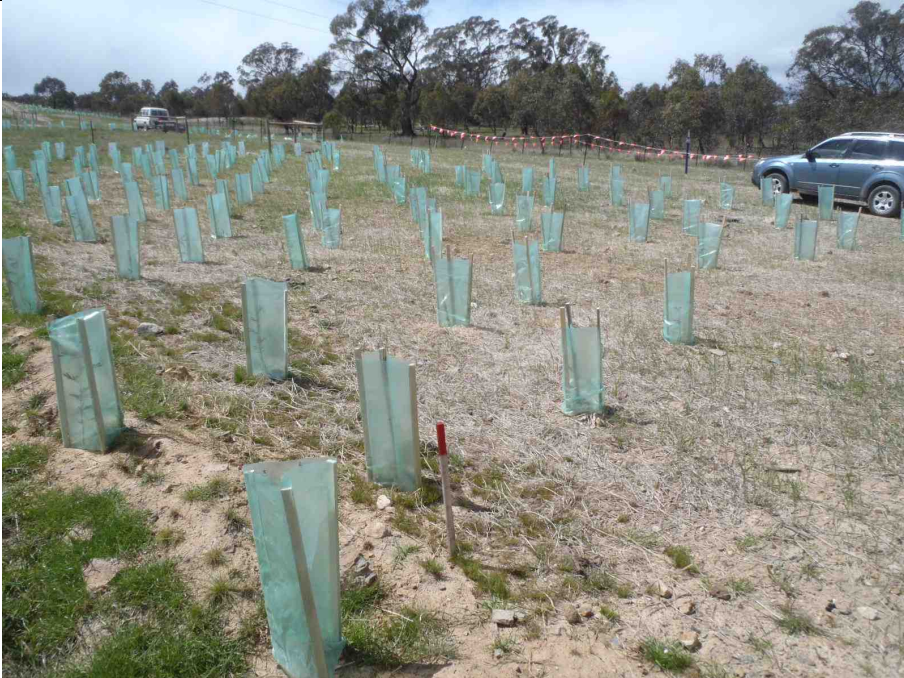
Plate 2: Monitoring Site TSP2

<b>Jurisdiction</b>		<b>ACT</b>	TSP2 is located within the Murrumbidgee River Corridor, about 1,025 m from the LLPS.
Co-ordinates	691964 - 6060519		
<b>No. of tree &amp; shrub species</b>	<b>5</b>		
<b>Seedling Health</b>			
Good	68		
Poor	46		
Dead	13		
<b>Total plantings</b>	<b>127</b>

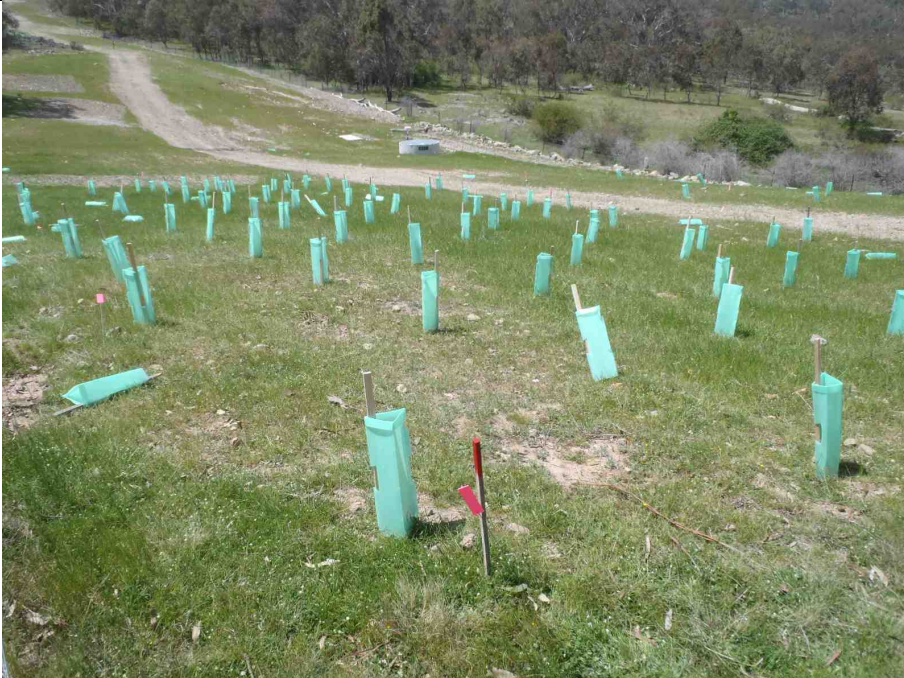
Plate 3: Monitoring Site TSP3

<b>Jurisdiction</b>		<b>ACT</b>	TSP3 is located within the Murrumbidgee River Corridor, about 1,350 m from the LLPS.
Co-ordinates	692256 - 6060605		
<b>No. of tree &amp; shrub species</b>	<b>4</b>		
<b>Seedling Health</b>			
Good	39		
Poor	39		
Dead	17		
<b>Total plantings</b>	<b>95</b>

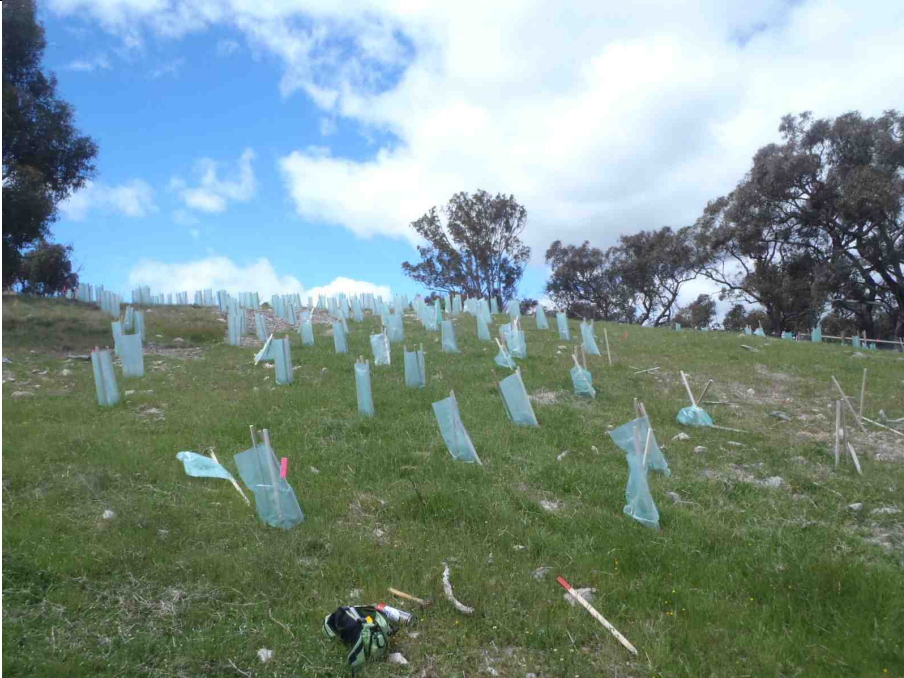
Plate 4: Monitoring Site TSP4

<b>Jurisdiction</b>		<b>ACT</b>	<b>TSP4</b> is located about 1,900 m from the LLPS within the ACT.	
Co-ordinates	692592 - 6060707			
<b>No. of tree &amp; shrub species</b>	<b>3</b>			
<b>Seedling Health</b>				
Good	19			
Poor	27			
Dead	28			
<b>Total plantings</b>	<b>74</b>

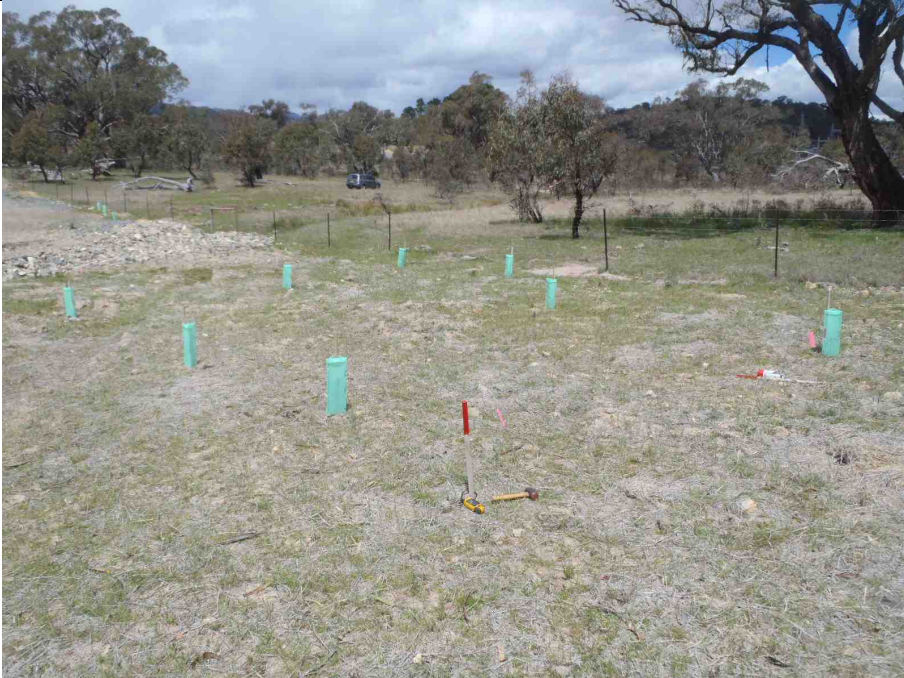
Plate 5: Monitoring Site TSP5

<b>Jurisdiction</b>	<b>ACT</b>	<p><b>TSP5</b> is located about 2,325 m from the LLPS within the ACT.</p> <p>Note: Small infestation of ALG along S corridor boundary fence at 693271 - 6060554.</p>
Co-ordinates	693226 - 6060578	
<b>No. of tree &amp; shrub species</b>	<b>2</b>	
<b>Seedling Health</b>		
Good	8	
Poor	6	
Dead	2	
<b>Total plantings</b>	<b>16</b>

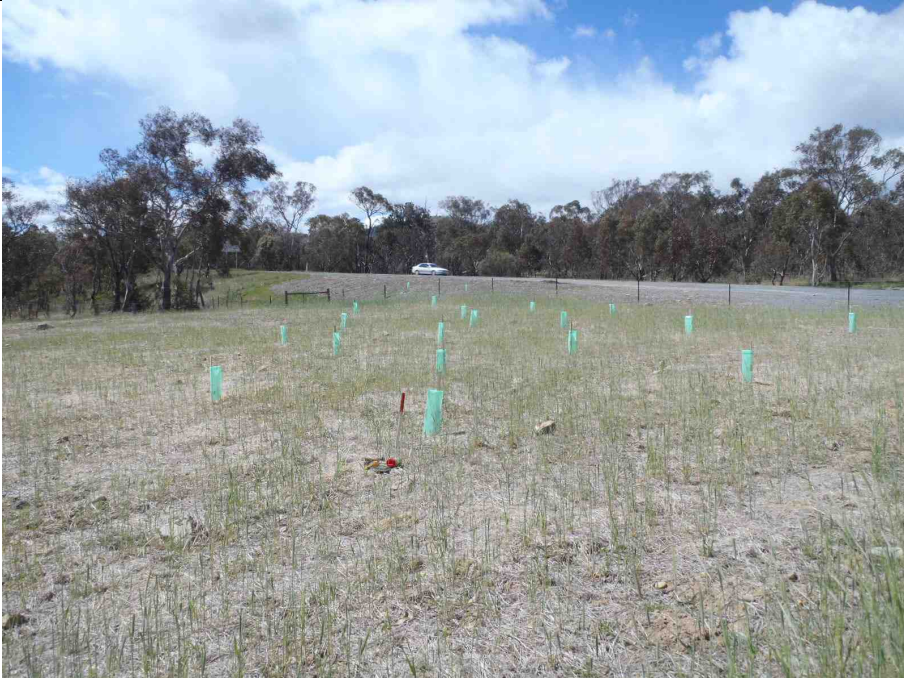
Plate 6: Monitoring Site TSP6

<b>Jurisdiction</b>	<b>ACT</b>	<p><b>TSP6</b> is located about 2,650 m from the LLPS - west of and adjacent to the Monaro Hwy within the ACT.</p>
Co-ordinates	693528 - 6060505	
<b>No. of tree &amp; shrub species</b>	<b>2</b>	
<b>Seedling Health</b>		
Good	3	
Poor	10	
Dead	7	
<b>Total plantings</b>	<b>20</b>

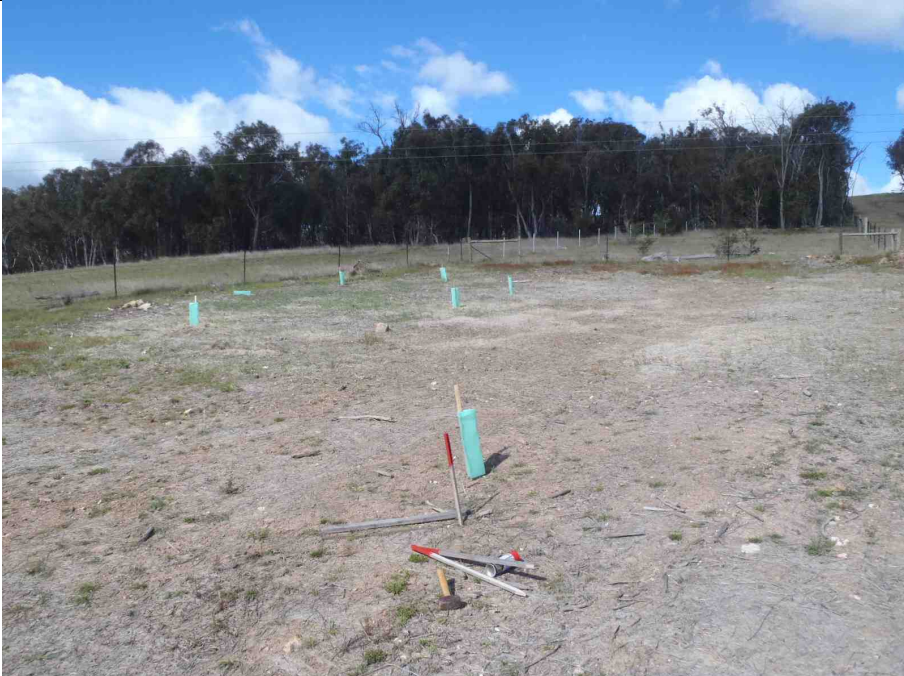
Plate 7: Monitoring Site TSP7

<b>Jurisdiction</b>		<b>ACT</b>	<p><b>TSP7</b> is located about 3,040 m from the LLPS within the Smith property, NSW.</p> <p>NOTE: site separated in to two areas on the N and S side of the construction corridor.</p>	
Co-ordinates		693927 - 6060542		
<b>No. of tree &amp; shrub species</b>		<b>2</b>		
<b>Seedling Health</b>				
Good		14		
Poor		2		
Dead		2		
<b>Total plantings</b>		<b>18</b>

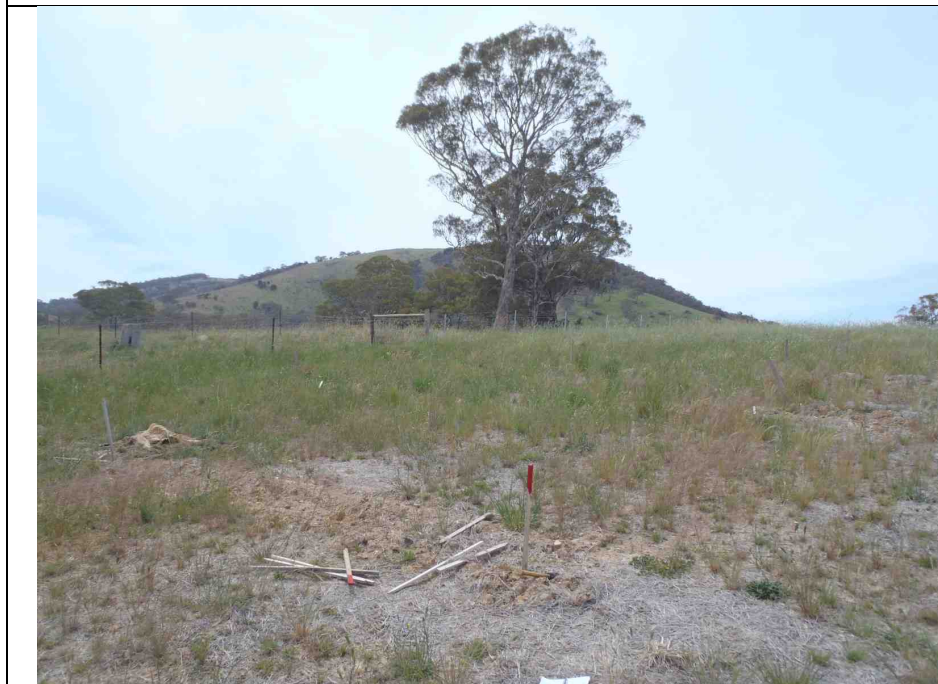
Plate 8: Monitoring Site TSP8

<b>Jurisdiction</b>	<b>NSW</b>	<p><b>TSP8</b> is located about 4,975 m from the LLPS within the Lonergan property, NSW.</p> <p>NOTE: Threatened Brown Treecreeper <i>Climacteris picumnus</i> at 695469 – 6060425 in stand of Yellow Box Woodland N. of construction corridor.</p>
Co-ordinates	695663 - 6060392	
<b>No. of tree &amp; shrub species</b>	<b>2</b>	
<b>Seedling Health</b>		
Good	6	
Poor	0	
Dead	3	
<b>Total plantings</b>	<b>9</b>

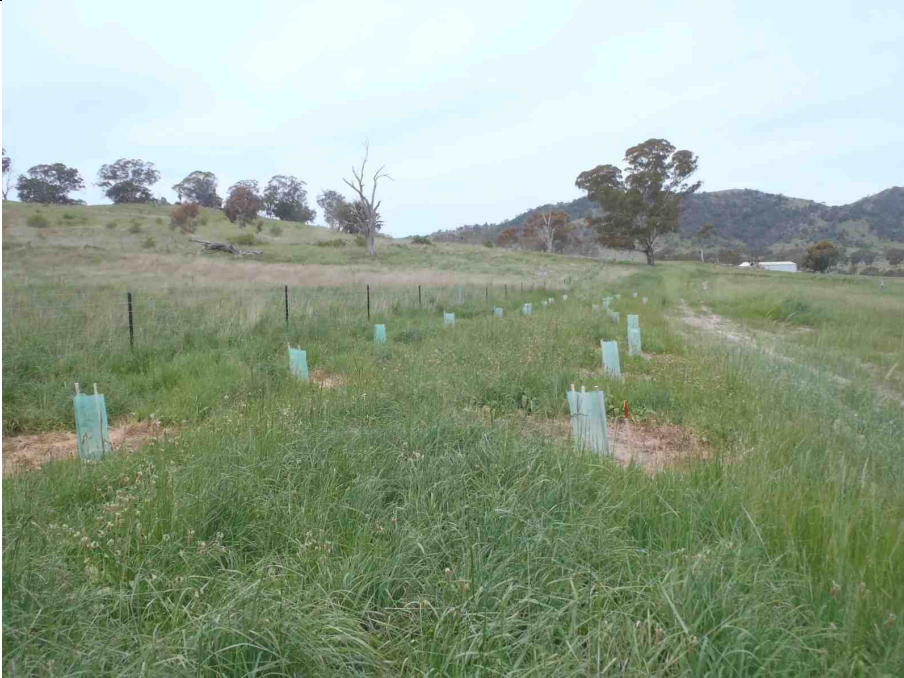
**Plate 9: Monitoring Site TSP9**

<b>Jurisdiction</b>	<b>NSW</b>	<p><b>TSP9</b> is located about 5,475 m from the LLPS within the Lonergan property, NSW.</p>
Co-ordinates	695663 - 6060392	
<b>No. of tree &amp; shrub species</b>	<b>4</b>	
<b>Seedling Health</b>		
Good	20	
Poor	3	
Dead	0	
<b>Total plantings</b>	<b>23</b>

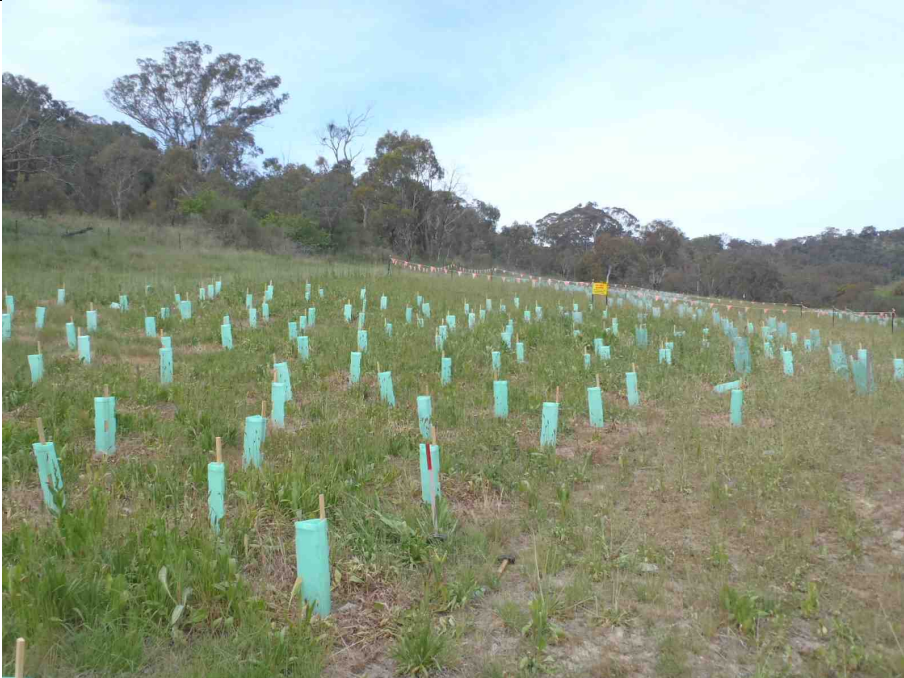
Plate 10: Monitoring Site TSP10

<b>Jurisdiction</b>	<b>NSW</b>	<p><b>TSP10</b> is located about 6,425 m from the LLPS within the Johanson property, NSW.</p> <p>NOTE: top-soil erosion and minor gullyng evident through this section of the corridor.</p>
Co-ordinates	697084 - 6060204	
<b>No. of tree &amp; shrub species</b>	<b>7</b>	
<b>Seedling Health</b>		
Good	56	
Poor	31	
Dead	25	
<b>Total plantings</b>	<b>112</b>

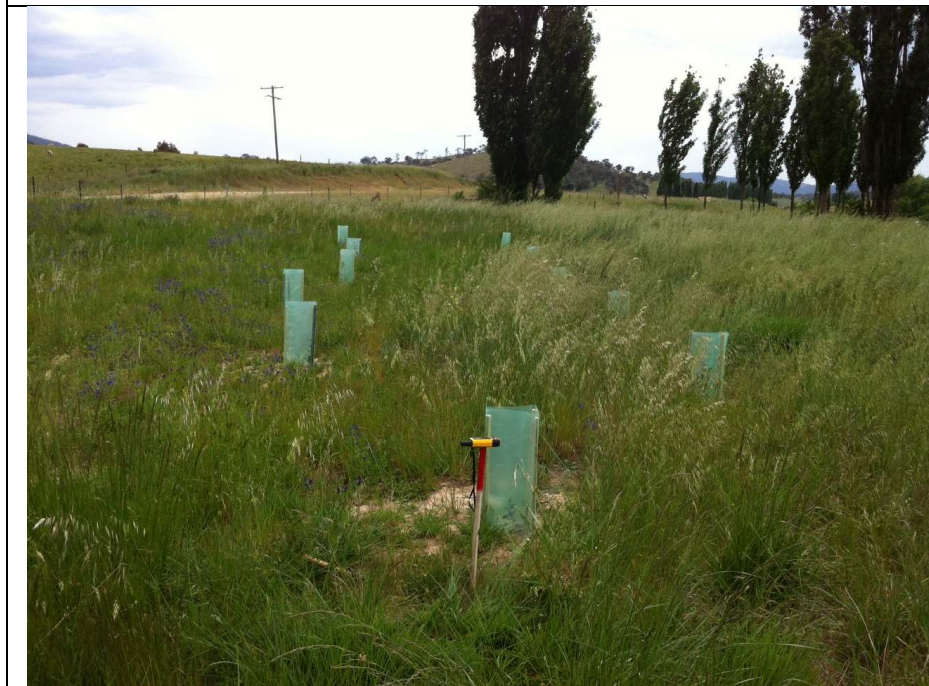
Plate 11: Monitoring Site TSP11

<b>Jurisdiction</b>	<b>NSW</b>	<p><b>TSP11</b> is located about 9,300 m from the LLPS within the Latimer property, NSW.</p> <p>NOTE: Vipers Bugloss <i>Echium vulgare</i> infestation adjacent to sample site.</p>
Co-ordinates	699277 - 6061925	
<b>No. of tree &amp; shrub species</b>	<b>2</b>	
<b>Seedling Health</b>		
Good	10	
Poor	1	
Dead	0	
<b>Total plantings</b>	<b>11</b>

Small eruptions of Vipers Bugloss *Echium vulgare* were observed at HP1 in the ACT and TSP11 in eastern section of the construction corridor.

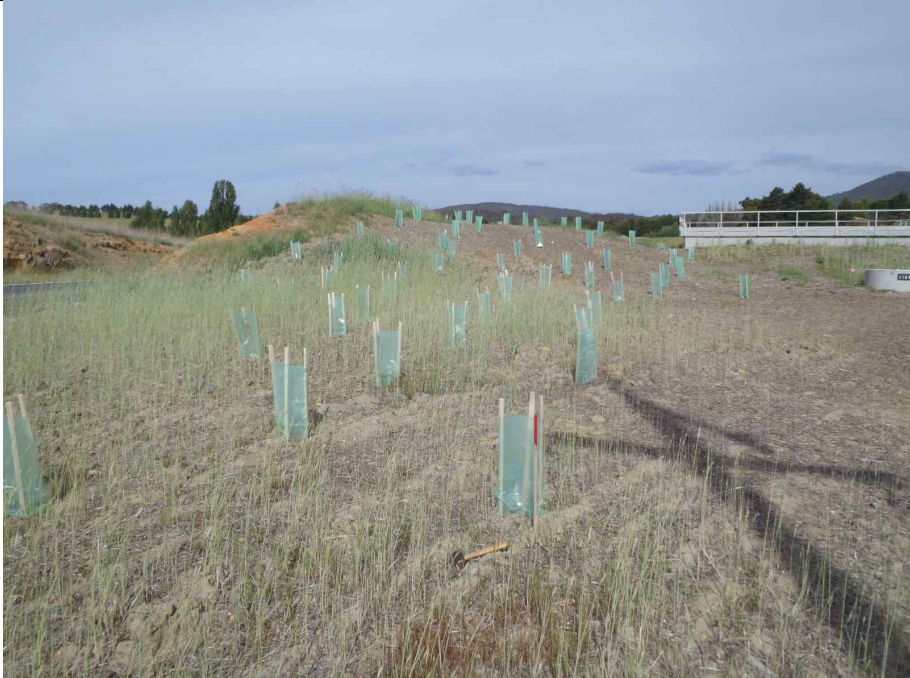
Plate 12: Monitoring Site TSP12

<b>Jurisdiction</b>	<b>NSW</b>	<b>TSP12</b> is located about 11,900 m from the LLPS near the Discharge facility, NSW.
Co-ordinates	701346 - 6063099	
<b>No. of tree &amp; shrub species</b>	<b>3</b>	
<b>Seedling Health</b>		
Good	52	
Poor	8	
Dead	5	
<b>Total plantings</b>	<b>65</b>

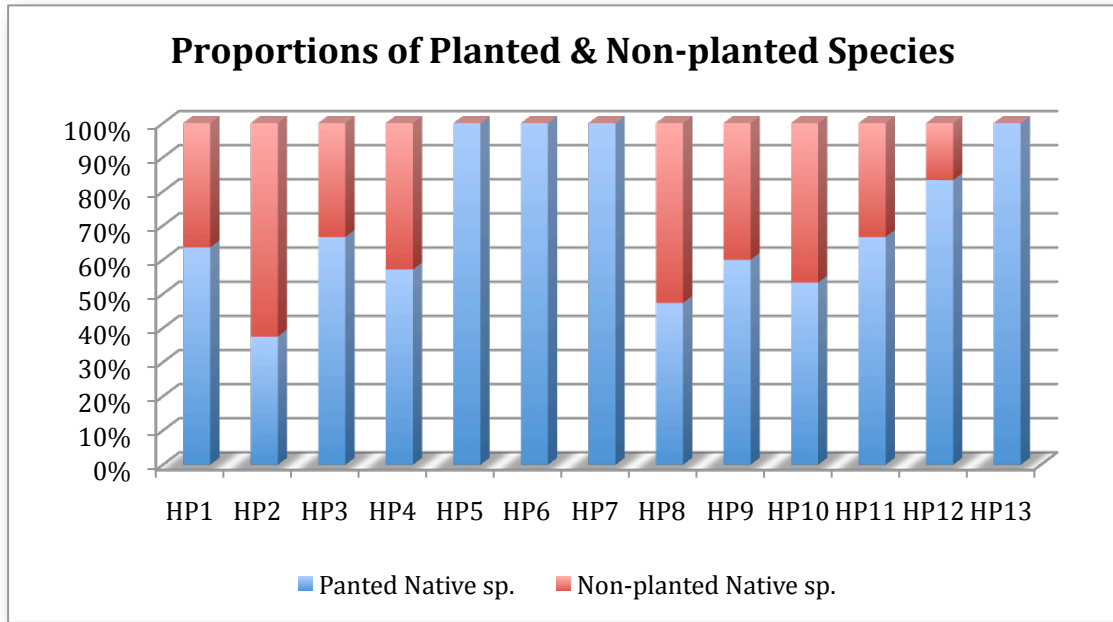
**Chart 2: Proportion of planted and non-planted native herbaceous species at each monitoring site.**

A total of 37 native herbaceous species<sup>4</sup> were recorded at thirteen monitoring sites within the M2G construction corridor and structure sites. This included at least 15<sup>5</sup> of 19 *planted* species (Table 1) and 21 *non-planted* native species. The distribution of planted species across all sample sites was variable with *Austrodanthonia* sp. and *Microlaena stipoides* occurring at all thirteen sites, followed by *Austrostipa* spp. (twelve sites), *Chrysocephalum apiculatum* (nine sites), *Themeda australis* (eight sites), *Wahlenbergia* sp. and *Chloris truncata* (six sites) and *Elymus scaber* (five sites), with remaining species were see Table A3.2 in Appendix 3.

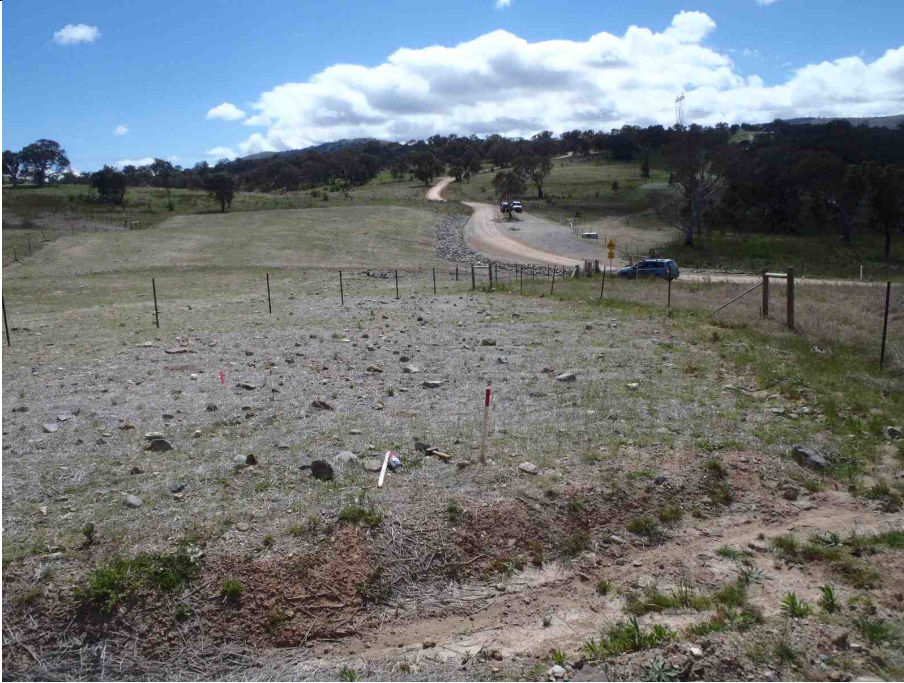
Plate 13: Monitoring Site HP1

<b>Jurisdiction</b>		<b>ACT</b>	<p><b>HP1</b> is located about 750 m from the LLPS within the Murrumbidgee River corridor.</p> <p>NOTE: Weeds: <i>Echium</i> sp., <i>Conya</i> sp, <i>Briza maxima</i> and <i>Hirschfeldia incana</i>.</p>
Co-ordinates	691706 - 6060396		
<b>No. of native herbaceous species</b>		<b>11</b>	
Planted	7		
Non-planted	4		
<b>Estimated cumulative cover score</b>			
Planted	<5%		
Non-planted	<5%

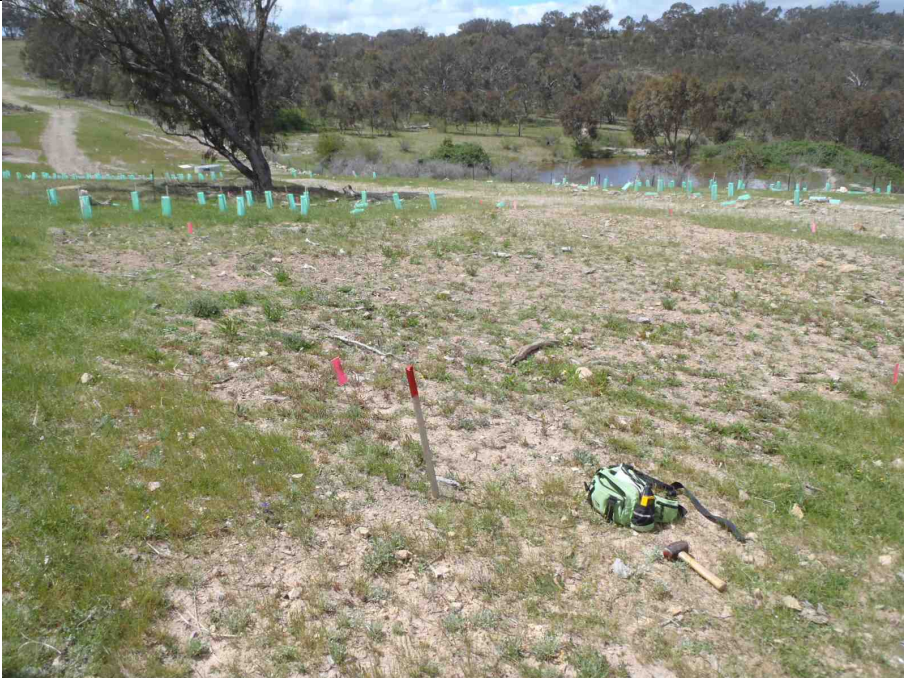
Plate 14: Monitoring Site HP2

<b>Jurisdiction</b>		<b>ACT</b>	<p><b>HP2</b> is located about 1,300 m from the LLPS within the ACT.</p> <p>NOTE: Plot sprayed out. Non-native <i>Conyza</i> sp., dominant. The NSW threatened Silky Swainson-pea <i>Swainsona sericea</i> was recorded within monitoring site, may have germinated from an existing tuber or seeded.</p>	
Co-ordinates	692219 - 6060594			
<b>No. of native herbaceous species</b>		<b>16</b>		
Planted	6			
Non-planted	10			
<b>Estimated cumulative cover score</b>				
Planted	<5%			
Non-planted	5-25%

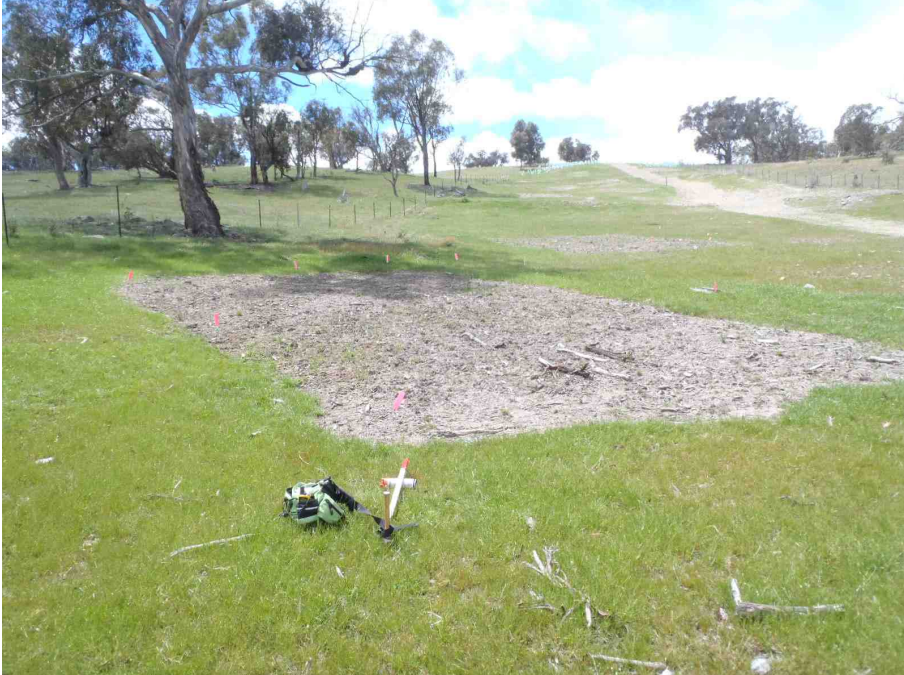
Plate 15: Monitoring Site HP3

<b>Jurisdiction</b>		<b>NSW</b>	<p><b>HP3</b> is located about 1,550 m from the LLPS within the ACT.</p> <p>NOTE: Plot was treated with herbicide prior to planting. Surrounding groundcover is a result of artificial seeding and other forms of regeneration.</p> <p>A large proportion of Viro Cells have been removed or have not survived. Dominant grasses non-native: <i>Vulpia</i> sp., <i>Lolium</i> sp. and <i>Brome</i> sp.</p>	
Co-ordinates		692459 - 6060660		
<b>No. of native herbaceous species</b>		<b>6</b>		
Planted		4		
Non-planted		2		
<b>Estimated cumulative cover score</b>				
Planted		<5%		
Non-planted		<5%

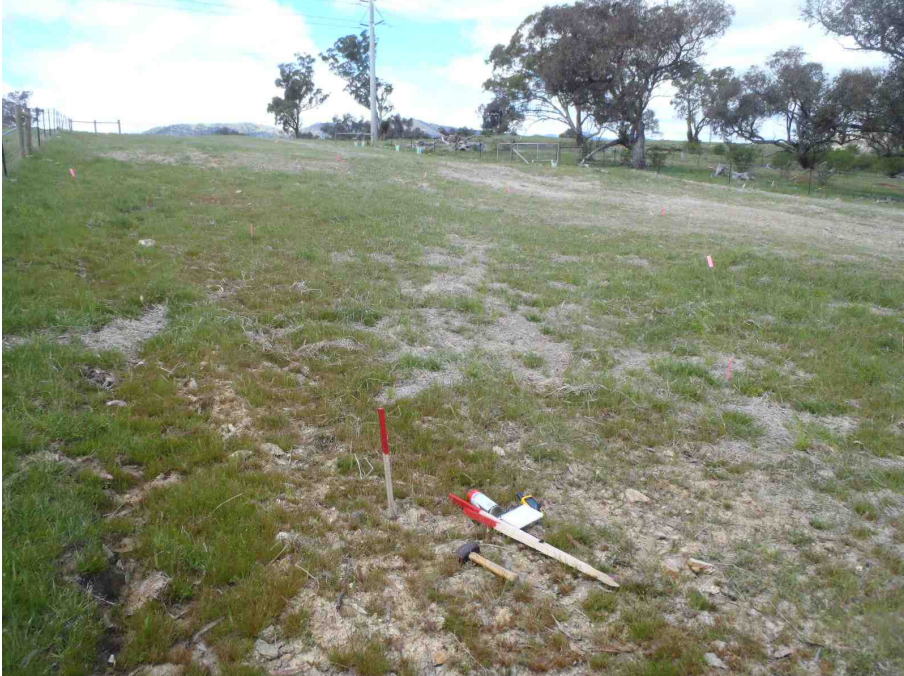
Plate 16: Monitoring Site HP4

<b>Jurisdiction</b>	<b>NSW</b>	<p><b>HP4</b> is located about 1,770 m from the LLPS within the ACT.</p> <p>NOTE: Plot sprayed out. Dominated by non-native grasses. Low proportion of native herbaceous species.</p>
Co-ordinates	692797 - 6060687	
<b>No. of native herbaceous species</b>	<b>7</b>	
Planted	4	
Non-planted	3	
<b>Estimated cumulative cover score</b>		
Planted	<5%	
Non-planted	<5%

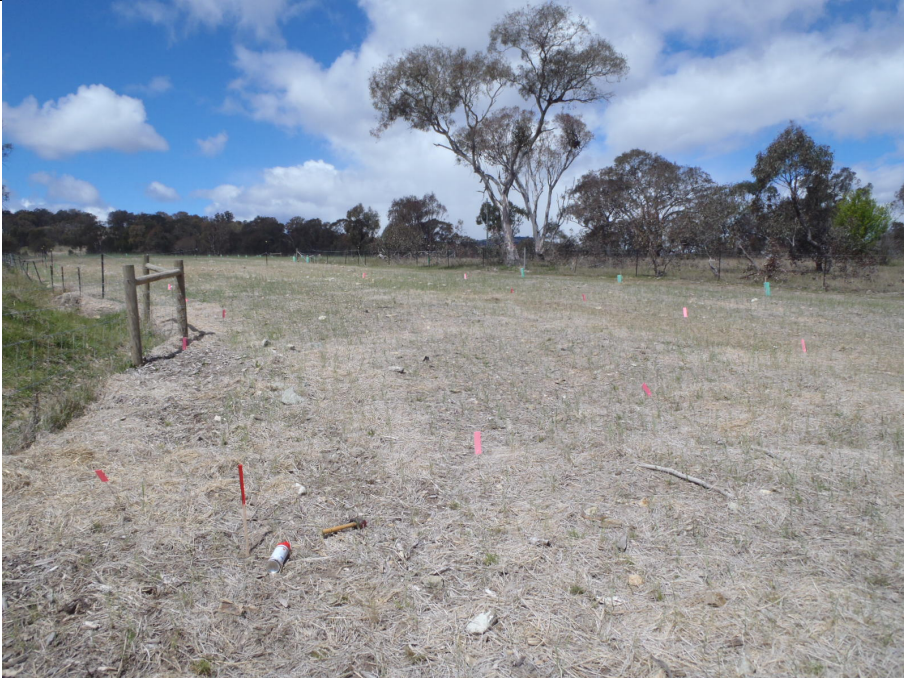
Plate 17: Monitoring Site HP5

<b>Jurisdiction</b>		<b>NSW</b>	<p><b>HP5</b> is located about 2,550 m from the LLPS within the ACT, W of the Monaro Hwy.</p> <p>NOTE: Evidence of cell removal. Exotic grasses emerging: i.e. <i>Bromus</i> sp., <i>Loilium</i> sp., <i>Briza</i> sp. though not dominant.</p> <p>Approximately +400 ALG tussocks S. of the construction corridor on W. side of the Monaro Hwy at coordinates 693550 - 6060502.</p>	
Co-ordinates	693442 - 6060534			
<b>No. of native herbaceous species</b>	<b>9</b>			
Planted	9			
Non-planted	0			
<b>Estimated cumulative cover score</b>				
Planted	<5%			
Non-planted	0

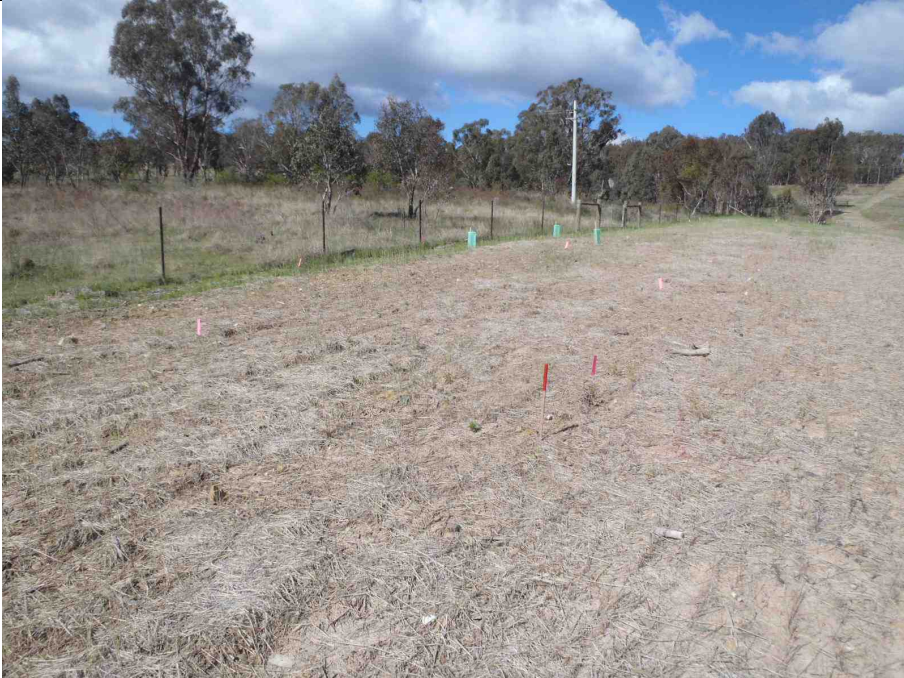
Plate 18: Monitoring Site HP6

<b>Jurisdiction</b>		<b>NSW</b>	<p><b>HP6</b> is located about 2,780 m from the LLPS within the ACT, between the Monaro Hwy and Cooma-Goulburn Railway corridor.</p> <p>NOTE: Sparse ground cover vegetation. Three cells dead one in poor condition with roots not penetrating surrounding soil.</p>	
Co-ordinates	693683 - 6060542			
<b>No. of native herbaceous species</b>	<b>6</b>			
Planted	6			
Non-planted	0			
<b>Estimated cumulative cover score</b>				
Planted	<5%			
Non-planted	0

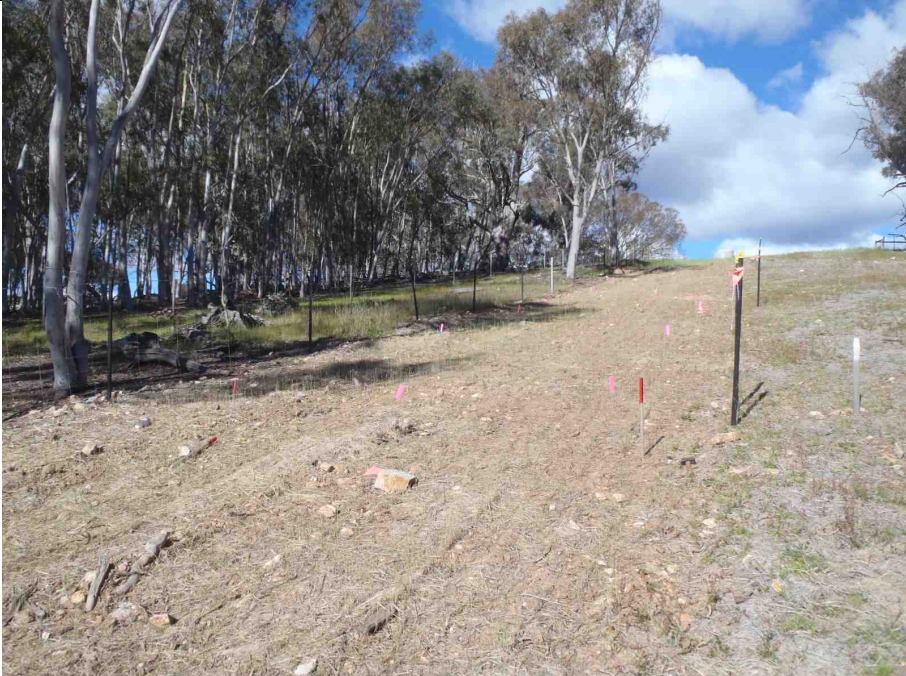
Plate 19: Monitoring Site HP7

<b>Jurisdiction</b>		<b>NSW</b>	<p>HP7 is located about 3,200 m from the LLPS within the Smith property, NSW.</p> <p>NOTE: One cell removed and one dead. Groundcover sparse.</p>	
Co-ordinates	694084 - 6060511			
<b>No. of native herbaceous species</b>	<b>5</b>			
Planted	5			
Non-planted	0			
<b>Estimated cumulative cover score</b>				
Planted	<5%			
Non-planted	0

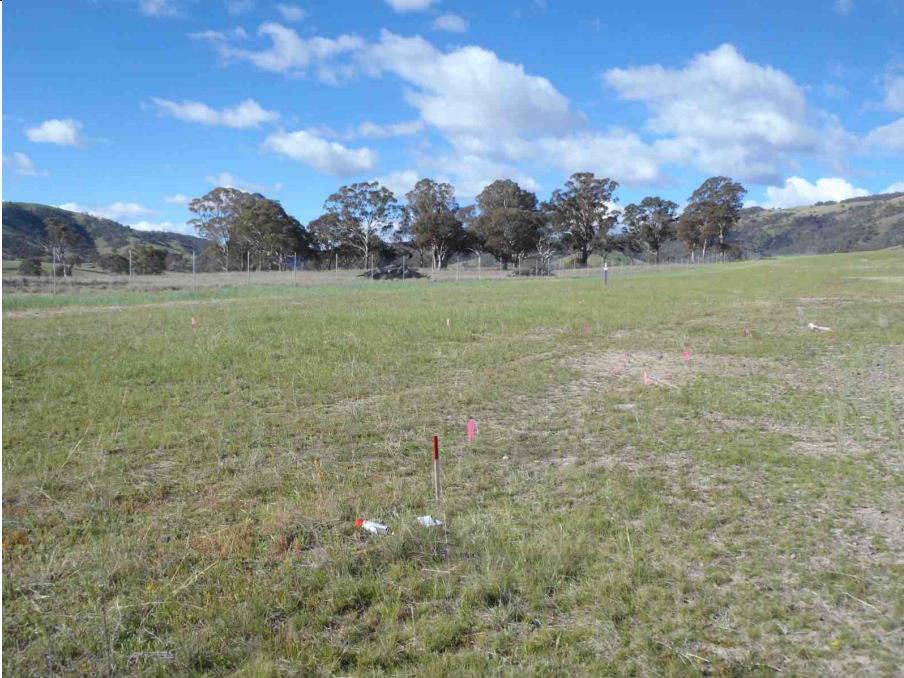
Plate 20: Monitoring Site HP8

<b>Jurisdiction</b>	<b>NSW</b>	<p><b>HP8</b> is located about 3,650 m from the LLPS within the McDonald property, NSW.</p> <p>NOTE: Exotic <i>Bromus hordeaceus</i> dominant.</p>
Co-ordinates	694525 - 6060591	
<b>No. of native herbaceous species</b>	<b>19</b>	
Planted	9	
Non-planted	10	
<b>Estimated cumulative cover score</b>		
Planted	5-25%	
Non-planted	5-25%

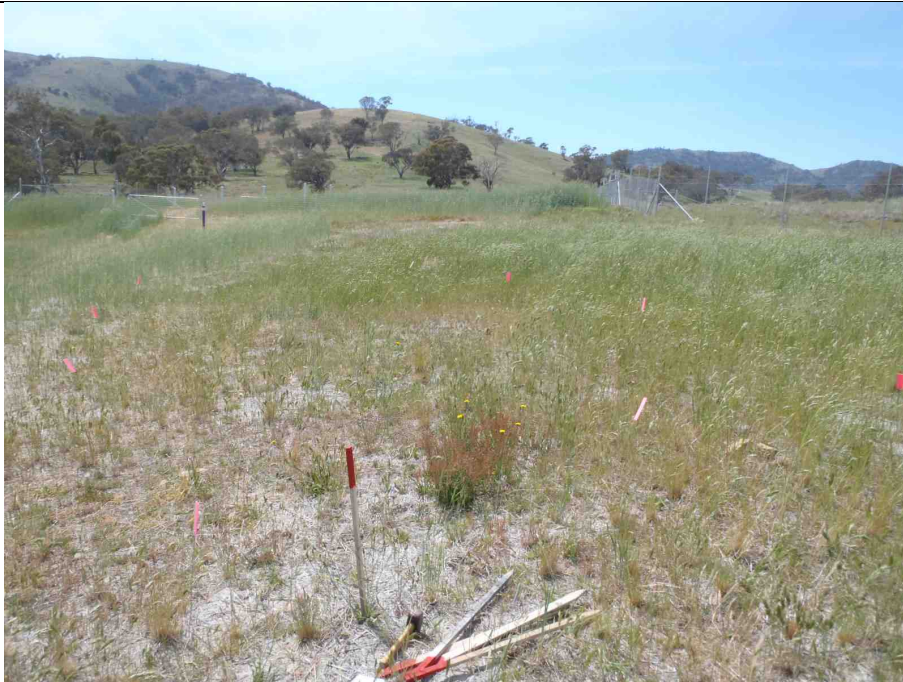
Plate 21: Monitoring Site HP9

<b>Jurisdiction</b>	<b>NSW</b>	<p><b>HP9</b> is located about 4,050 m from the LLPS within the McDonald property, NSW</p> <p>NOTE: ALG present (marked with stake and pink tape). Site dominated by <i>Bromus hordeaceus</i>. Threatened Silky Swainson-pea <i>Swainsona sericea</i> in adjacent areas of retained groundcover within construction corridor W of multi gate complex.</p>
Co-ordinates	694890 - 6060767	
<b>No. of native herbaceous species</b>	<b>10</b>	
Planted	6	
Non-planted	4	
<b>Estimated cumulative cover score</b>		
Planted	5-25%	
Non-planted	<5%

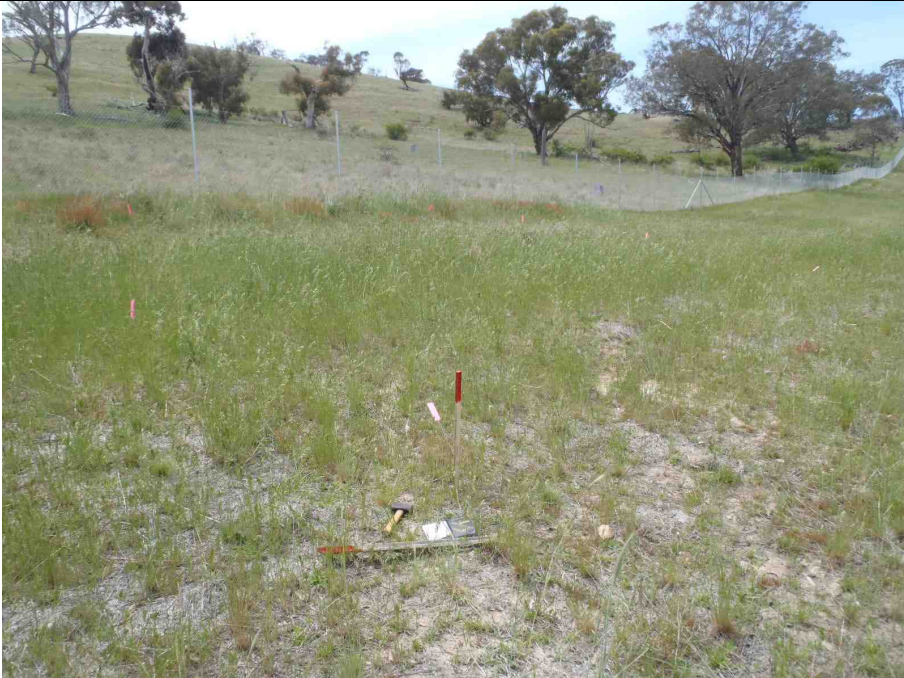
Plate 22: Monitoring Site HP10

<b>Jurisdiction</b>		<b>NSW</b>	<p><b>HP10</b> is located about 4,475 m from the LLPS within the McDonald property, NSW.</p> <p>NOTE: Exotic <i>Bromus hordeaceus</i> was dominant. At least 8 cells have been removed, with 21 additional cells removed from nearby planting sites. Two cells were desiccated <i>in situ</i>.</p>	
Co-ordinates	695248 - 6060569			
<b>No. of native herbaceous species</b>		<b>15</b>		
Planted	8			
Non-planted	7			
<b>Estimated cumulative cover score</b>				
Planted	<5%			
Non-planted	<5%

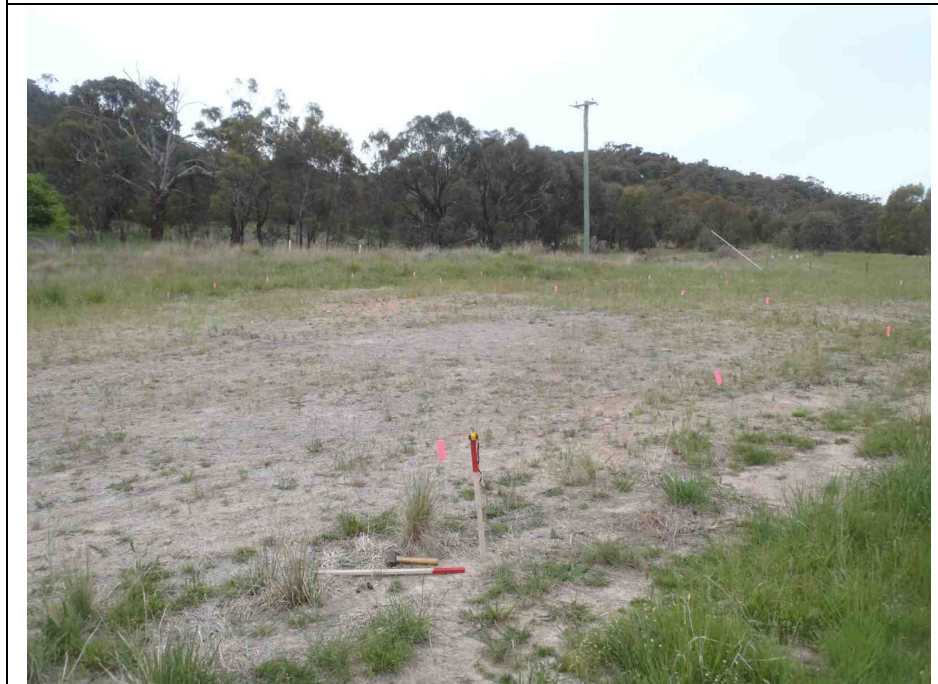
**Plate 23: Monitoring Site HP11**

<b>Jurisdiction</b>	<b>NSW</b>	<b>HP11</b> is located about 6,175 m from the LLPS within the Codd/Howarth property, NSW.
Co-ordinates	696826 - 6060127	
<b>No. of native herbaceous species</b>	<b>11</b>	
Planted	6	
Non-planted	3	
<b>Estimated cumulative cover score</b>		
Planted	<5%	
Non-planted	<5%

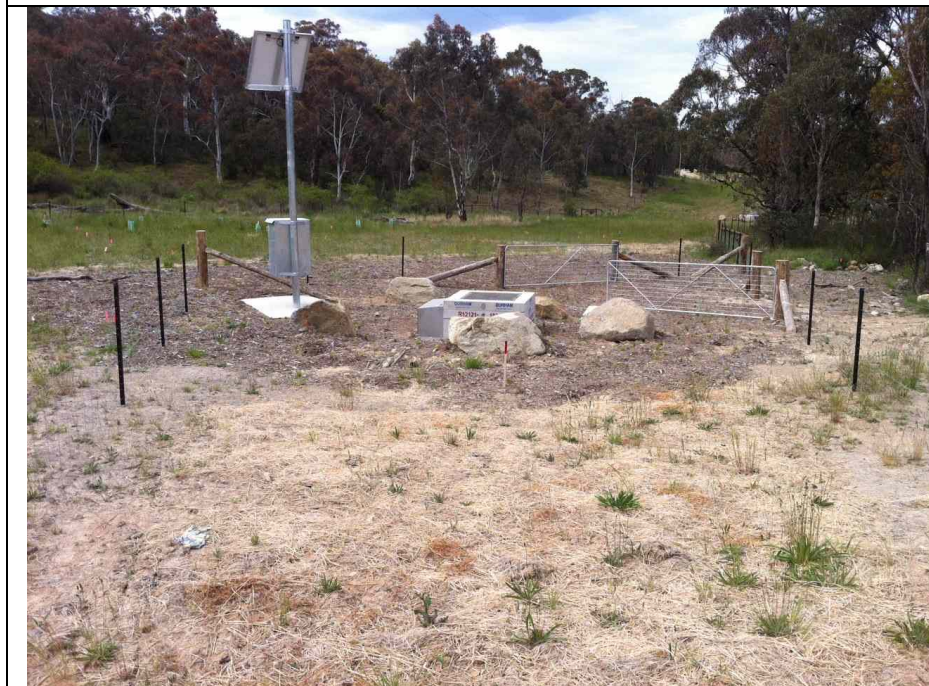
Plate 24: Monitoring Site HP12

HP12 is located about 7,550 m from the LLPS within the Devitt property, NSW.

NOTE: Heavy mulch cover persists. *Austrostipa* sp. tube stock appears to be in poor health, although some tussocks have produced seed.

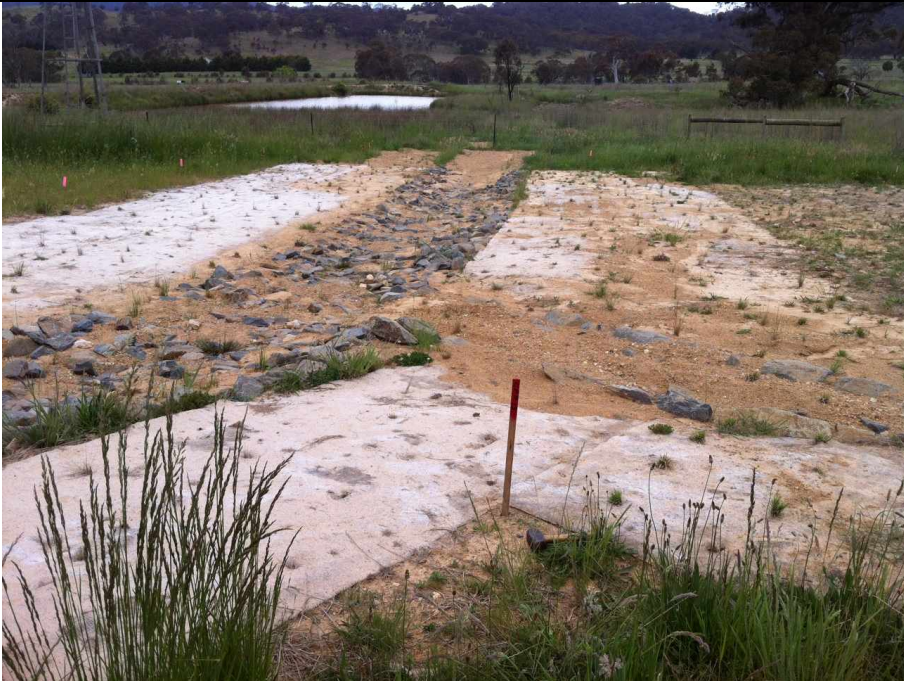
<p>N/A</p>
<p>Plate 25: Monitoring Site HP13</p>

<b>Jurisdiction</b>		<b>NSW</b>	<p><b>HP13</b> is located about 8,250 m from the LLPS within the Boss property, NSW.</p> <p>NOTE: Non-viable cells accounted for approximately 50% of all plantings.</p> <p>NOTE: Diamond Firetail x2 observed attempting to feed on non-native grass seed at edge of property access.</p>	
Co-ordinates		698541 - 6061210		
<b>No. of native herbaceous species</b>		<b>8</b>		
Planted		8		
Non-planted		0		
<b>Estimated cumulative cover score</b>				
Planted		<5%		
Non-planted		0
