ACTEW Water
MEMP
Macroinvertebrate Sampling
Field observation report: spring 2012

November 2012

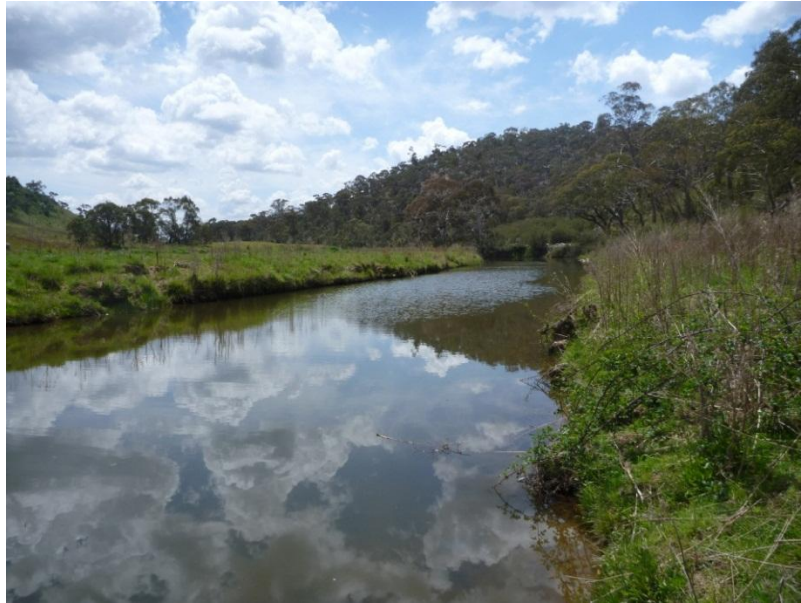
Plate 1. BUR 3 inundated by Googong Reservoir (Drawdown crossing is in the background)

Sampling in Burra Creek and the Queanbeyan River was conducted on the 29th and 30th of October 2012. The original BUR 3 and QBYN 2 sites remain inundated by water backing up from Googong reservoir (Plate 1).

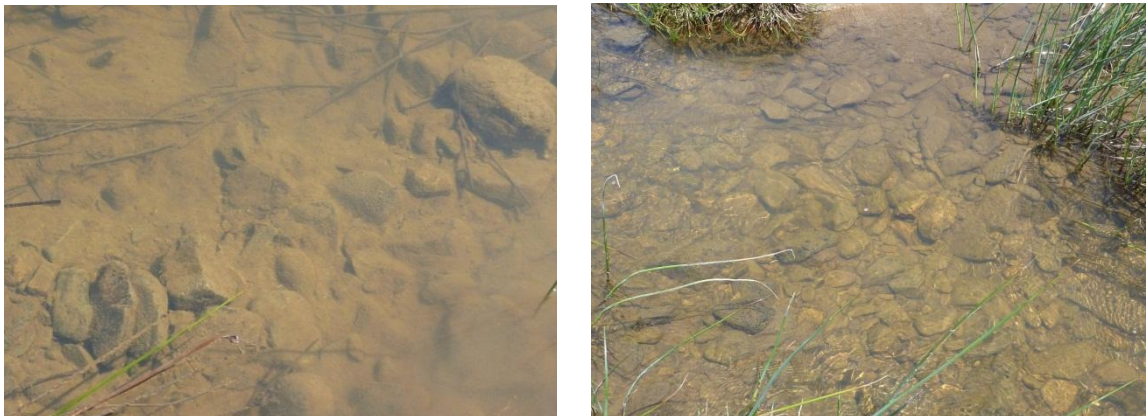
Plate 2. Substrate at BUR 1c in autumn 2012 (left) and spring 2012

There was a notable reduction of silt and organic material from the riffle habitats across all sites. This was particularly evident at BUR 1c, which because of its situation upstream of the M2G outlet, suggests that the high flow events in early and mid-spring contributed to this, rather than being solely due to the M2G commissioning (Plate 2).

Macroinvertebrate scans showed that despite the improvement in the riffle quality at BUR 1c, diversity was still relatively low compared to the other sites. Despite this, there was a notable increase in mayfly diversity and an increase in the size and abundance of the stonefly family, Gripopterygidae. Across all sites the visual assessment of the macroinvertebrate communities show a range of families with SIGNAL scores ranging from 2-8, indicating healthy communities at each of the Burra Creek sites.

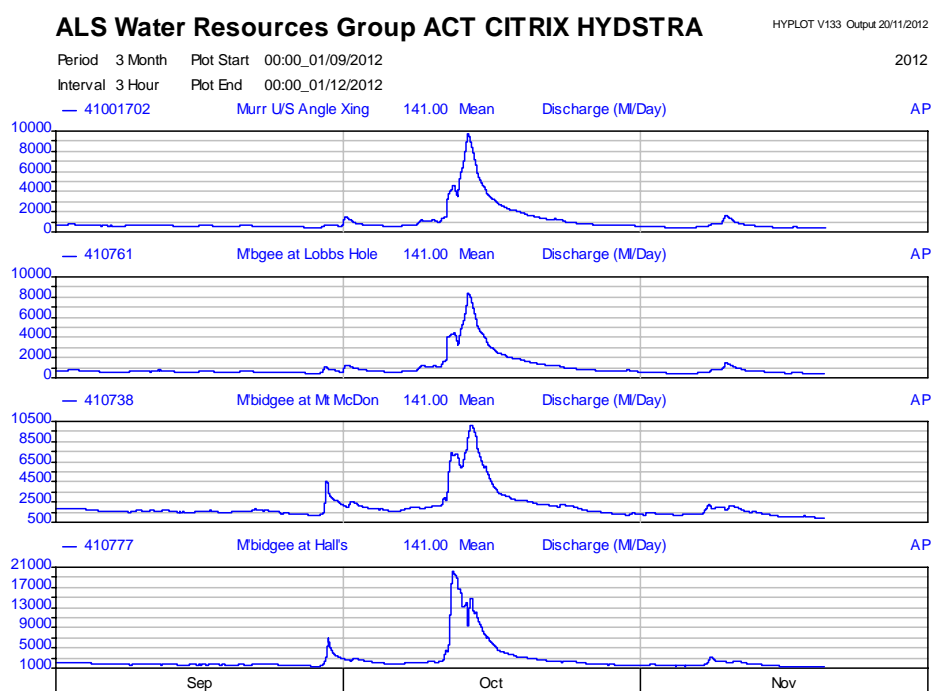
Figure 2 Hydrographs for the Queanbeyan River (top) and Burra Creek for September, October and the sampling period in November

Periphyton cover was fairly high among all sites (60-90%) but there was a definite absence of common submerged macrophytes such as *Myriophyllum sp.* and filamentous algae in this section of the Murrumbidgee. One likely reason for this observation is the effect of scouring and bed movement during the previous high flow event in mid-October (Figure 2).
