Murrumbidgee Ecological Monitoring Program

Annual Report - Sentinel Monitoring 2024

Icon Water

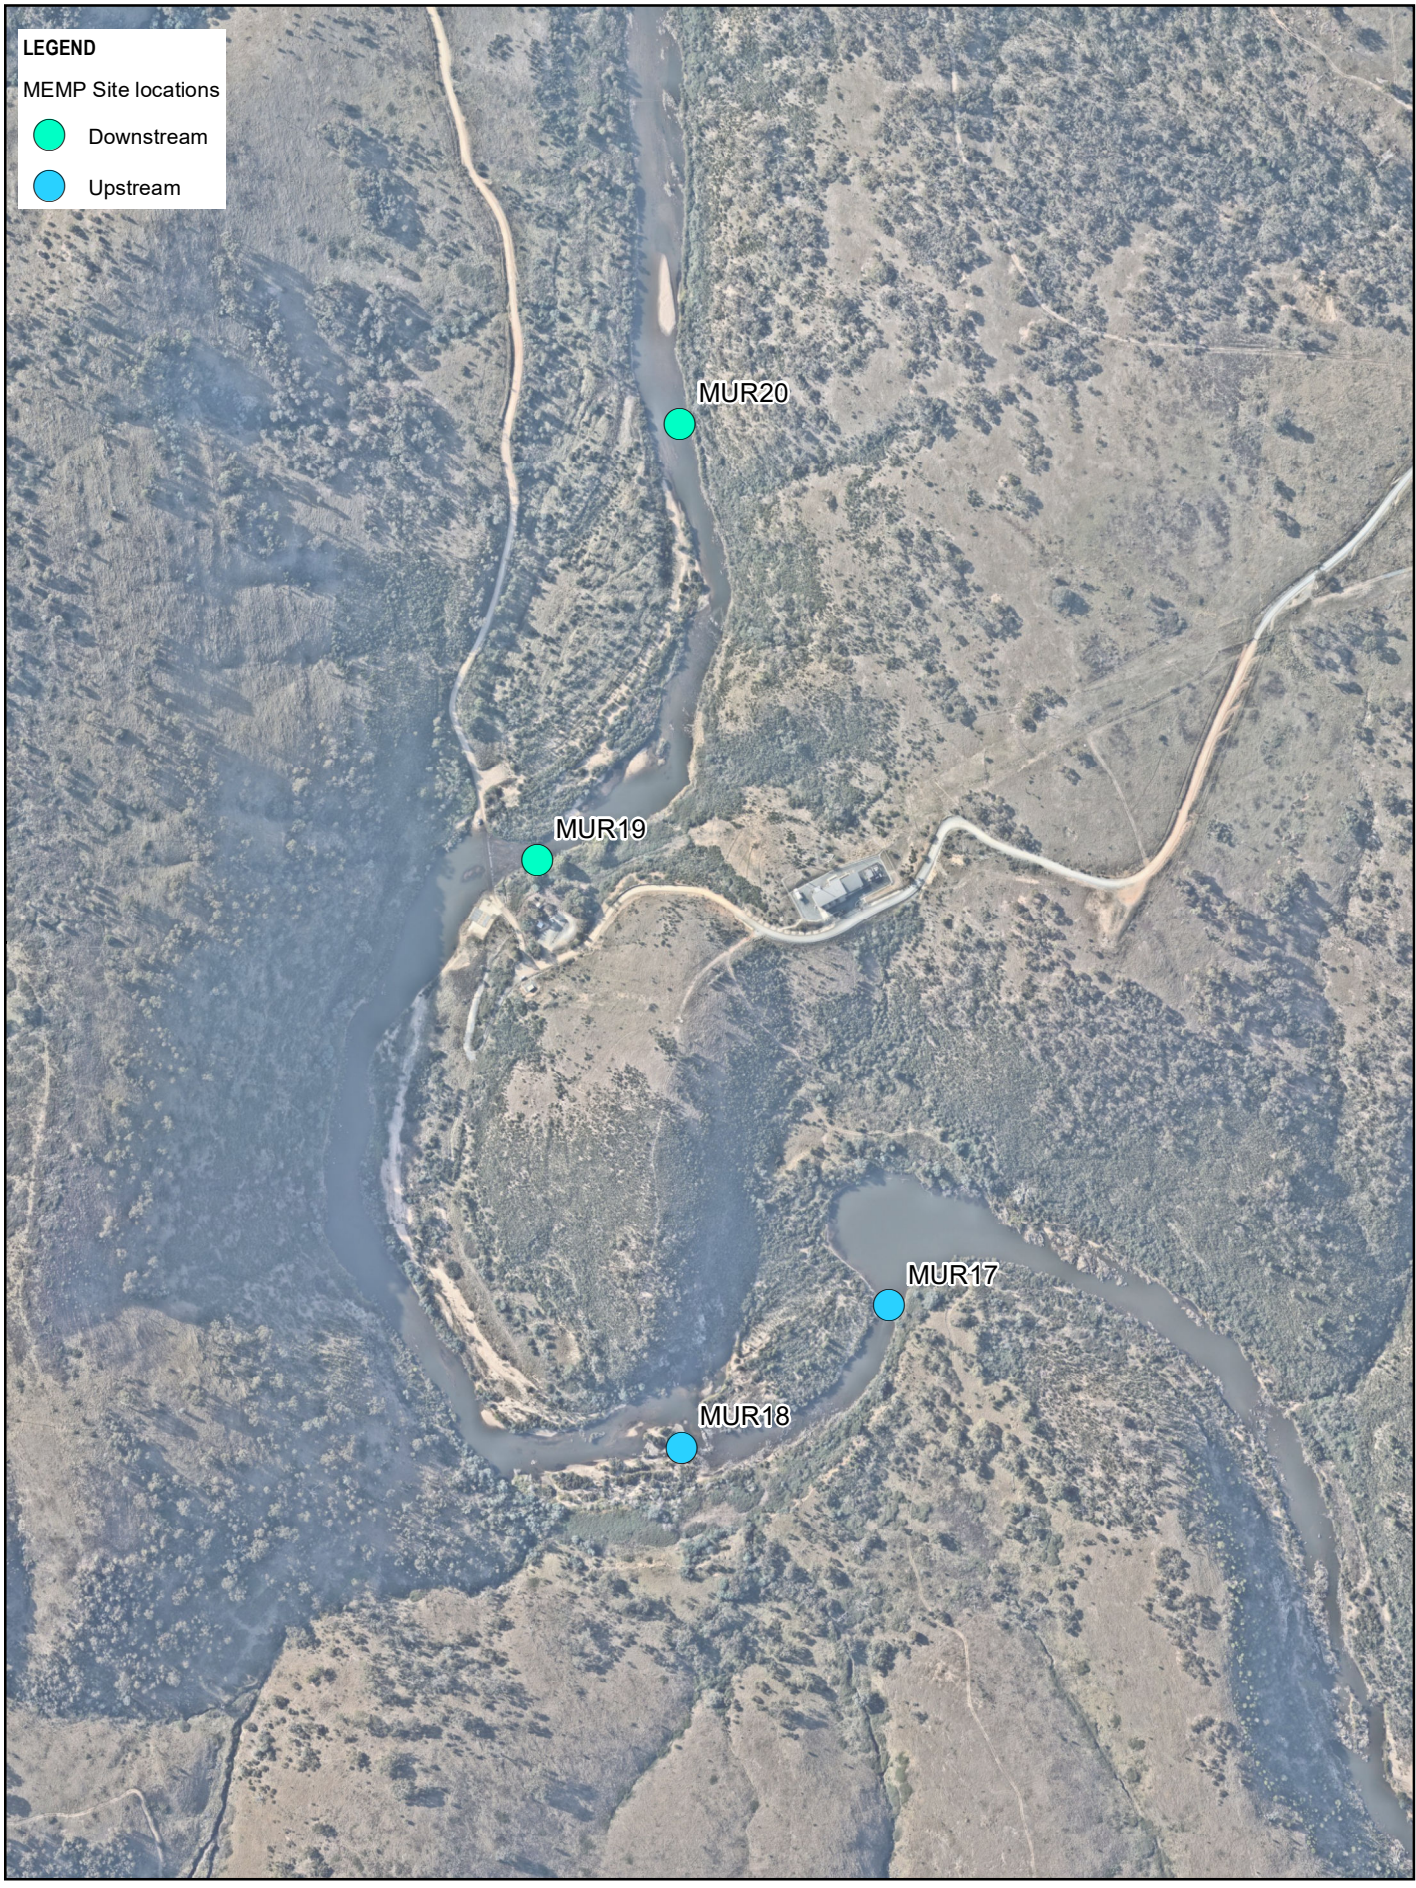
FIGURE 4

Details of monitoring site locations are included in Table 5. Locations of Burra Creek monitoring sites are shown in Figure 4, and locations of Murrumbidgee River monitoring sites related to the M2G are shown in Figure 5 and the MPS in Figure 6.

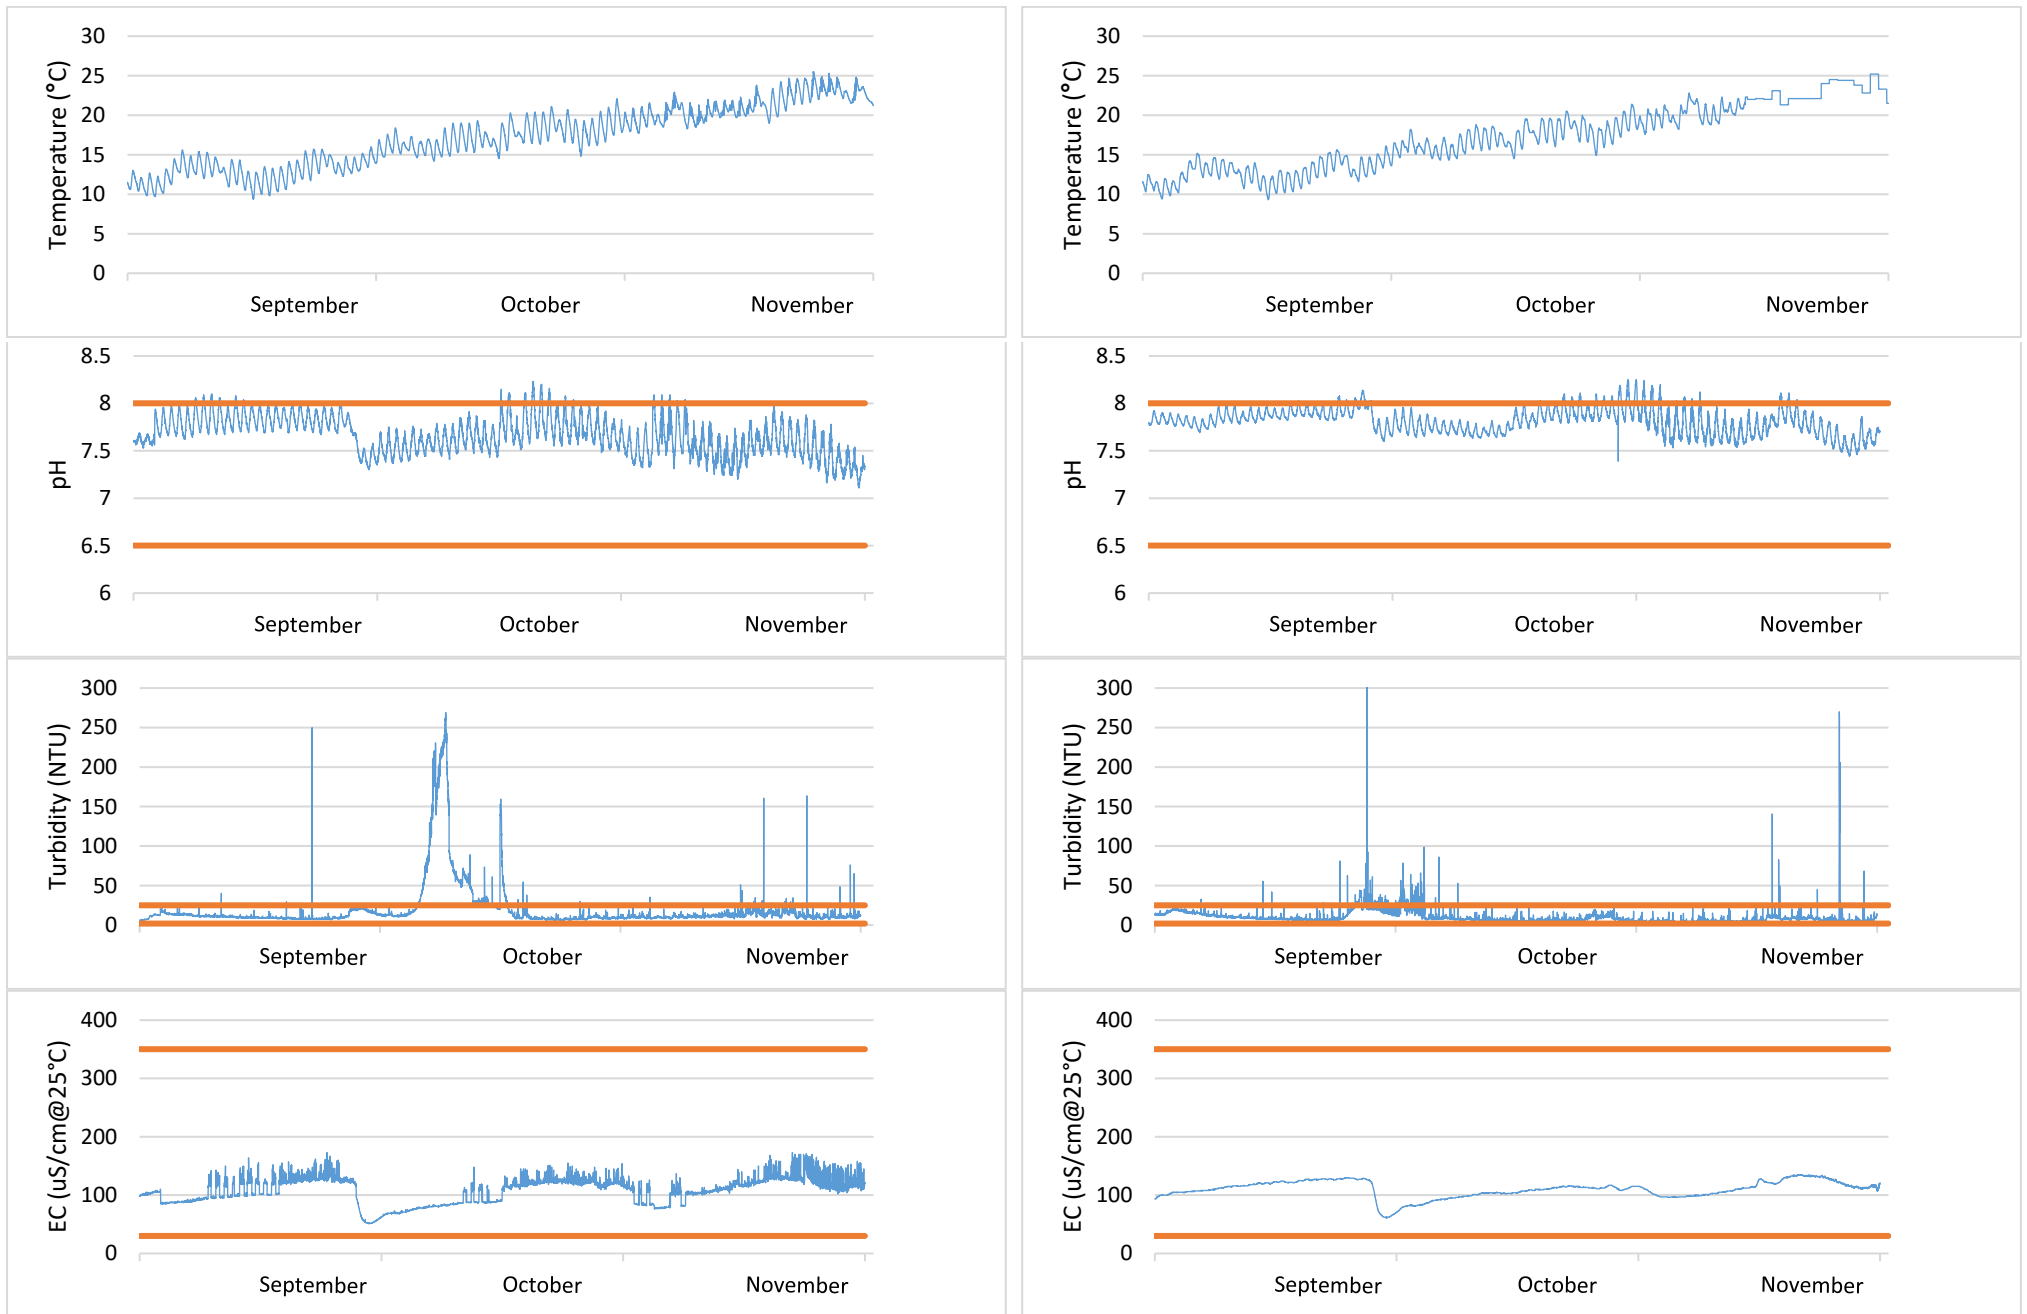
Figure 10 Continuous water quality records for spring 2024 from upstream Angle Crossing (41001702, left) and downstream at Lobbs Hole (410761, right). ANZG guideline values are in orange.

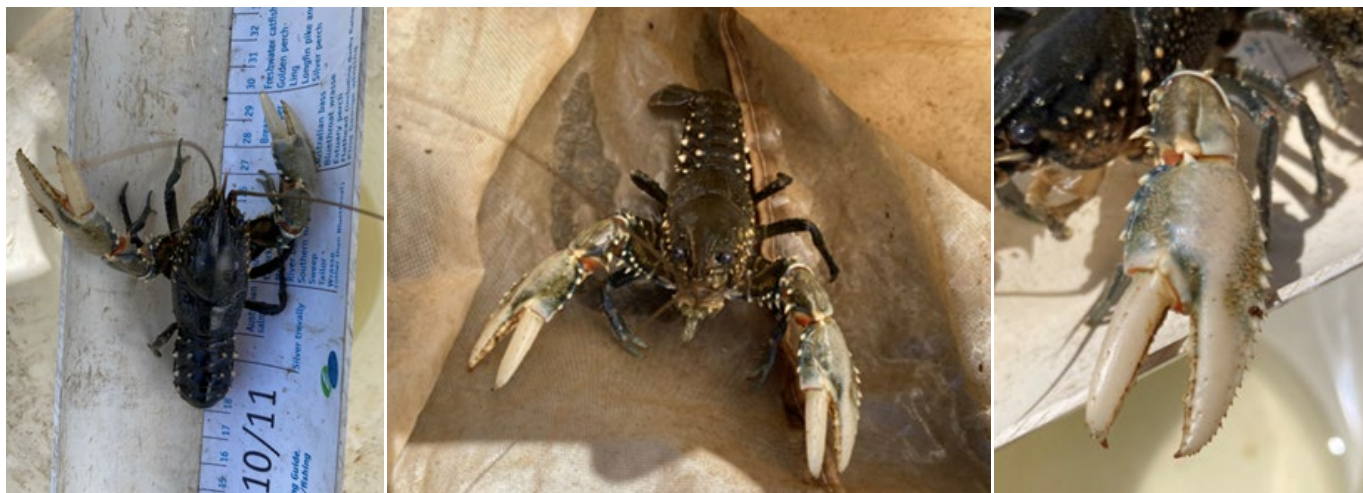
Figure 17 Murray Crayfish collected at MUR19 in spring 2024

While not part of formal fish surveys, during macroinvertebrate kick sampling in spring 2024 at MUR19, a single Murray Crayfish (listed as vulnerable under the ACT *Nature Conservation Act 2014* and NSW *Fisheries Management Act 2007*) was incidentally collected and returned unharmed. The Murray Crayfish was measured as having a 4.5 cm occipital carapace length (OCL) (see Figure 17).

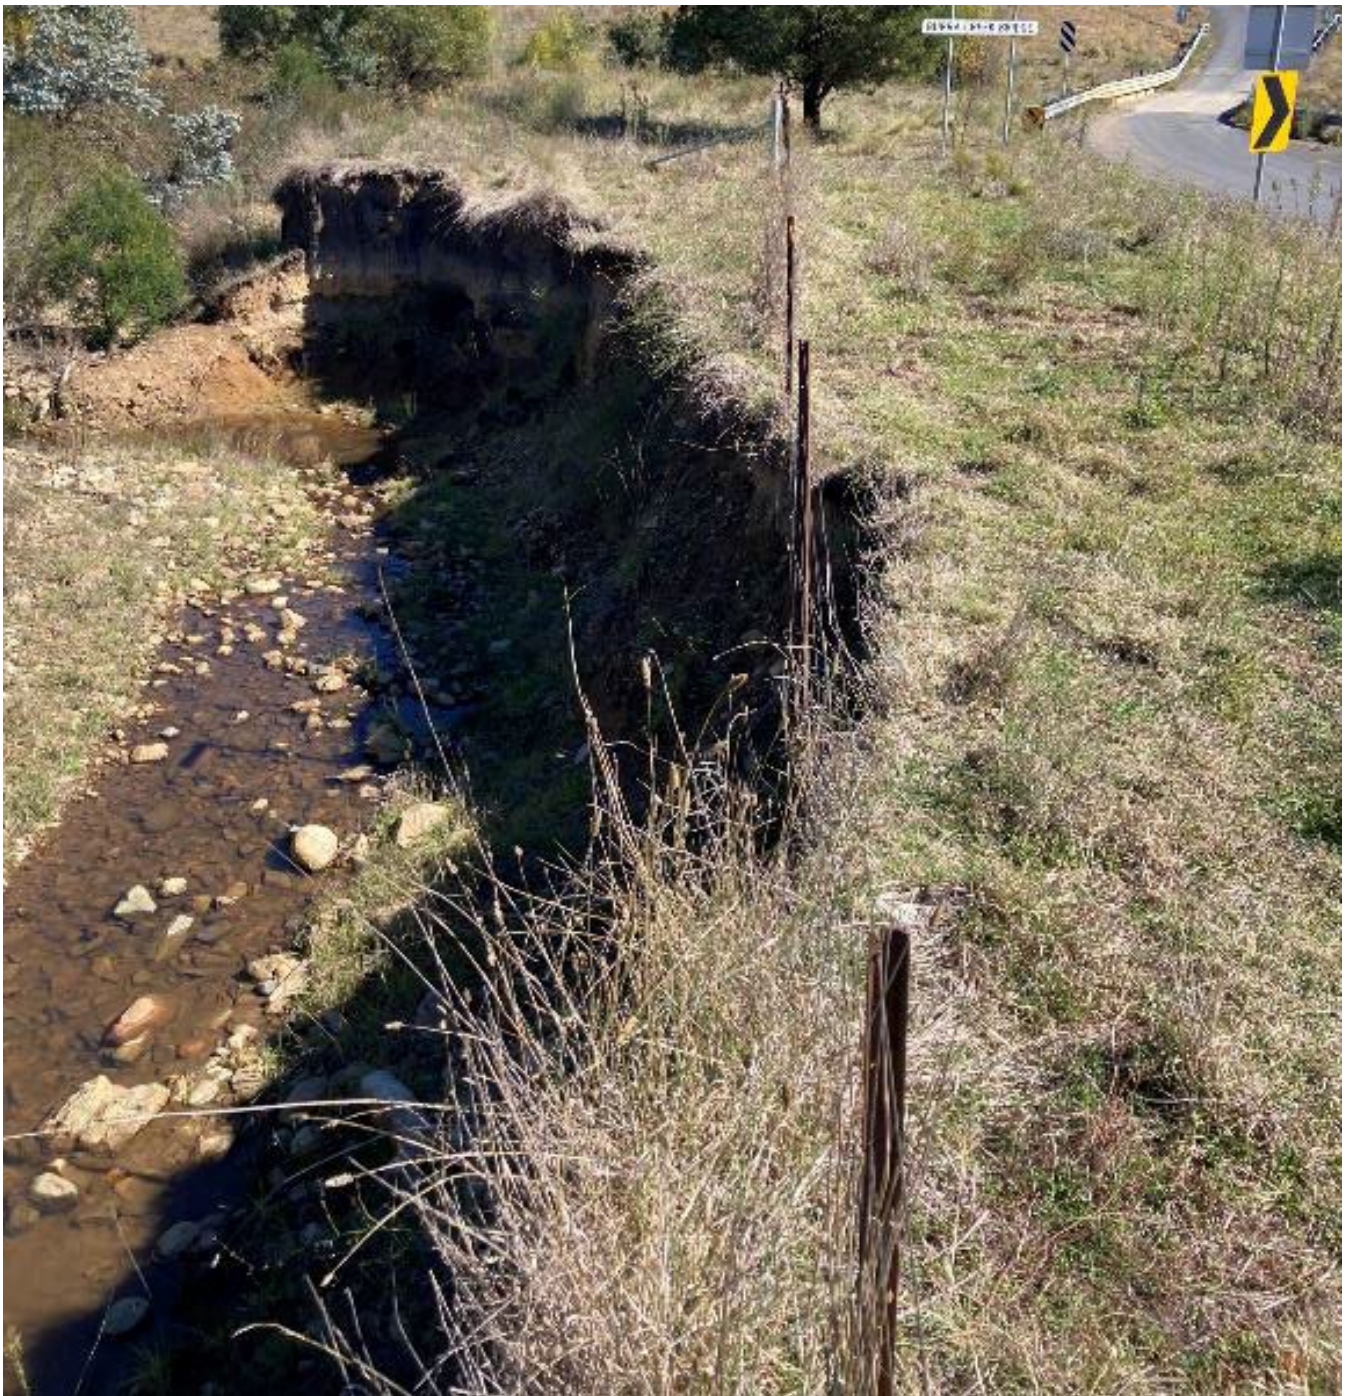
Figure 21 **Bank erosion at BUR1a**

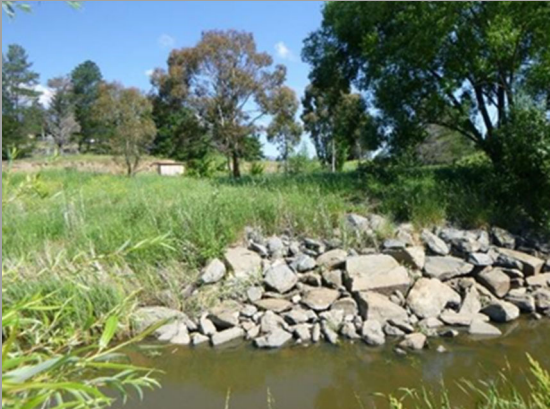
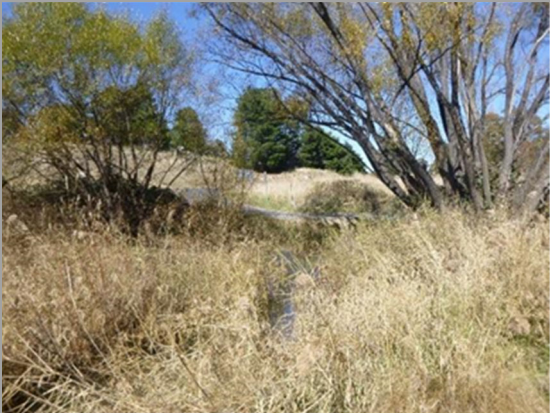
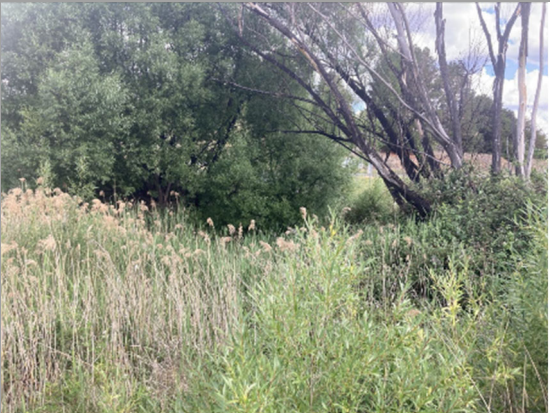
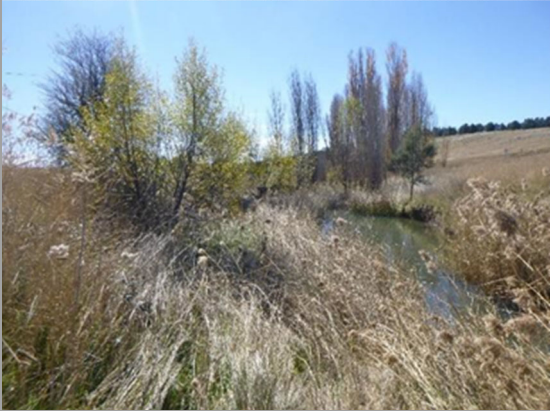
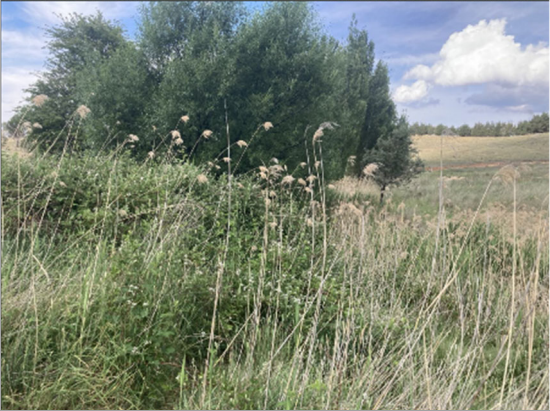
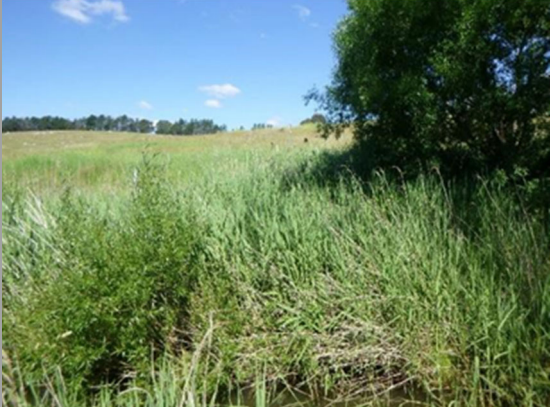
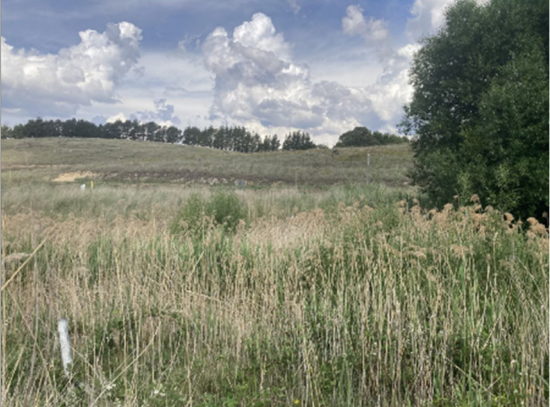
Photo point 3	A

- BUR2: No obvious geomorphological changes were observed (see Table 21). Emergent macrophytes and riparian trees observed to have been further established in relation to extent and tree size (see Photo point 1 and 2). Compared to 2020/2021, a large willow downstream of Williamsdale Road has since died, and the extent of blackberry has expanded and prevented complete access to Photo point 3.

Note: Photographs from Autumn 2024 were lost during the upload process so are unable to be presented.

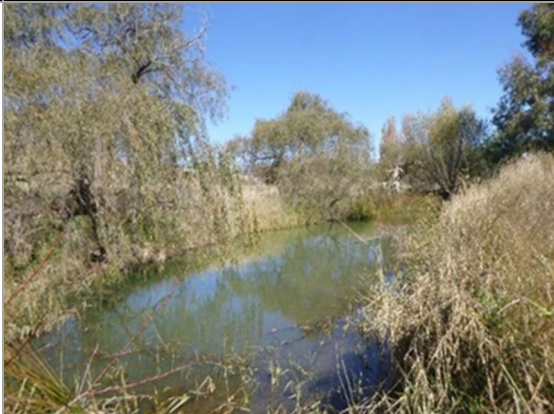
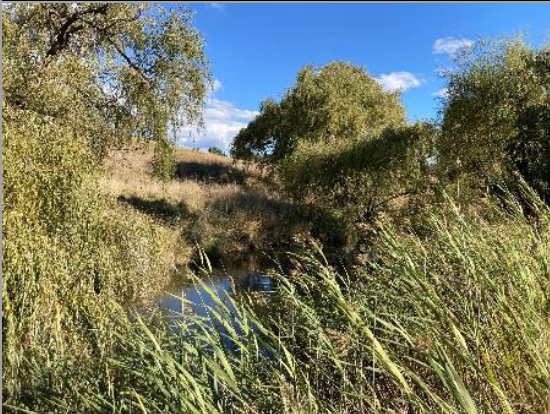
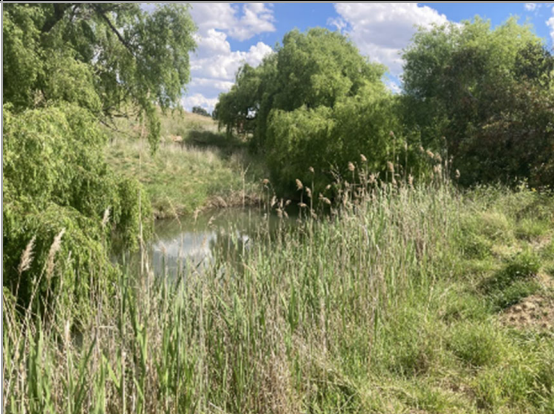
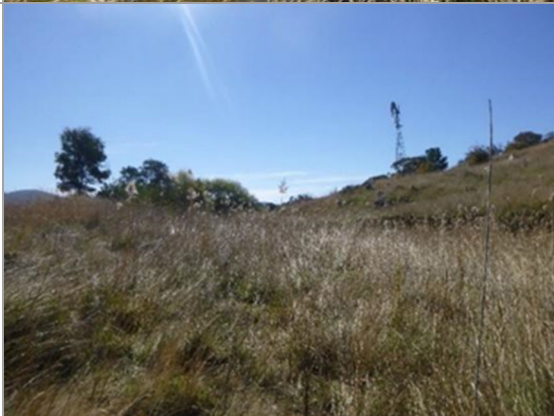
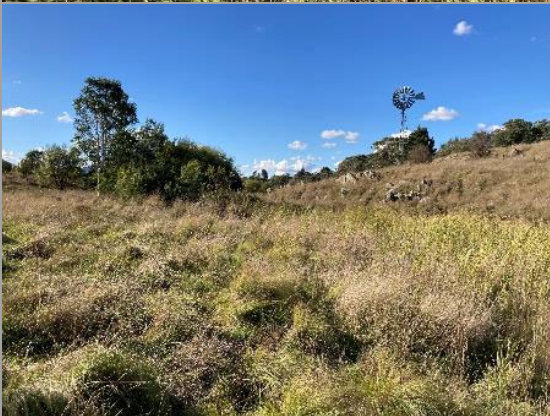
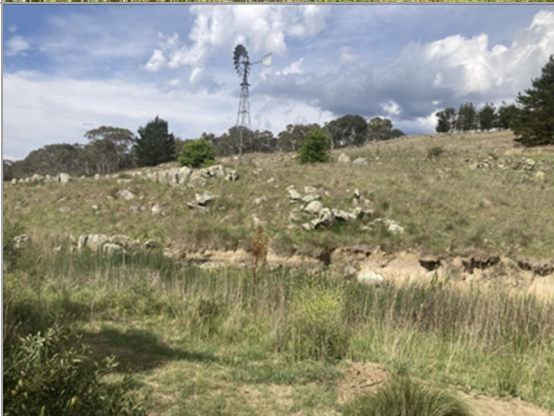
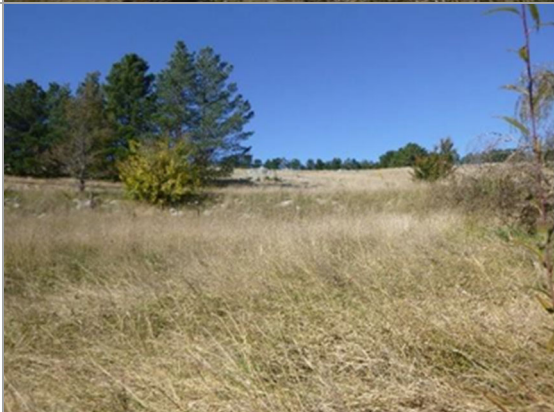
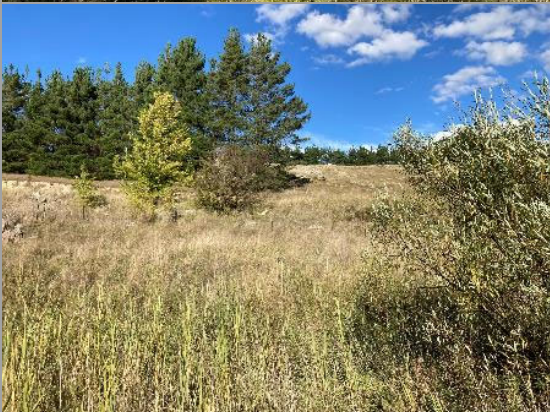
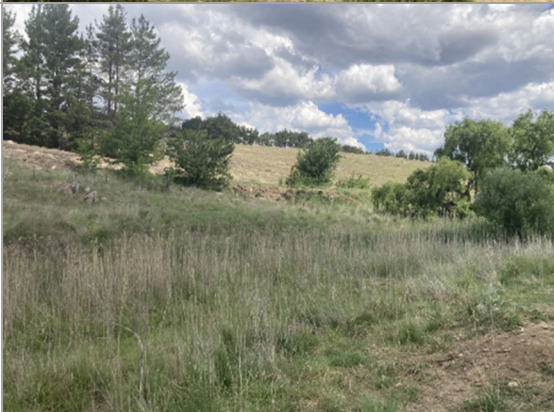
Table 22 Geomorphology at BUR2a

- BUR2a: No obvious geomorphological changes were observed with scarping of the right bank remaining in a similar condition to 2020/2021 (see Table 22, Photo point 2). Vegetation at the site was similar to previous monitoring.

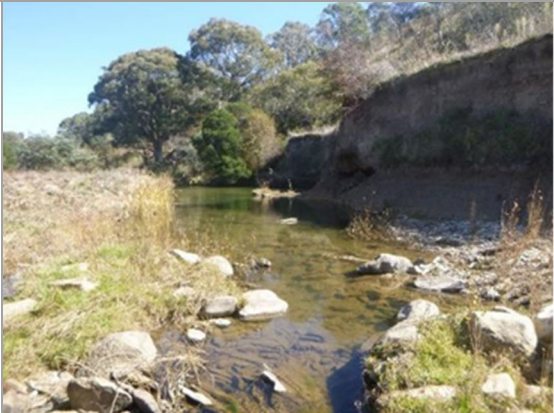
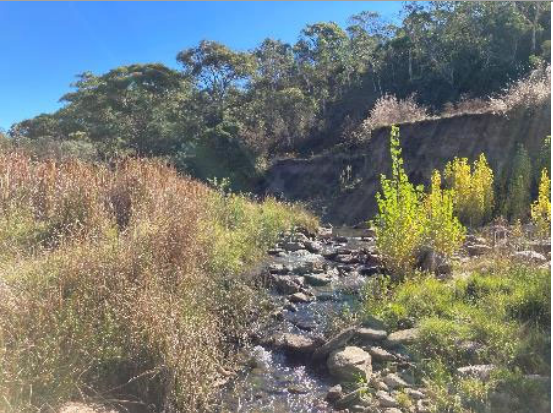
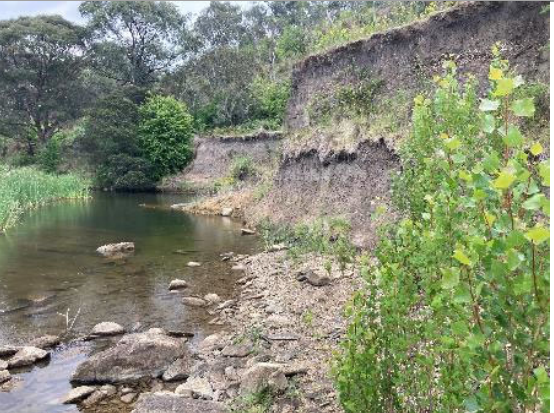
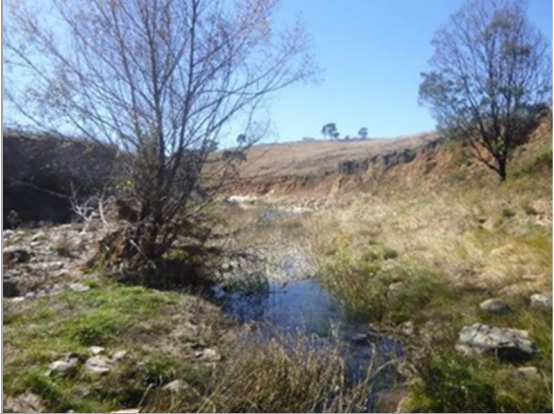
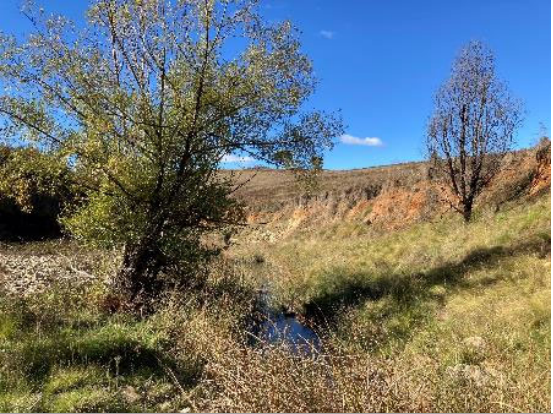
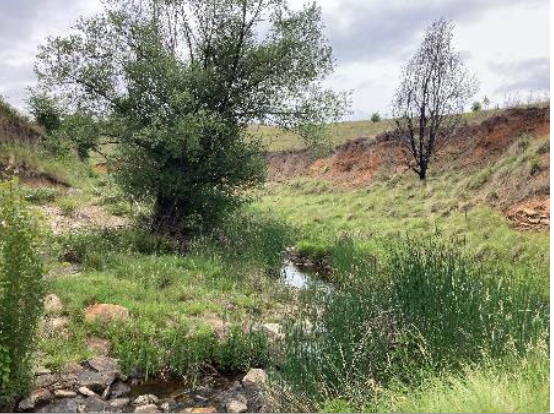
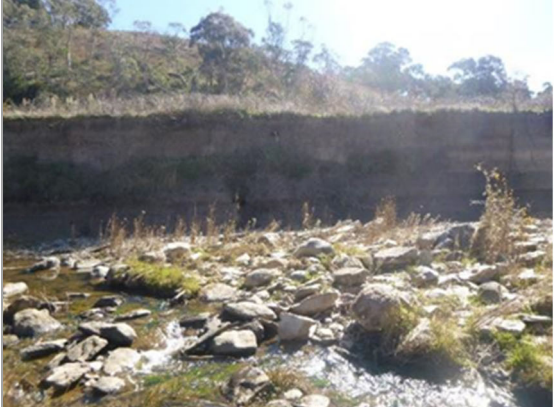
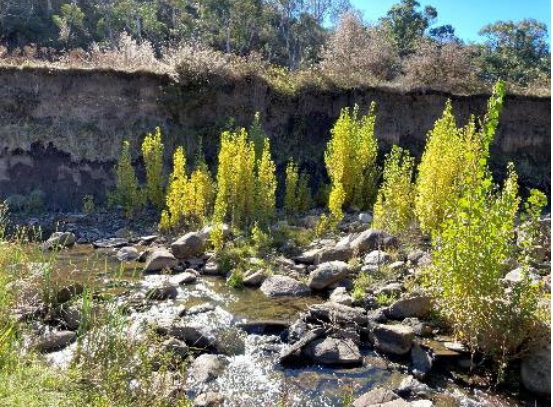
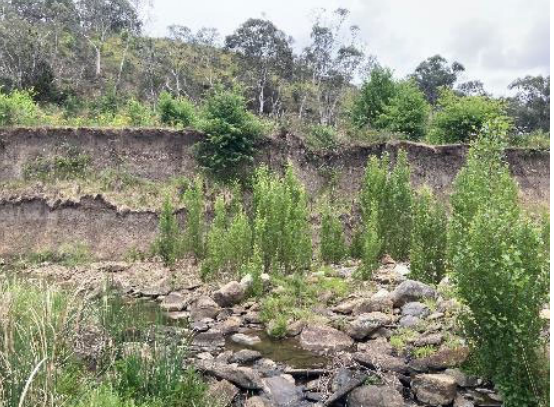
Table 23 *Geomorphology at Pool 29*

- Pool 29: No obvious geomorphological changes were observed with significant areas of scarping on the left bank remaining in a similar condition to 2020/2021 (see Table 23, Photo point 1). The point bar visible at Photo point 1 was observed to have new Poplar (*Populus* spp.) growth after former poplars were dislodged and washed away during 2020. There were no other obvious features of intensified erosion or geomorphological change.

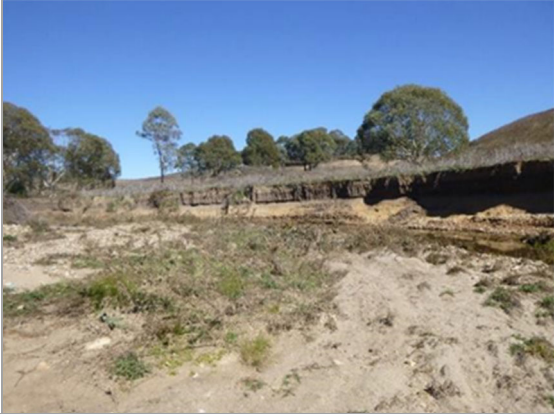
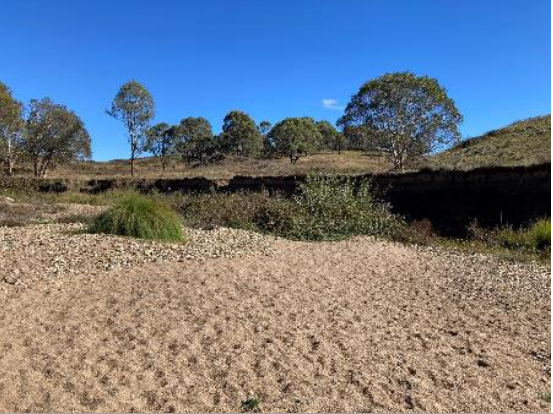
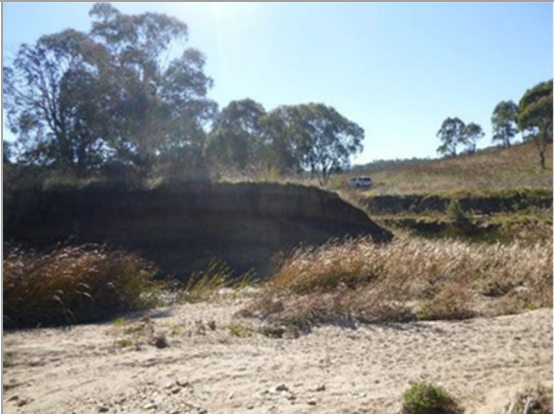
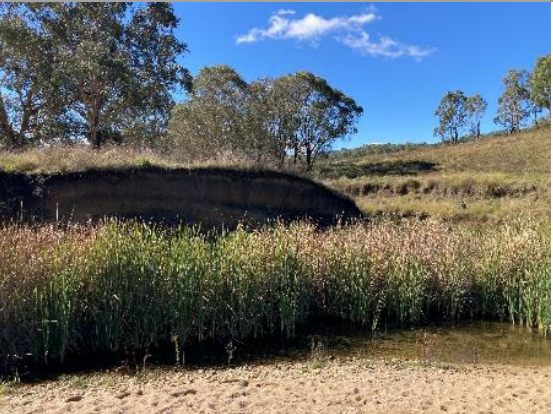
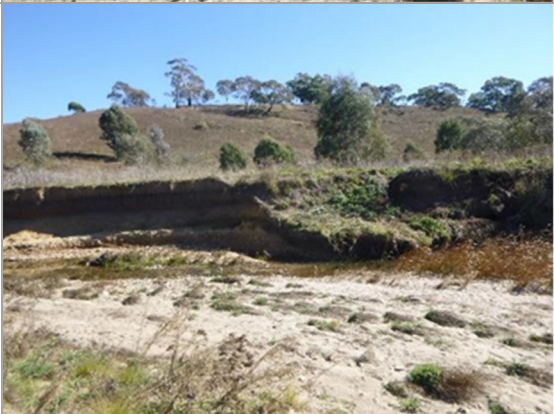
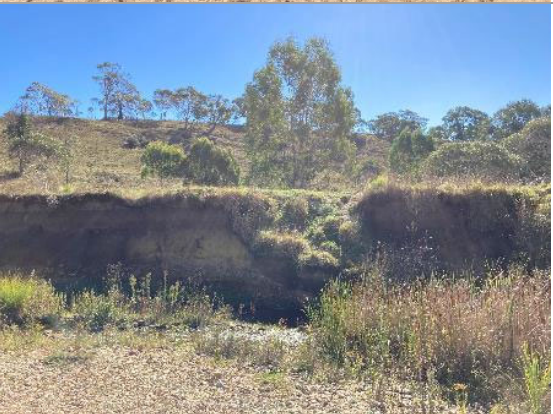
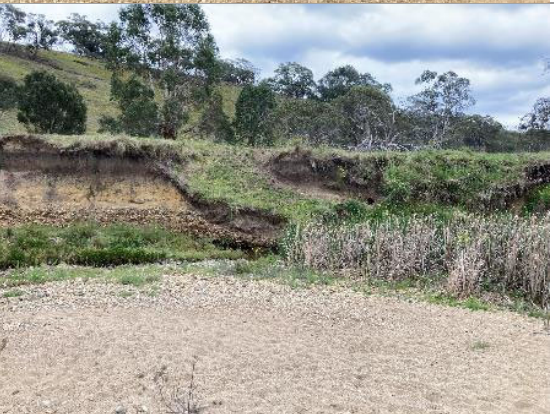
Photo point 2	A

- BUR2C: The point bar at Photo point 2 showed some evidence of recent change with reduced groundcover vegetation and/or sand deposition (see Table 24). All other parts of Burra Creek at BUR2C appeared to be similar to 2020/2021 with significant areas of scarping on the left bank remaining in a similar condition to 2020/2021 (see Photo point 2 and 3). Compared to 2020/2021, the extent of macrophytes was observed to be greater and the establishment and continued growth of Poplars in the riparian zone was also evident at Photo point 3.
