# GOOGONG DAM ACTIONS FOR CLEAN WATER PLAN UPDATE 2025

## 2025 ACWA PLAN UPDATE

Icon Water

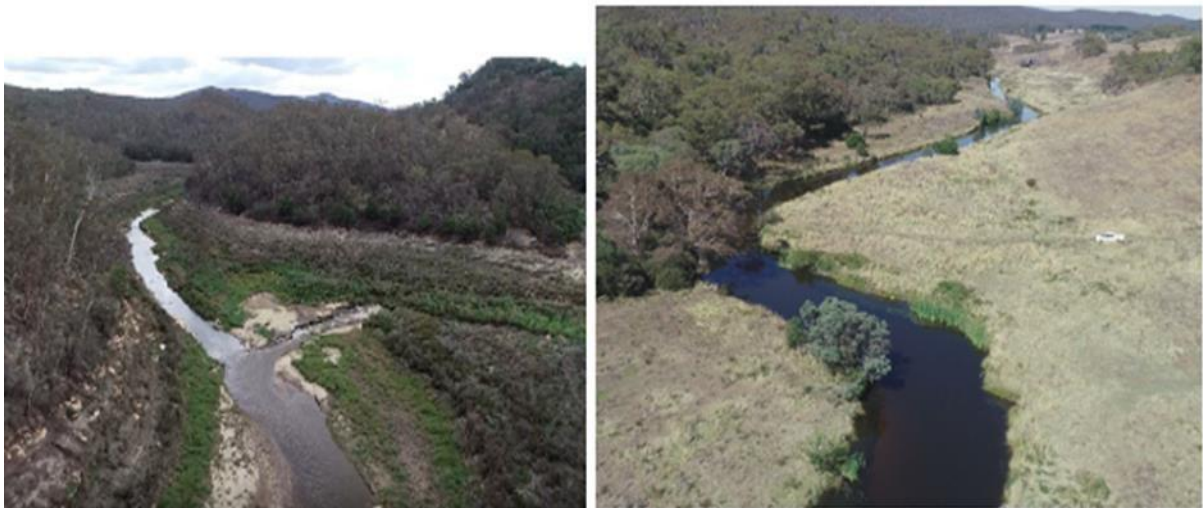
**Figure 2.** Comparison of Burra Creek inflows to Googong Reservoir between 2018 and 2025.

(Left) In 2018, the tributary of Burra Creek and the Queanbeyan River within the Googong Foreshores, with low water levels and visible sediment impacts. (Right) By 2023, following several wet years, modest improvements in riparian vegetation and water clarity were observed upstream of the confluence — suggesting some localised sediment buffering.

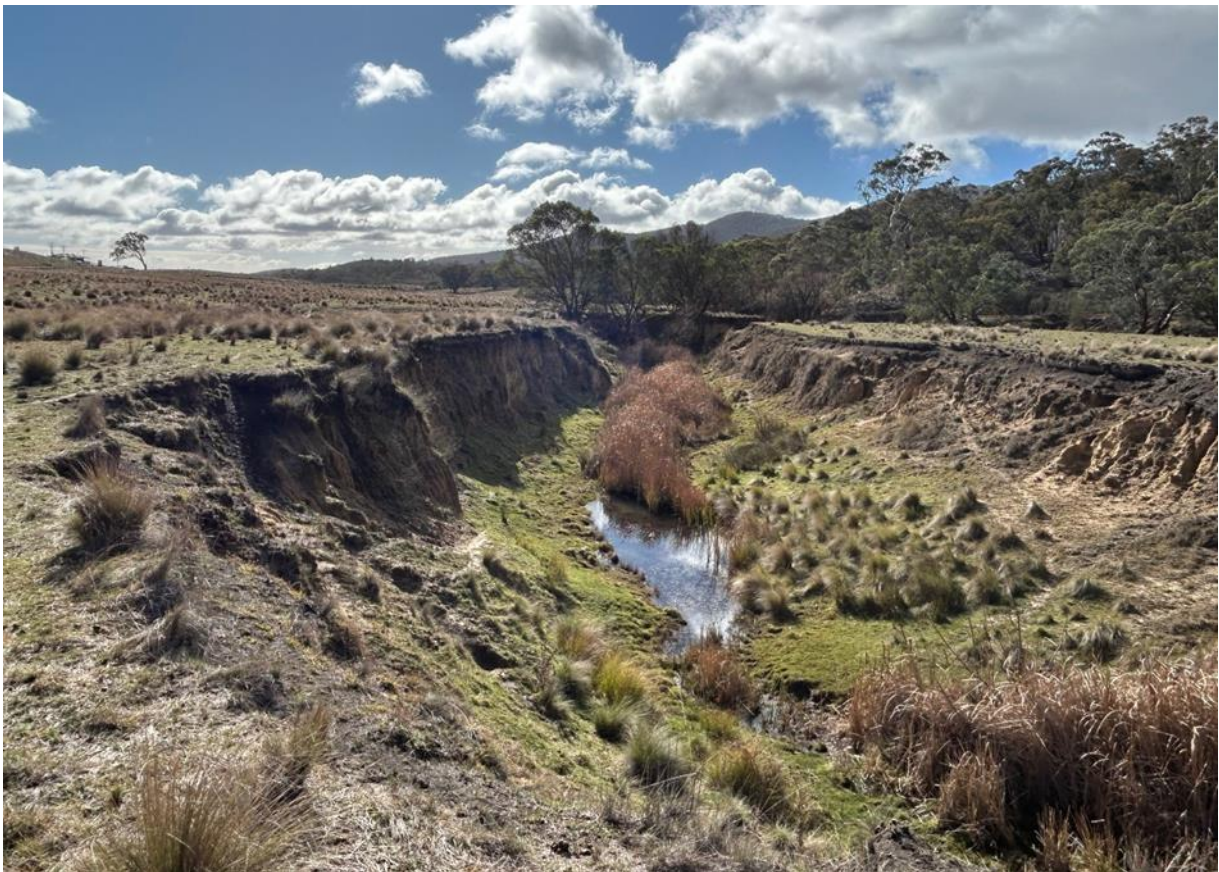
**Figure 3.** Severe gully erosion in Upper Burra Creek (2025)

Sub catchments G2, G9 remain actively eroding with strong sediment connectivity to Burra Creek. Figure 3 shows an example of severe gully erosion, where the lack of fencing has allowed stock access, accelerated sediment mobilisation and threatens downstream water quality.

Characteristics include deep incision, collapsing vertical banks, and a near-total absence of riparian vegetation. The lack of fencing has allowed unrestricted stock access, compounding erosion and sediment mobilisation. This site poses a serious and ongoing risk to downstream water quality and highlights the urgent need for stabilisation and landholder support.

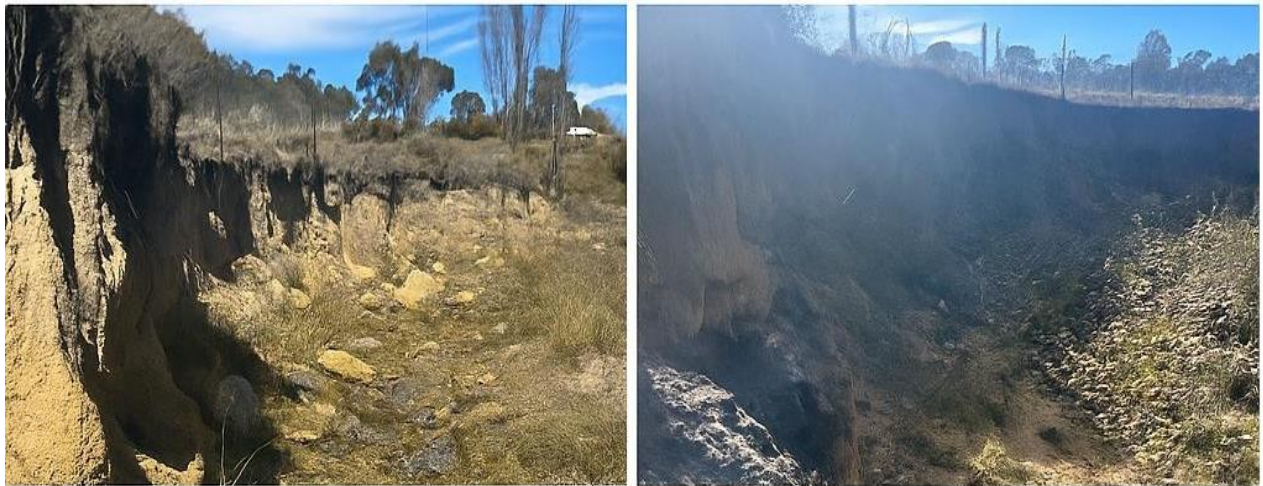
**Figure 5.** Tall vertical bank collapse, fencing at risk (left); overhanging bank, tunnel initiation, undercutting, potential tunnel erosion (right)

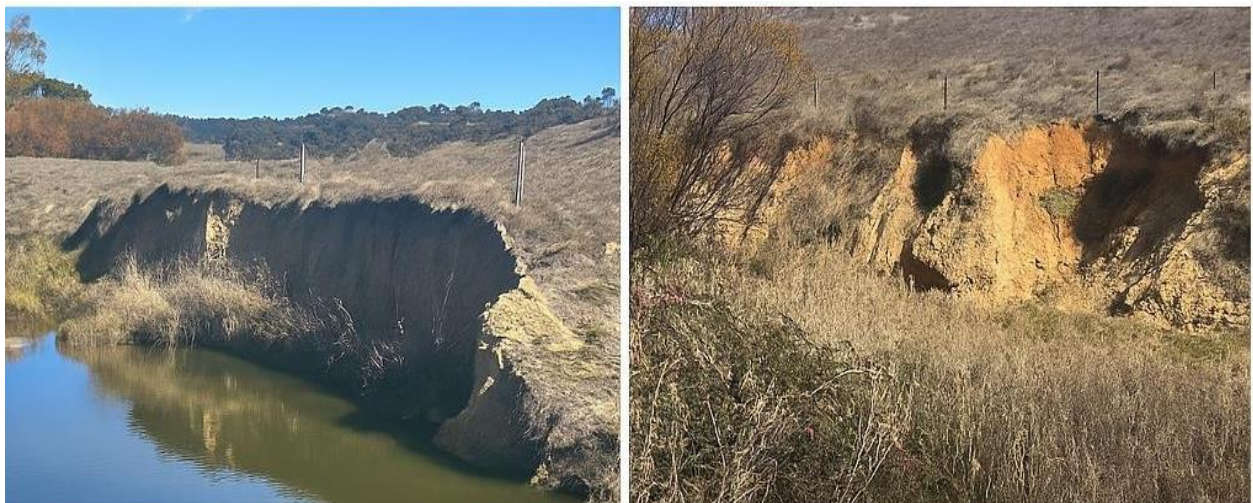
**Figure 6.** Collapsing meander near paddock and active head cut (left); lateral erosion, slumping and gully initiation showing red dispersive soils (right)

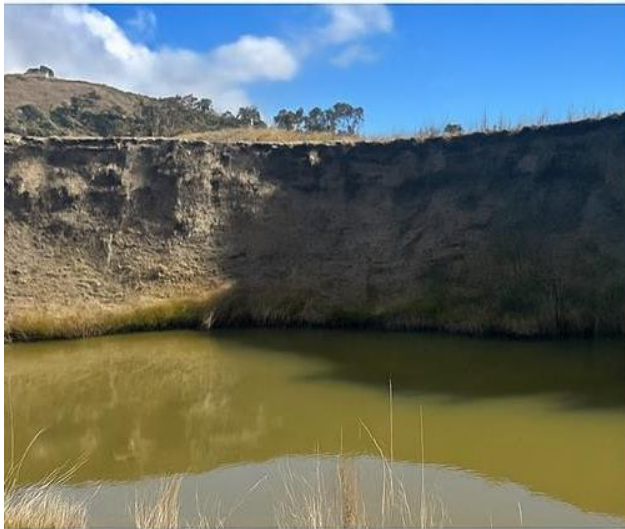
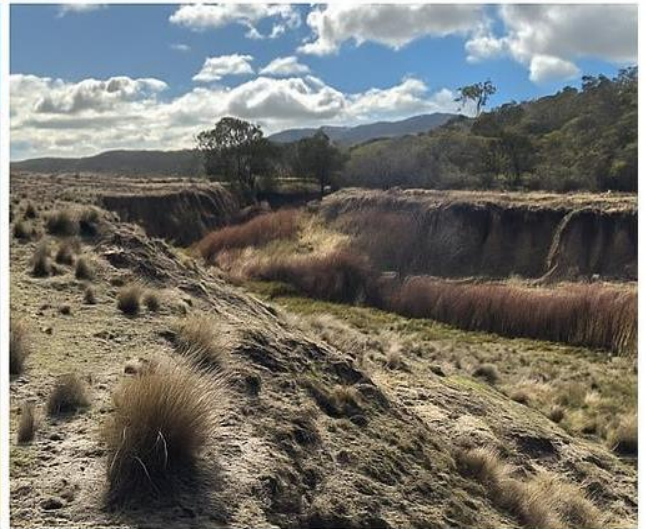
**Figure 7.** Deep scour pool and near-vertical wall showing hydraulic scour (left); incised gully with returning tussocks (right)

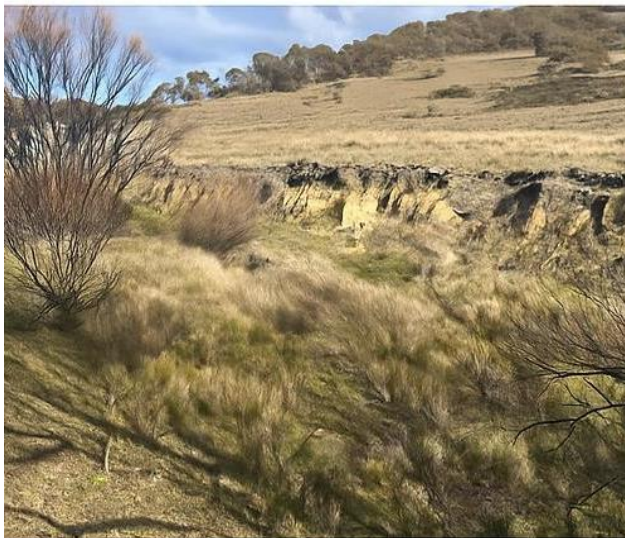
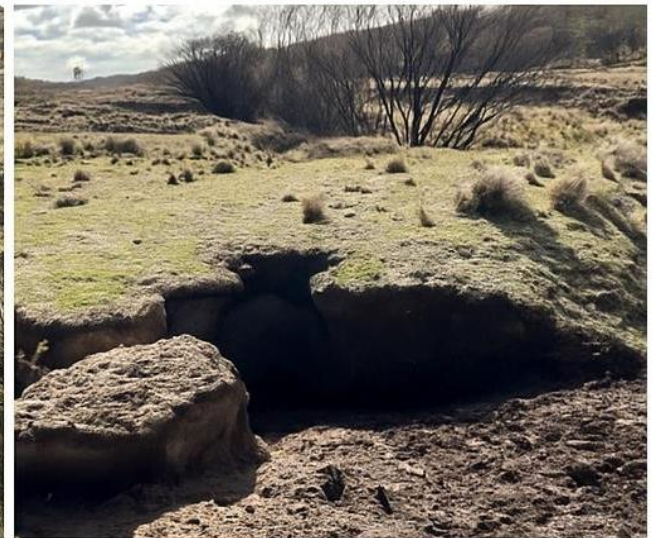
**Figure 8.** Moderate bank, rill and surface erosion (left); subsurface tunnel collapses due to wombats (right)

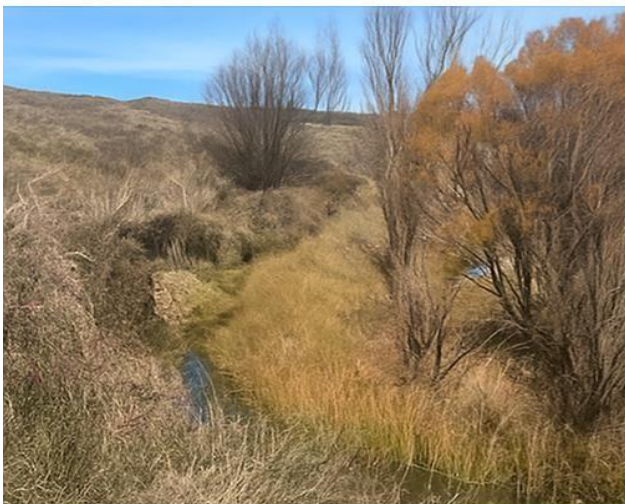
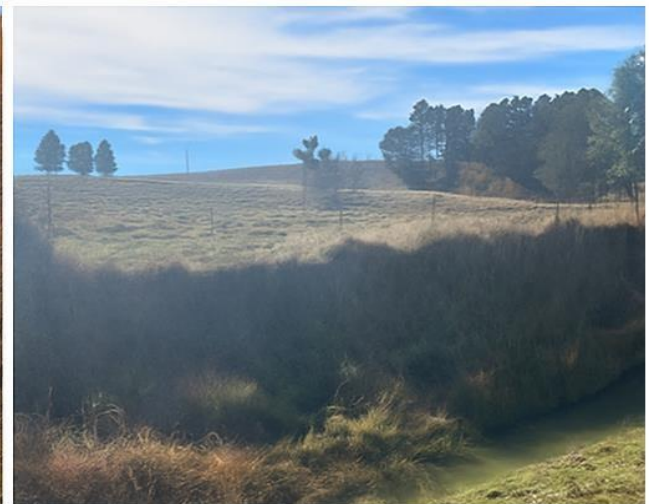
**Figure 9.** Grass/tussock cover in previous gully (left); fenced buffer with regrowth (right)

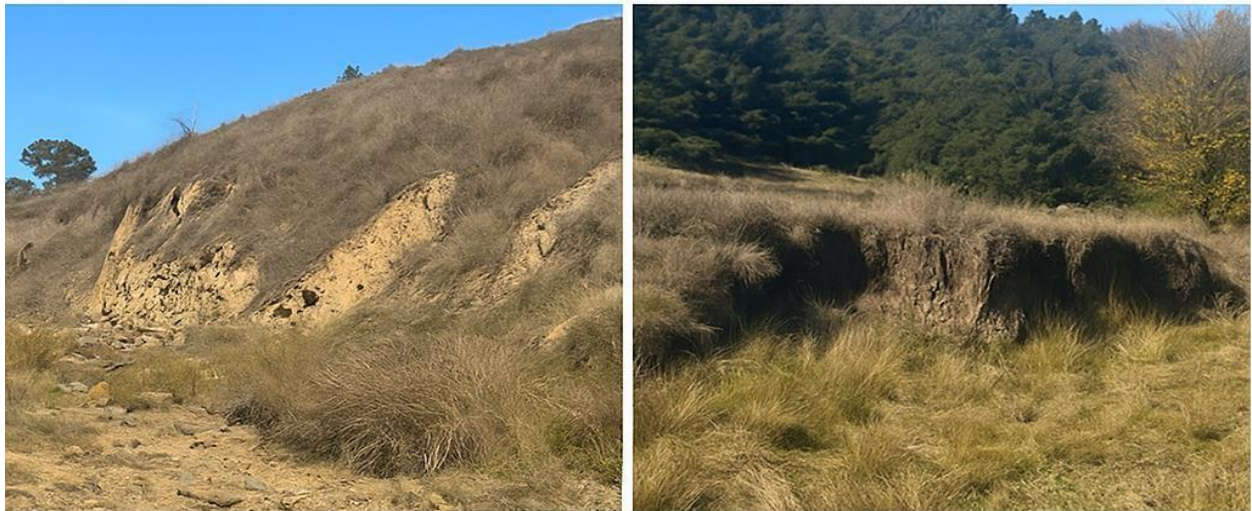
**Figure 10.** Dense tussocks in gully, self-armouring channel (left); sparse but emerging gully vegetation and early-stage recovery (right)

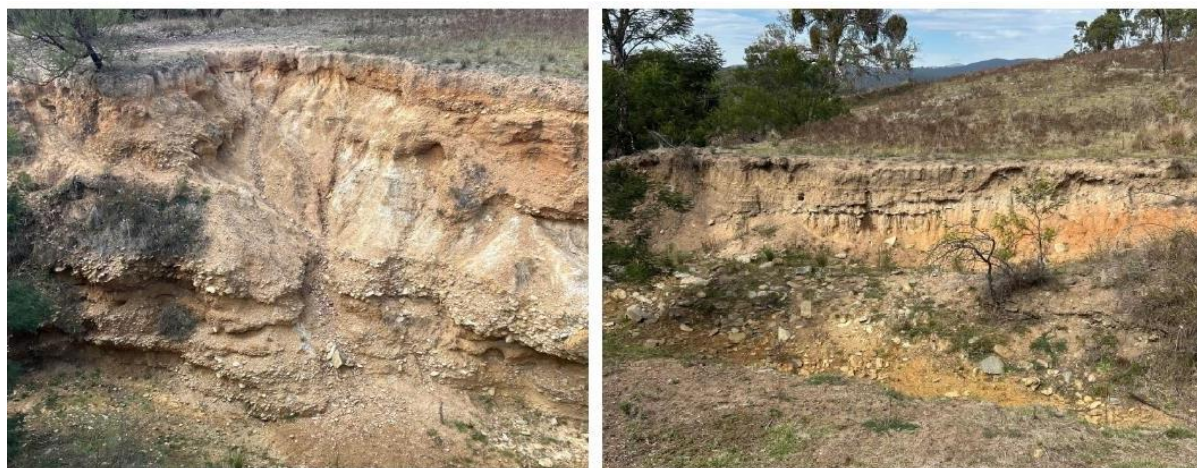
**Figure 12.** Active headwall collapse and gully deepening (left); bank undercutting and lateral widening (right)

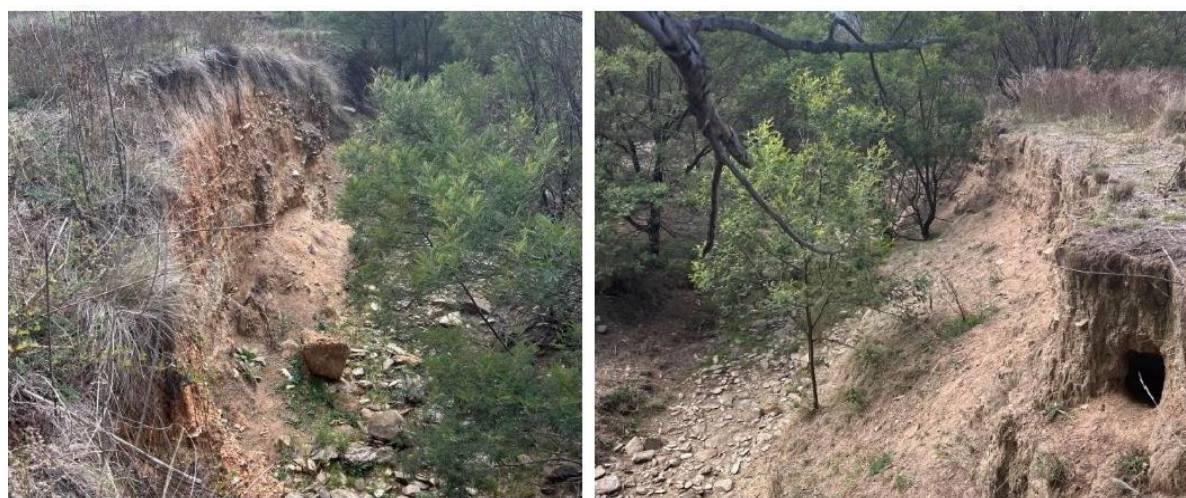
**Figure 13.** Active bank slumping and vertical gully walls (left); channel incision and faunal instability (right)

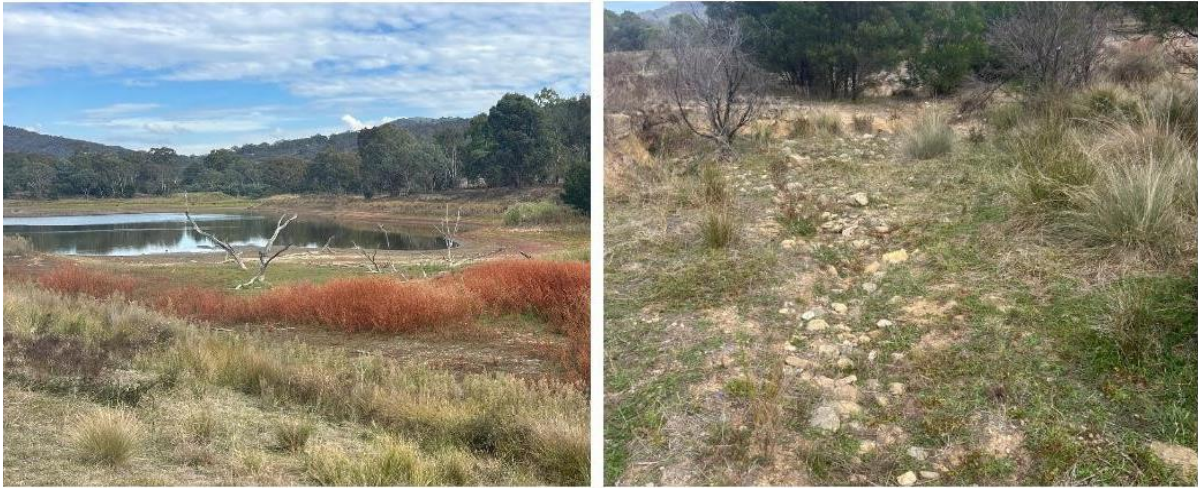
**Figure 14.** *Sediment deposition at Tin Hut Pond (left); early-stage rocky-based vegetation cover and stability (right)*

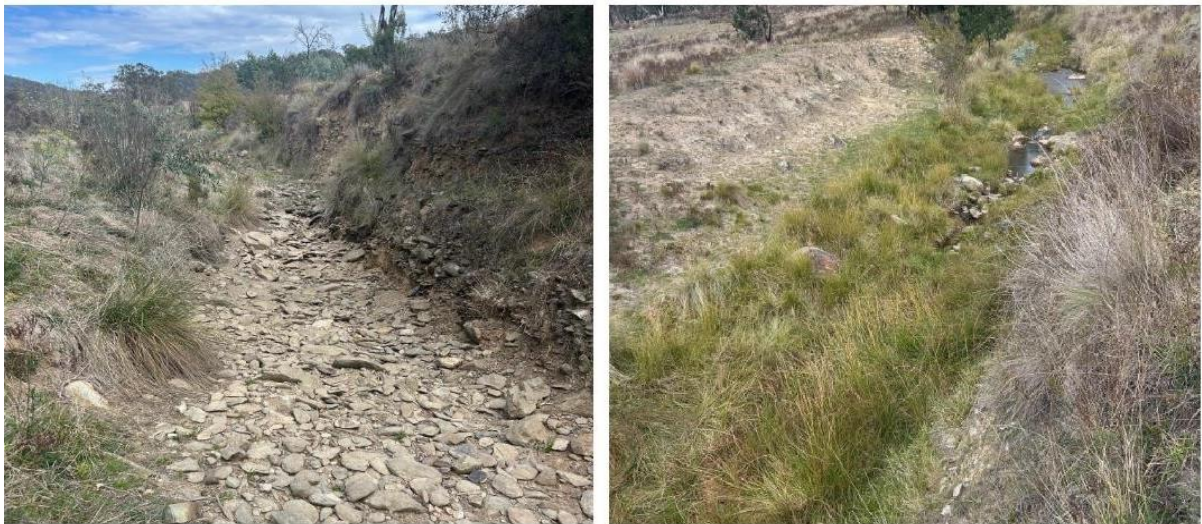
**Figure 15.** *Incised channel with exposed bedrock and active bank erosion (left); signs of vegetation recovery and flow dissipation (right)*

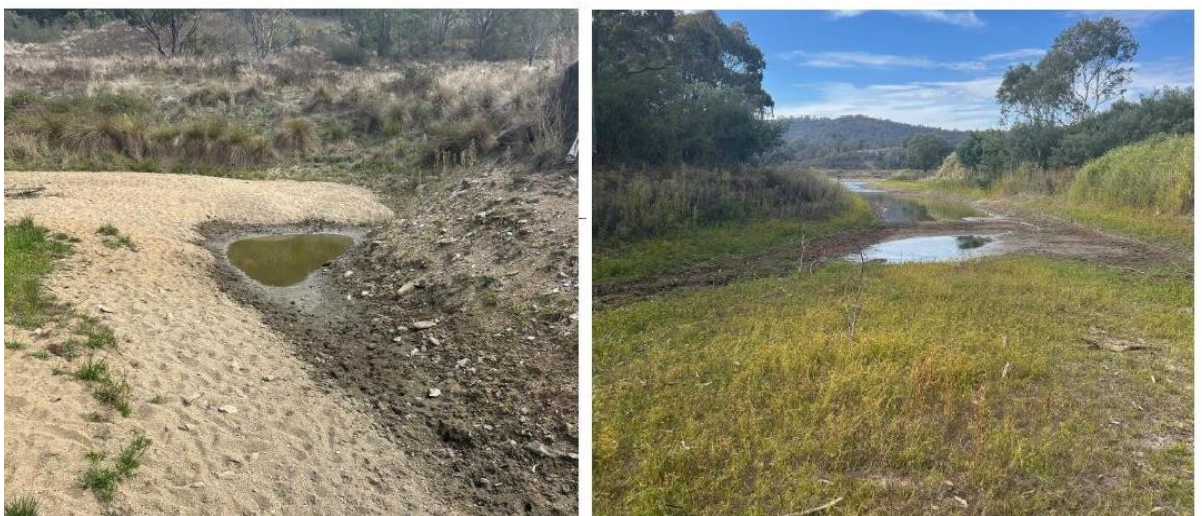
**Figure 16.** *Localised sediment deposition and fauna disturbance (left); vegetation establishment in a receding channel zone at Tim Hut bird pond (right)*

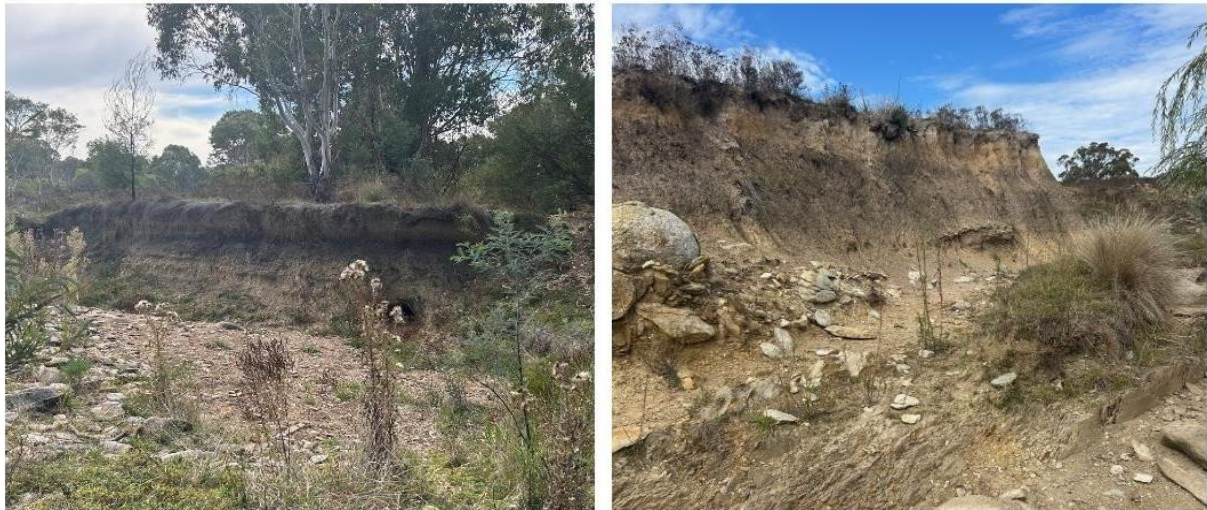
**Figure 17.** Deeply incised channel with faunal burrowing (left); bank collapse and highly dispersive soils (right)

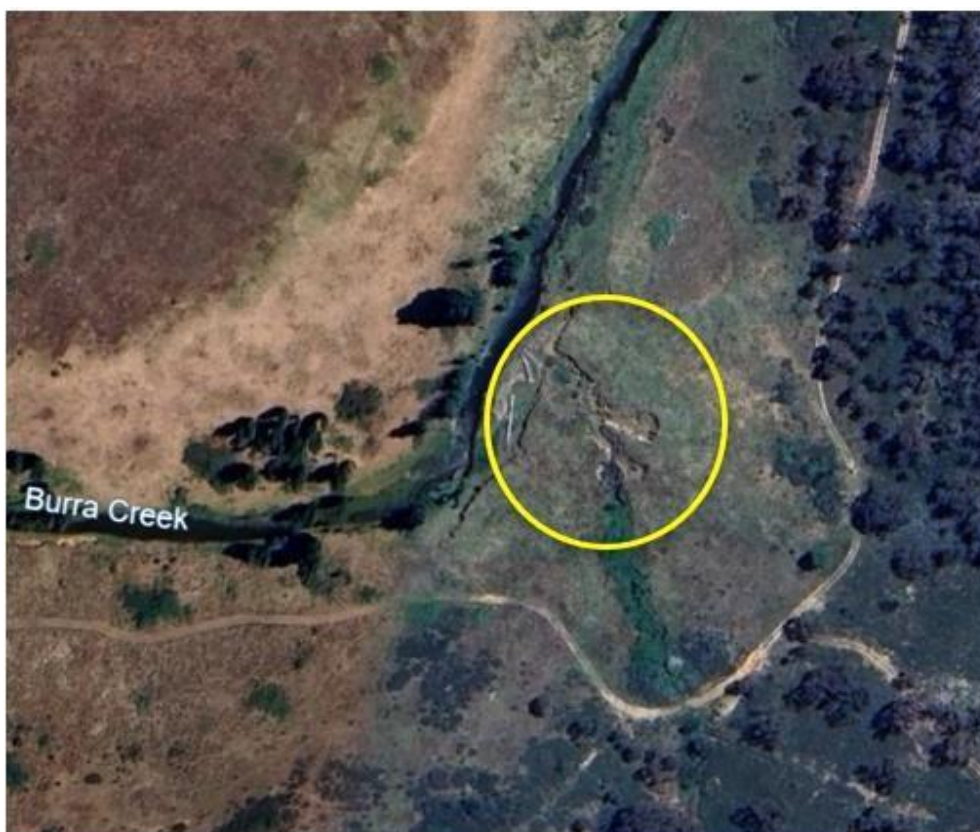
MZ7 shows clear signs of active erosion (see Figure 19), driven by concentrated stormwater runoff from a road culvert. This has caused deep gully incision, upslope head-cut migration (exceeding 1.5 m in height), and vertical walls composed of dispersive soils. The gully floor is poorly vegetated and shows active scouring and sediment transport. Widening and lateral erosion are occurring where minor surface flow lines intersect with grazing and bare soils.

**Figure 19.** Aerial view of the MZ7 (G9) erosion site on the true right bank of Burra Creek. Image shows active gully incision extending from the roadside toward the creek (parts of the lower gully are obscured by blackberry cover). The site drains directly into Burra Creek, posing a sediment risk to Googong Reservoir.

Downstream, the gully enters a blackberry-filled drainage depression that obscures visibility and may conceal further instability. Scattered poplars and woody debris offer minimal hydraulic resistance, and overall groundcover remains patchy. Given the site's proximity to Burra Creek and lack of control measures, sediment delivery risk to Googong Reservoir is high, highlighting the need for early stabilisation works.

Ongoing erosion contributed to the site's high-risk score of 40, a clear water quality risk (see Table 7). Intervention should prioritise stabilising head cuts, reshaping gullies, diverting channels, and revegetating banks. Traffic and fauna management are also recommended to reduce further disturbance.

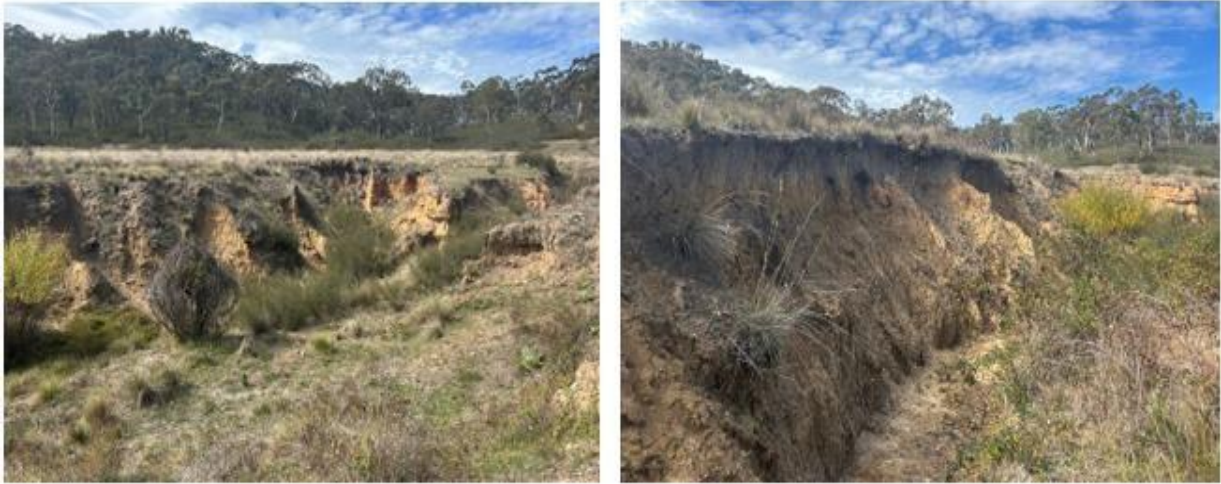
**Figure 20.** Gully erosion at G2

MZ7 remains actively unstable, with steep incised gully walls, dispersive subsoils, and sparse vegetation contributing to frequent slumping and sediment mobilisation (see Figures 20-21).

Photos show steep, actively incising walls and sparse vegetation. Exposed dispersive soils and a lack of stabilising groundcover highlight ongoing sediment risks to Burra Creek.

Strategic intervention is urgently required to halt further gully erosion and protect the integrity of Burra Creek. Recommended treatments include low-impact structural measures, erosion control matting, and targeted revegetation. A detailed assessment of flow paths is needed to identify opportunities for redirecting water away from the gully and into surrounding grasslands. Collaborative

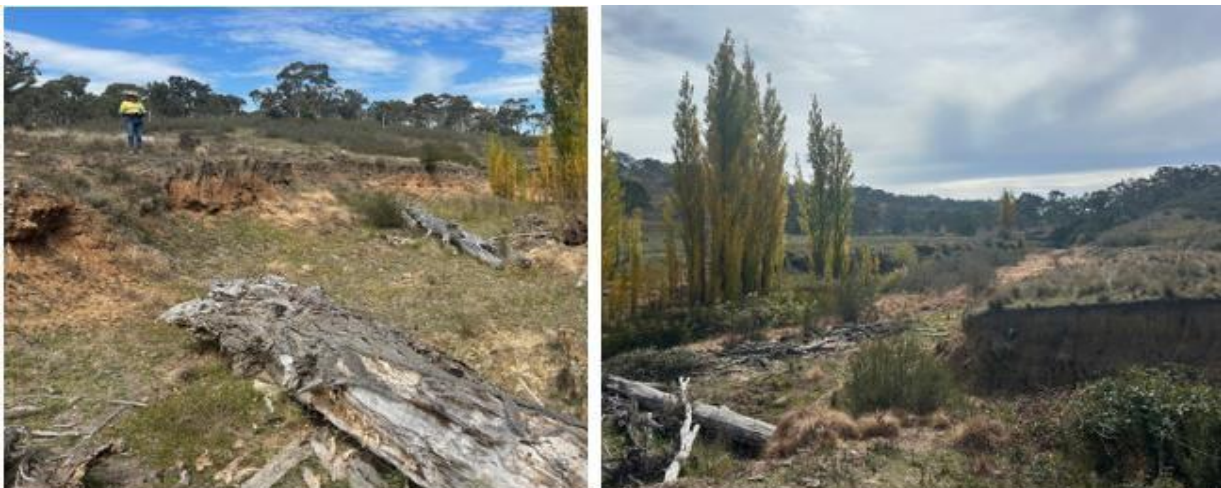
**Figure 21.** Downstream view of G2

Photos show eroding banks, exposed dispersive subsoils, and minimal recovery. Visible sediment layers and fallen timber indicate recent instability and ongoing sediment transport to Burra Creek.

Head cuts and tension cracks observed in 2025 indicate ongoing upslope migration and lateral expansion, exacerbated by runoff from adjacent roads. The gully floor is poorly vegetated and shows signs of scouring and concentrated flow. Blackberry thickets downstream obscure visibility and may conceal further erosion. With direct drainage into Burra Creek and limited buffering, the site poses an ongoing sediment risk to Googong Reservoir, especially during storm events.

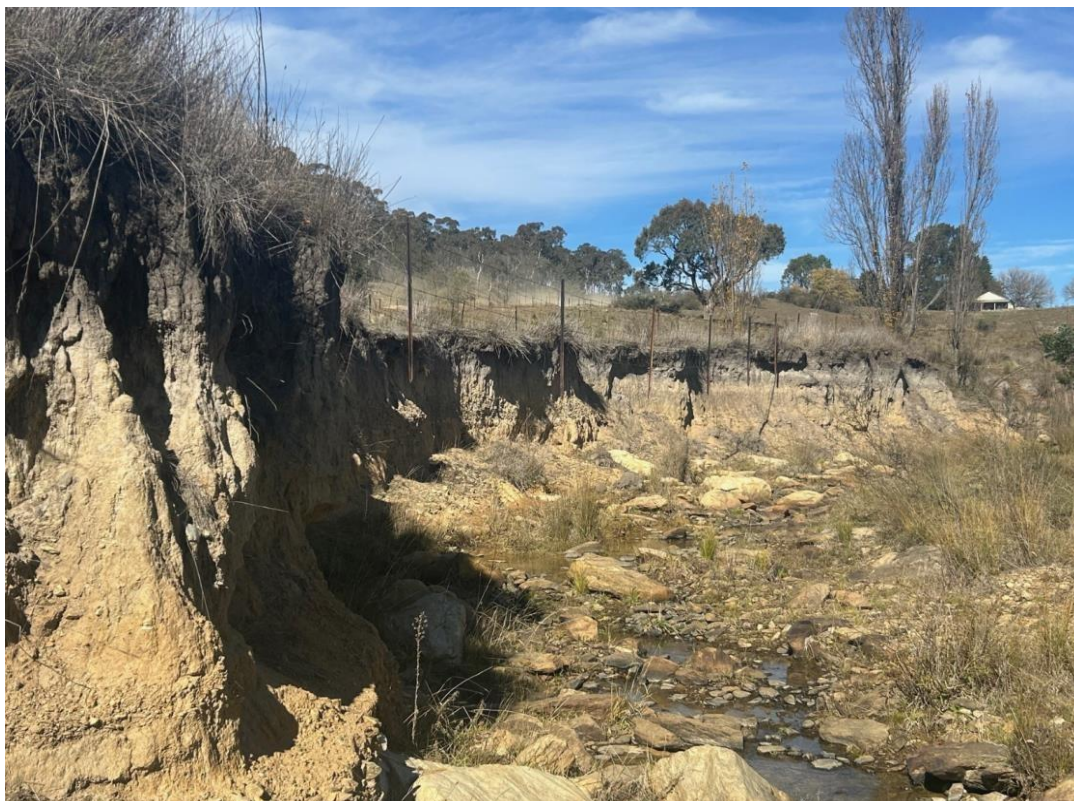
**Figure 22.** Severe streambank erosion along a small rural section of Burra Creek (G2)

Likely within an actively grazed area, this image highlights the extent to which riparian zones in this reach have been poorly managed or left unprotected, resulting in significant degradation of bank structure and loss of riparian health.

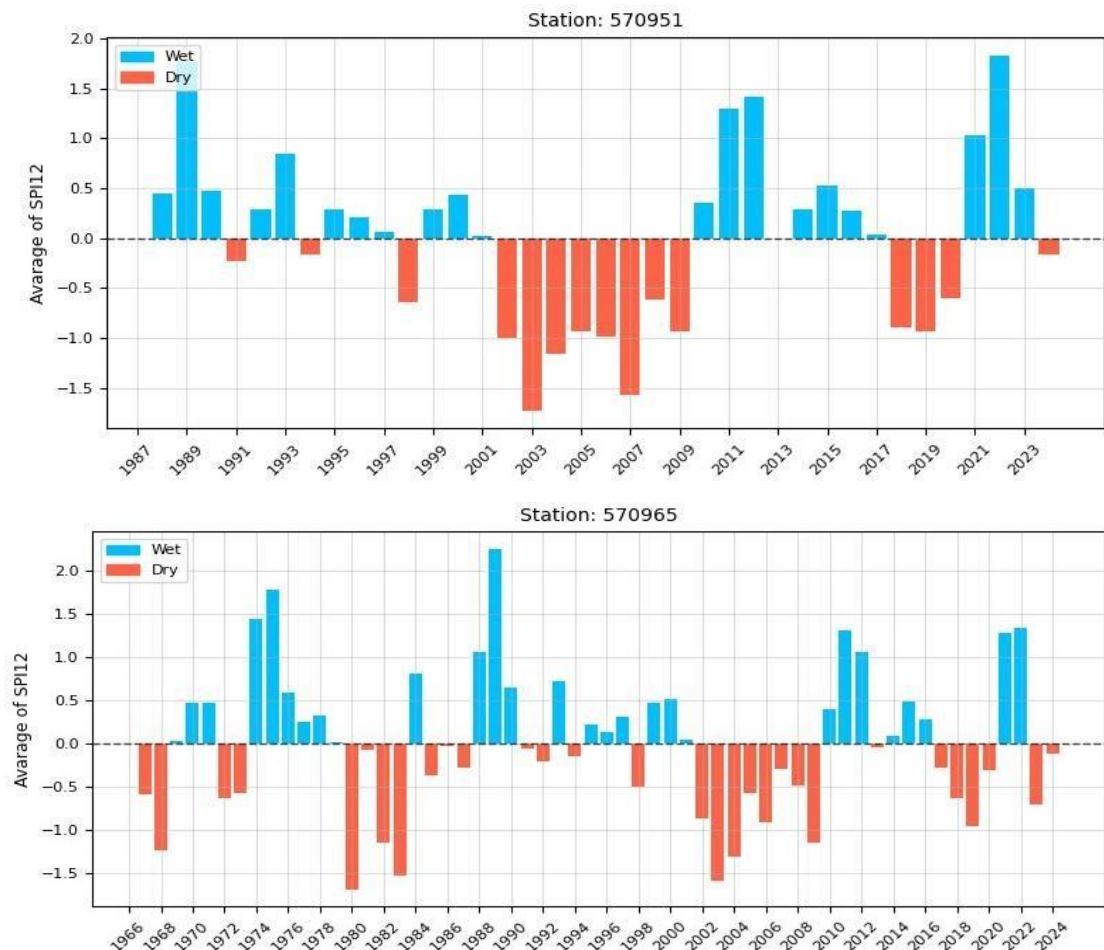
The calculated SPI values were used to define wet and dry periods and drought intensity for both stations, with the results shown in Figure 15. Both stations display similar results, except for a few years, indicating relative similar patterns in spell events spatially across the Googong Catchment. The graphs indicate that big swings between dry and wet periods (such as the swing that occurred between 2020 and 2021) have historically occurred in the catchment and are likely to occur in the future.

**Figure 15.** Spell events (wet and dry periods)

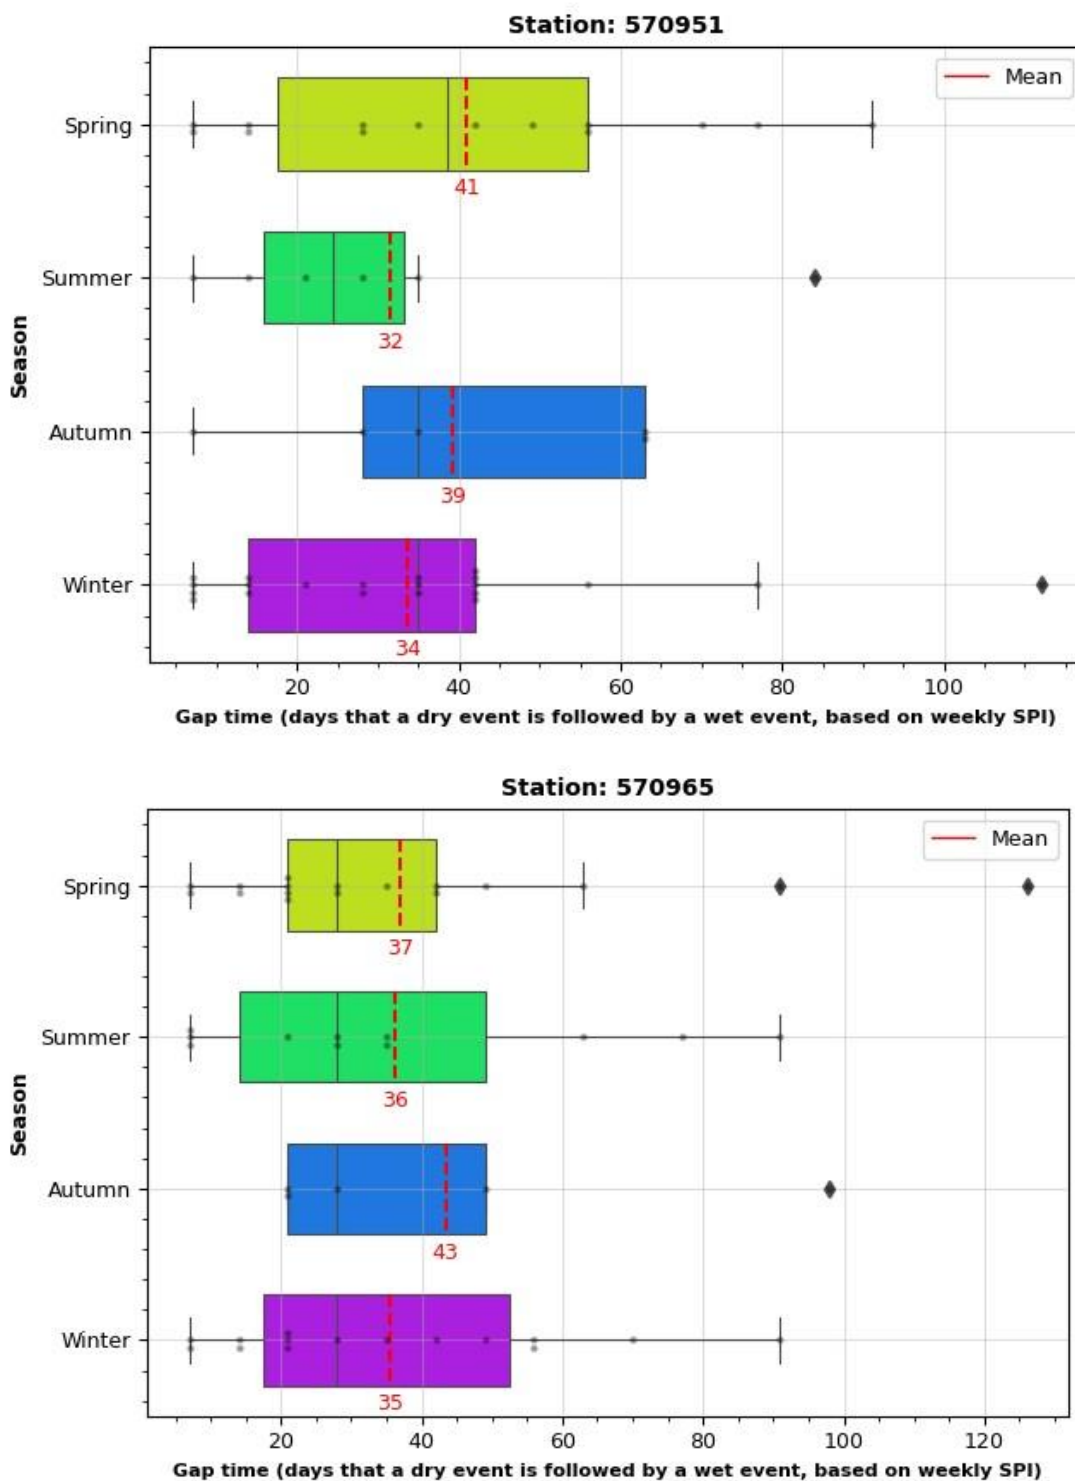
The shift from dry to wet conditions is of concern to catchment managers due to the potential for these wet-on-dry events to deliver larger volumes of fine sediment to Googong Reservoir than a wet-on-wet event might. To assess the average gap between a prolonged dry period and a wet period, we tagged weekly rainfall totals as wet, dry, or normal. The results of this analysis, separated by season, are shown in Figure 16. While the number of days between a dry and wet period is generally large (with normal conditions between the two, buffering any wet-on-dry type events), both stations have instances of this gap being 7 (one week), corresponding to a wet-on-dry rainfall event. Identifying the individual events and their characteristics is beyond the scope of this study, but the analysis points to the highly variable rainfall and the fact that such events can occur any time of year (not just in summer).

**Figure 16.** Box plot showing the distribution of the gaps between dry and wet events, where an event is a weekly rainfall total.
