## **Icon Water**

# **Murrumbidgee Ecological Monitoring Program 2015-21 Sentinel Monitoring - Autumn 2018**

September 2018

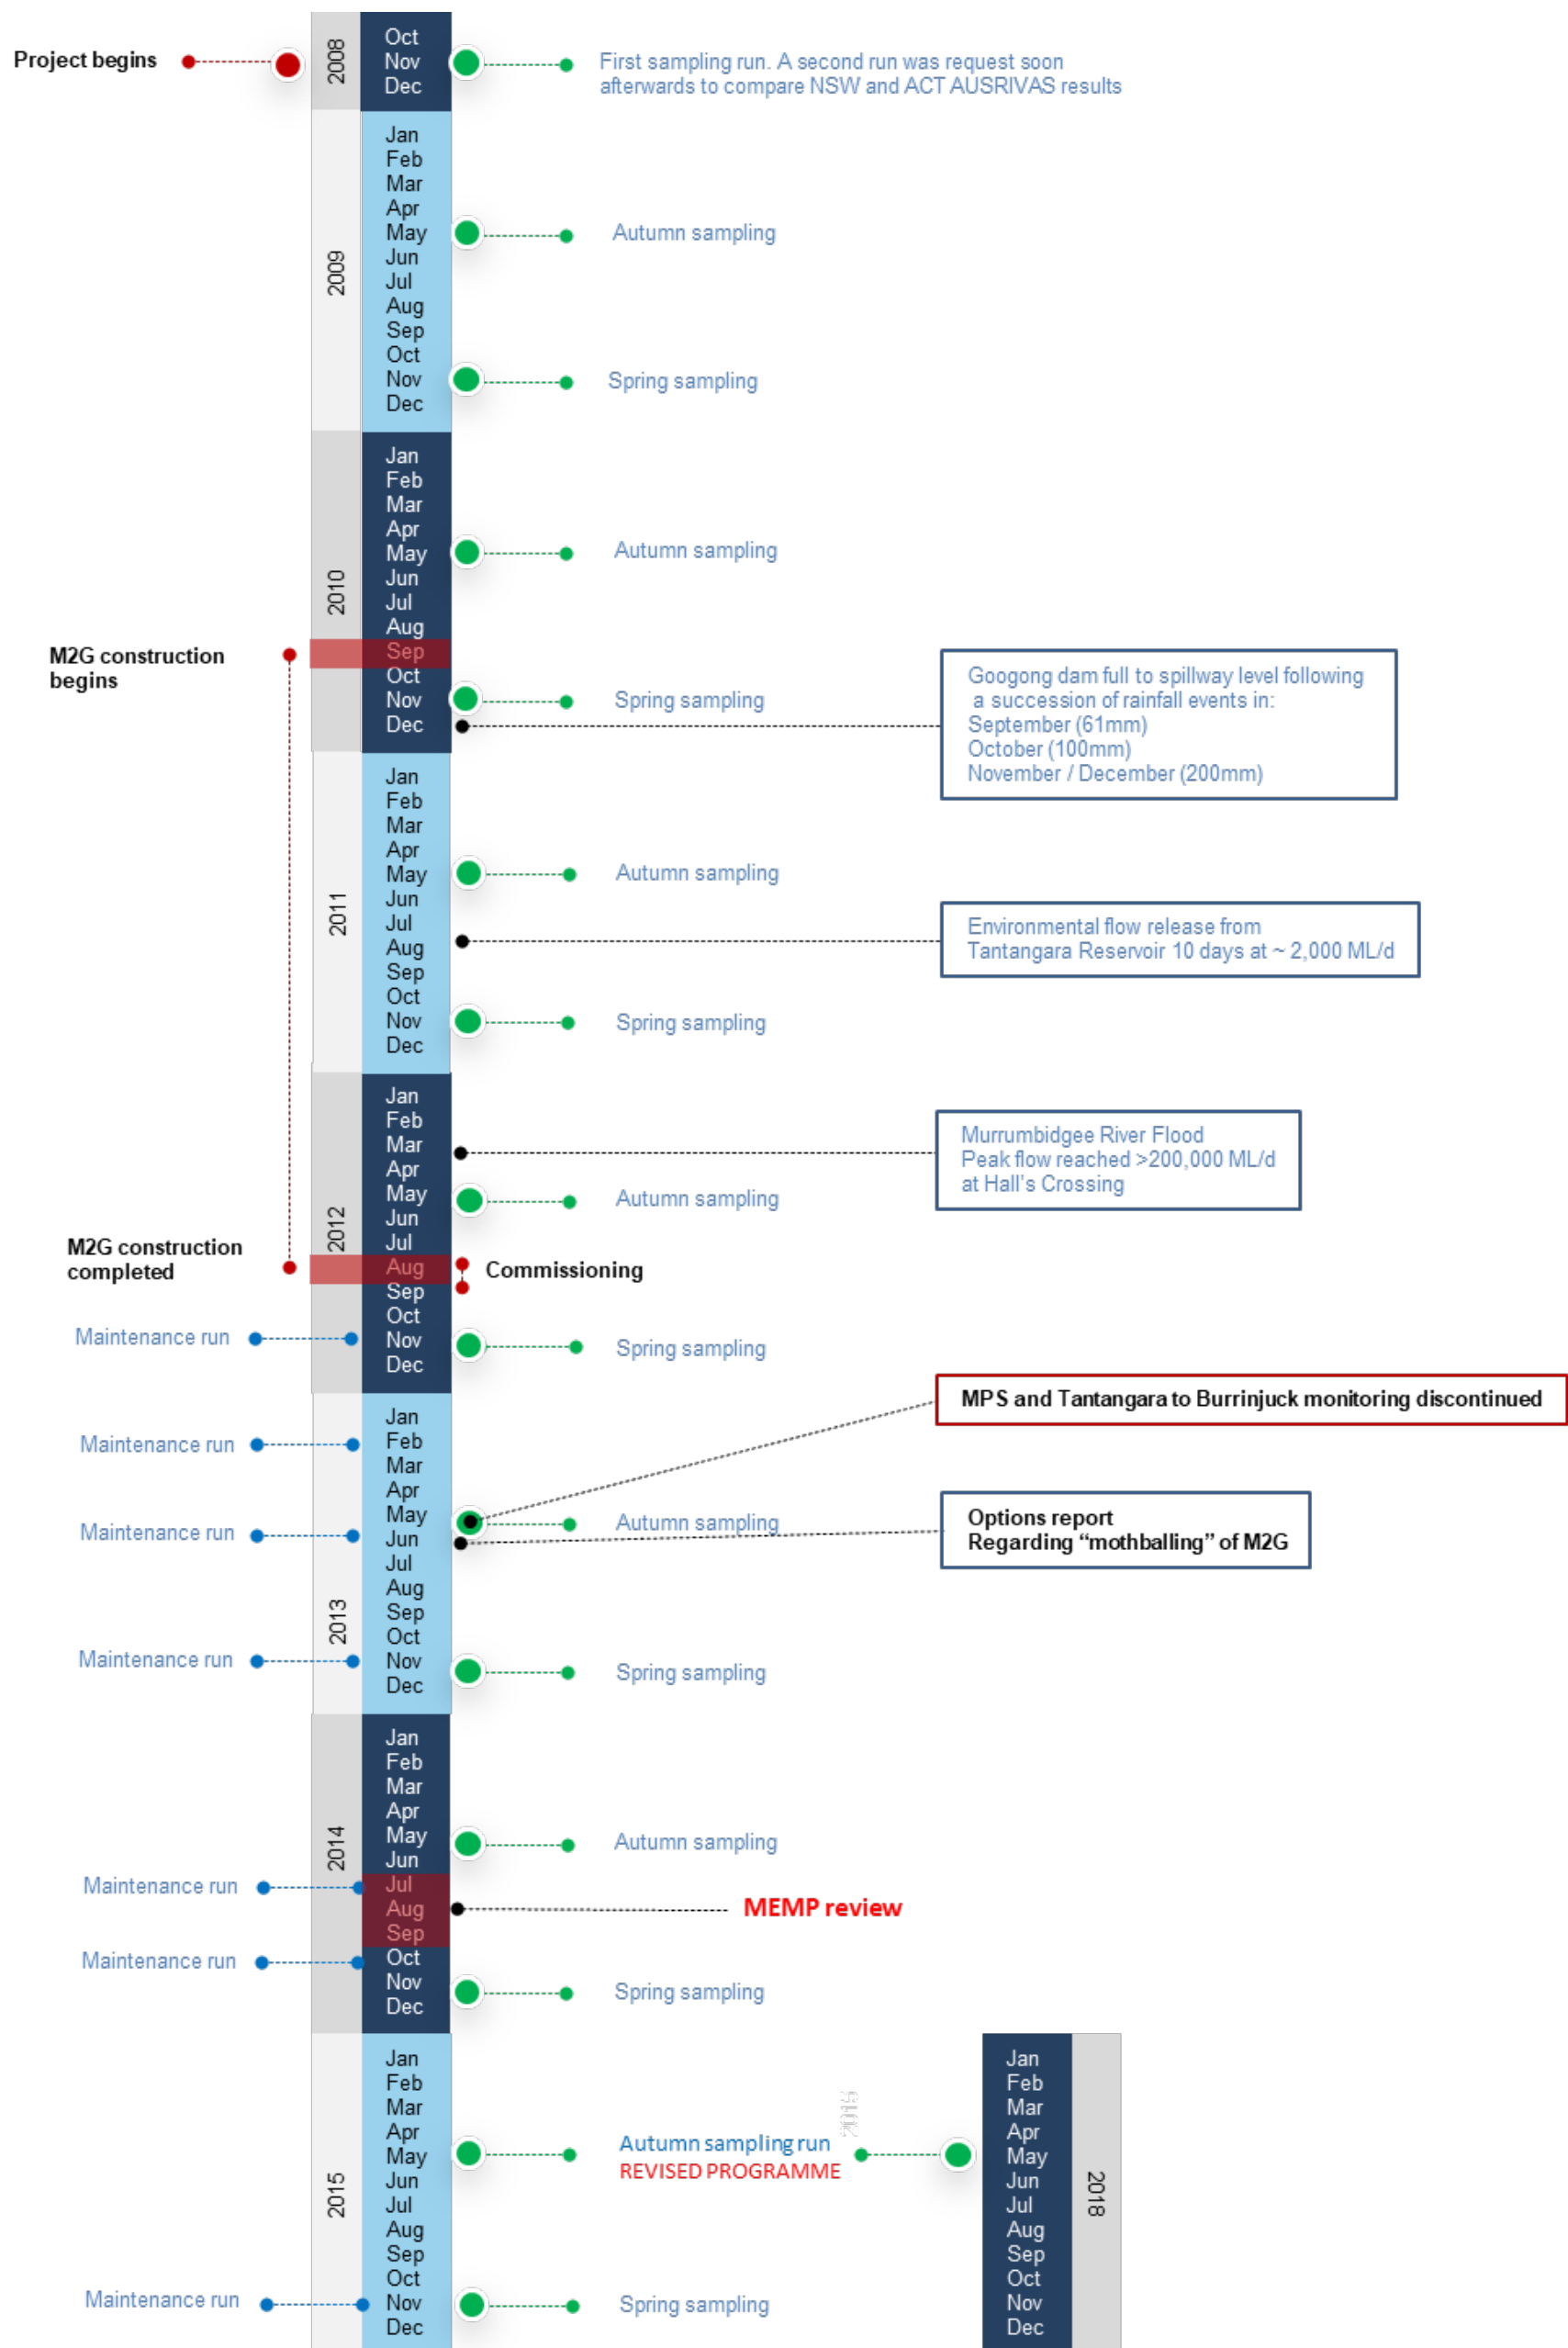
**Figure 1-1. Schematic time line of the Murrumbidgee Ecological Monitoring Program**

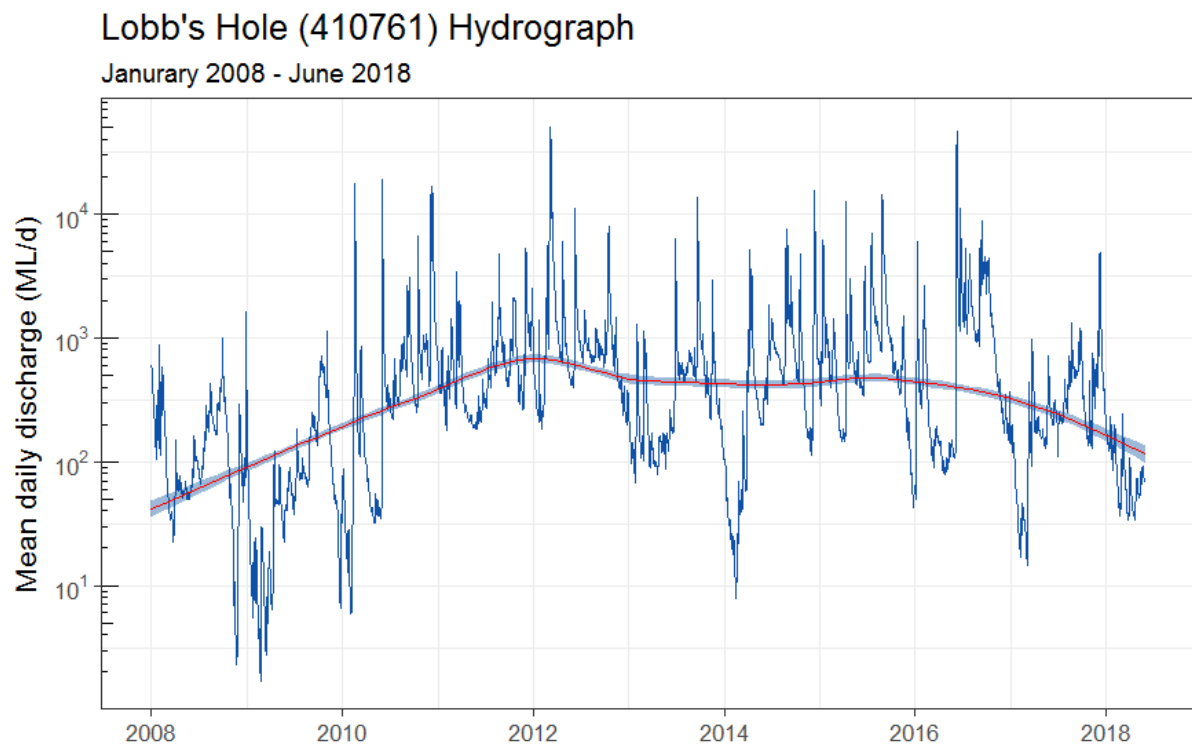
while flows remained stable during 2014-15, since 2016 base flows in the Murrumbidgee River have generally declined and continue to decline as of 31<sup>st</sup> May 2018 (Figure 1-3).

**Figure 1-3. Hydrograph of the Murrumbidgee River at Lobb's Hole (410761) from 2008 to May 2018**

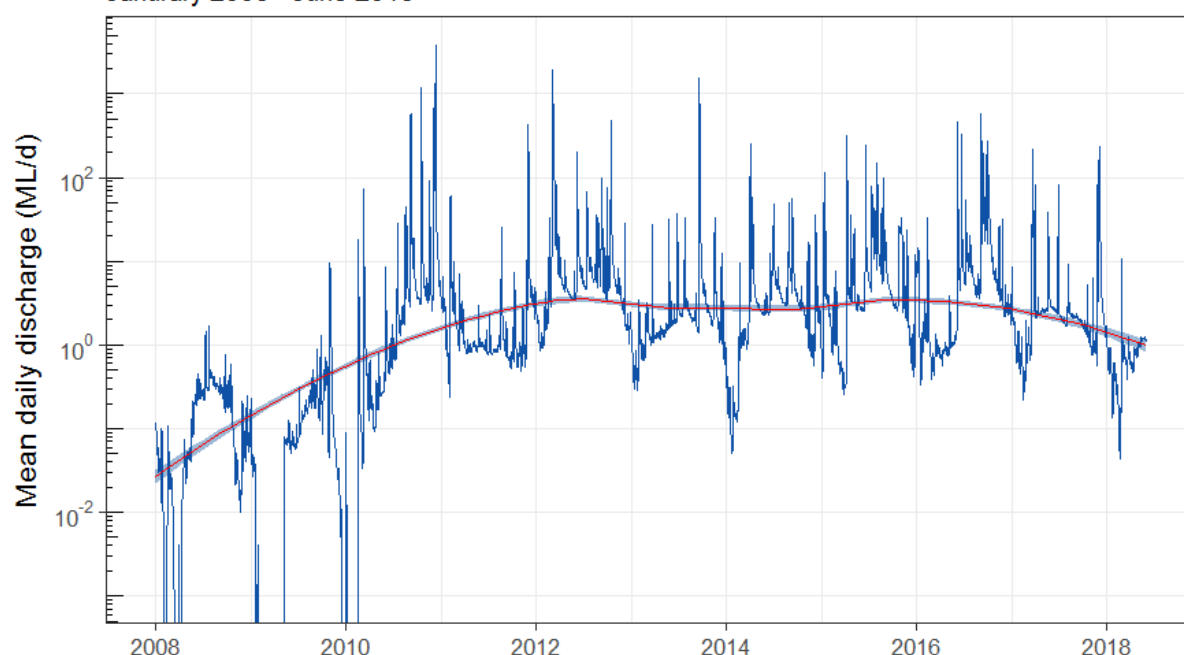
Flow conditions have varied considerably since the inception of the MEMP in late 2008 (Figure 1-4). In 2008 mean daily flow was 0.15 ML/d and this was followed by an equally dry year in 2009 when the mean daily flow was 0.18 ML/d. In early 2010 there were a few rainfall events and this pattern continued throughout most of the year resulting in an upward trend of daily mean flows, which reached 23.4 ML/d. 2011 was a moderately dry year and mean flows fell back to less than 5 ML/d until March 2012, which saw another period of large rainfall events. These rainfall events resulted in another upward trend in average flows until early spring 2012 (Figure 1-4). Summer in 2018 was the driest since 2010 (Figure 1-4). Summer flows are an ecologically important consideration because summer is potentially a particularly stressful period for macroinvertebrates, especially in intermittent streams and these flows have the potential to strongly influence the dynamics and structure of macroinvertebrate communities.

**Figure 1-4. Hydrograph of Burra Creek at the Burra Road weir (410774) from 2009 to May 2018**

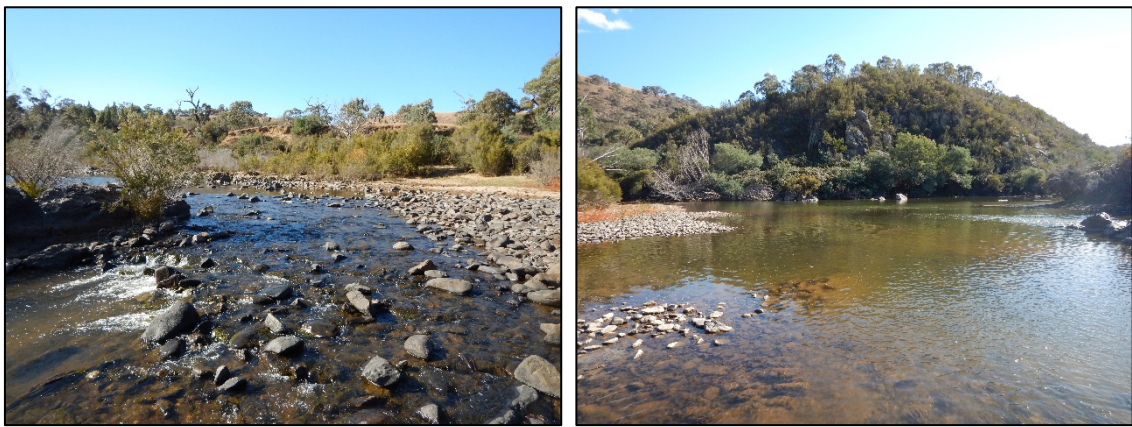
**MUR18:** Looking upstream (left) and downstream (right)

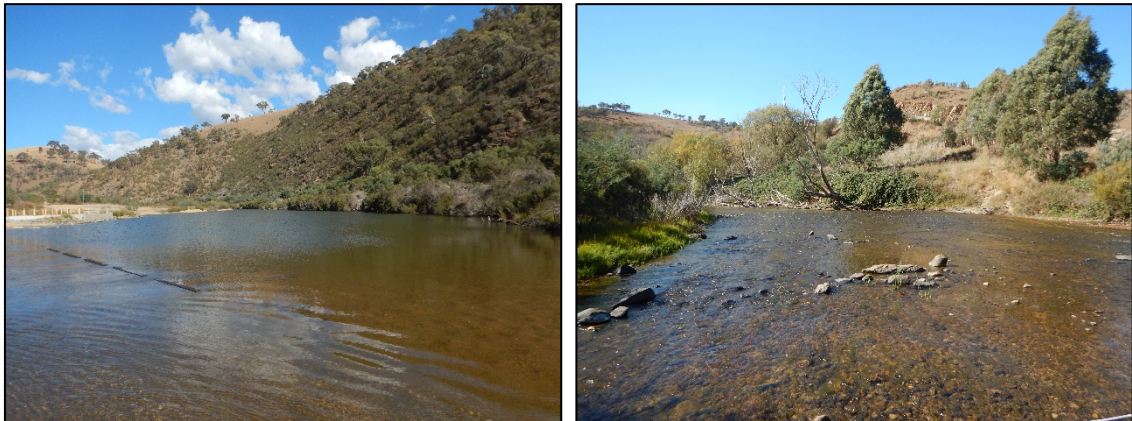
**MUR19:** Looking upstream (left) and downstream (right)

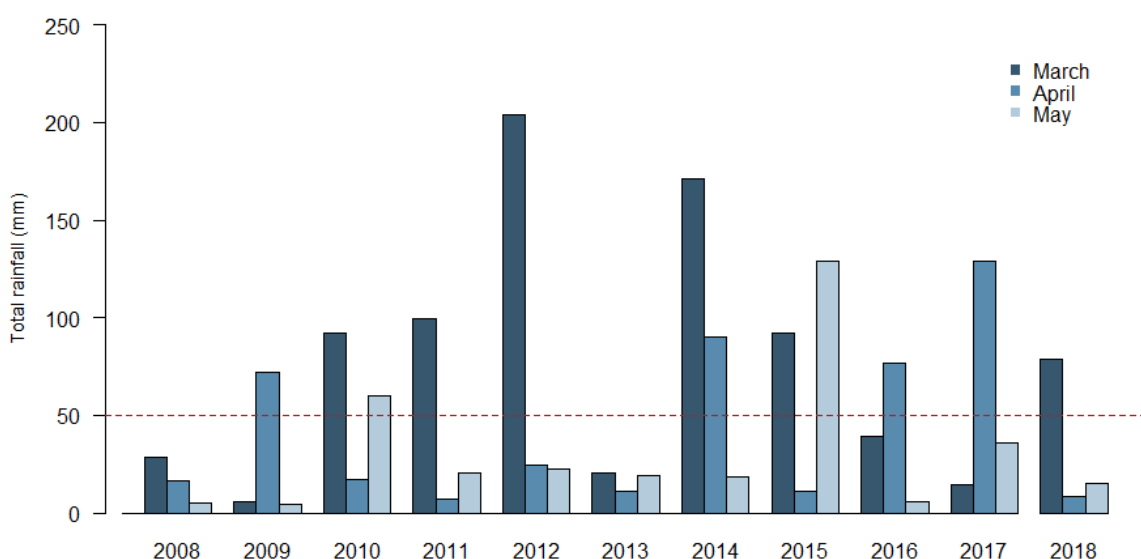
**Figure 3-1. Annual comparison of autumn rainfall (mm) recorded at Lobb's Hole (570985)**

Note: Red dotted line and text shows the mean autumn rainfall for (2008-2018) (49.8mm)

Full Rainfall and flow summaries for upstream and downstream of Angle Crossing in autumn 2018 are presented in Figure 3-1 and Table 3-1.

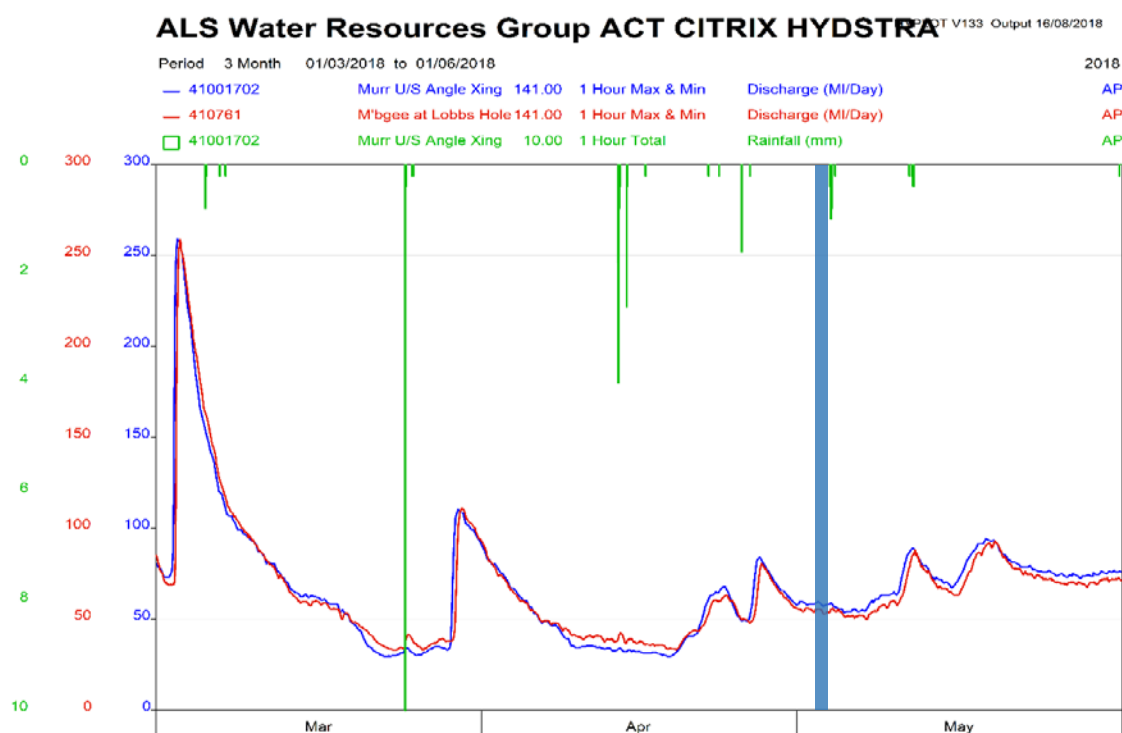
**Figure 3-2. Autumn 2018 hydrograph of the Murrumbidgee River upstream (41004102) and downstream (410761) of Angle Crossing**

Note: Sampling day highlighted by light blue shading.

River flow during autumn was characterised by long periods of low base flows (typically below 50ML/d), and two small rainfall events in March; the largest of these peaked at just 258 ML/d (Figure 3-2). During the same period in 2015, the autumn mean flow at Lobb's Hole was 850 ML/d compared to 67.8 ML/d for the 2018 period.

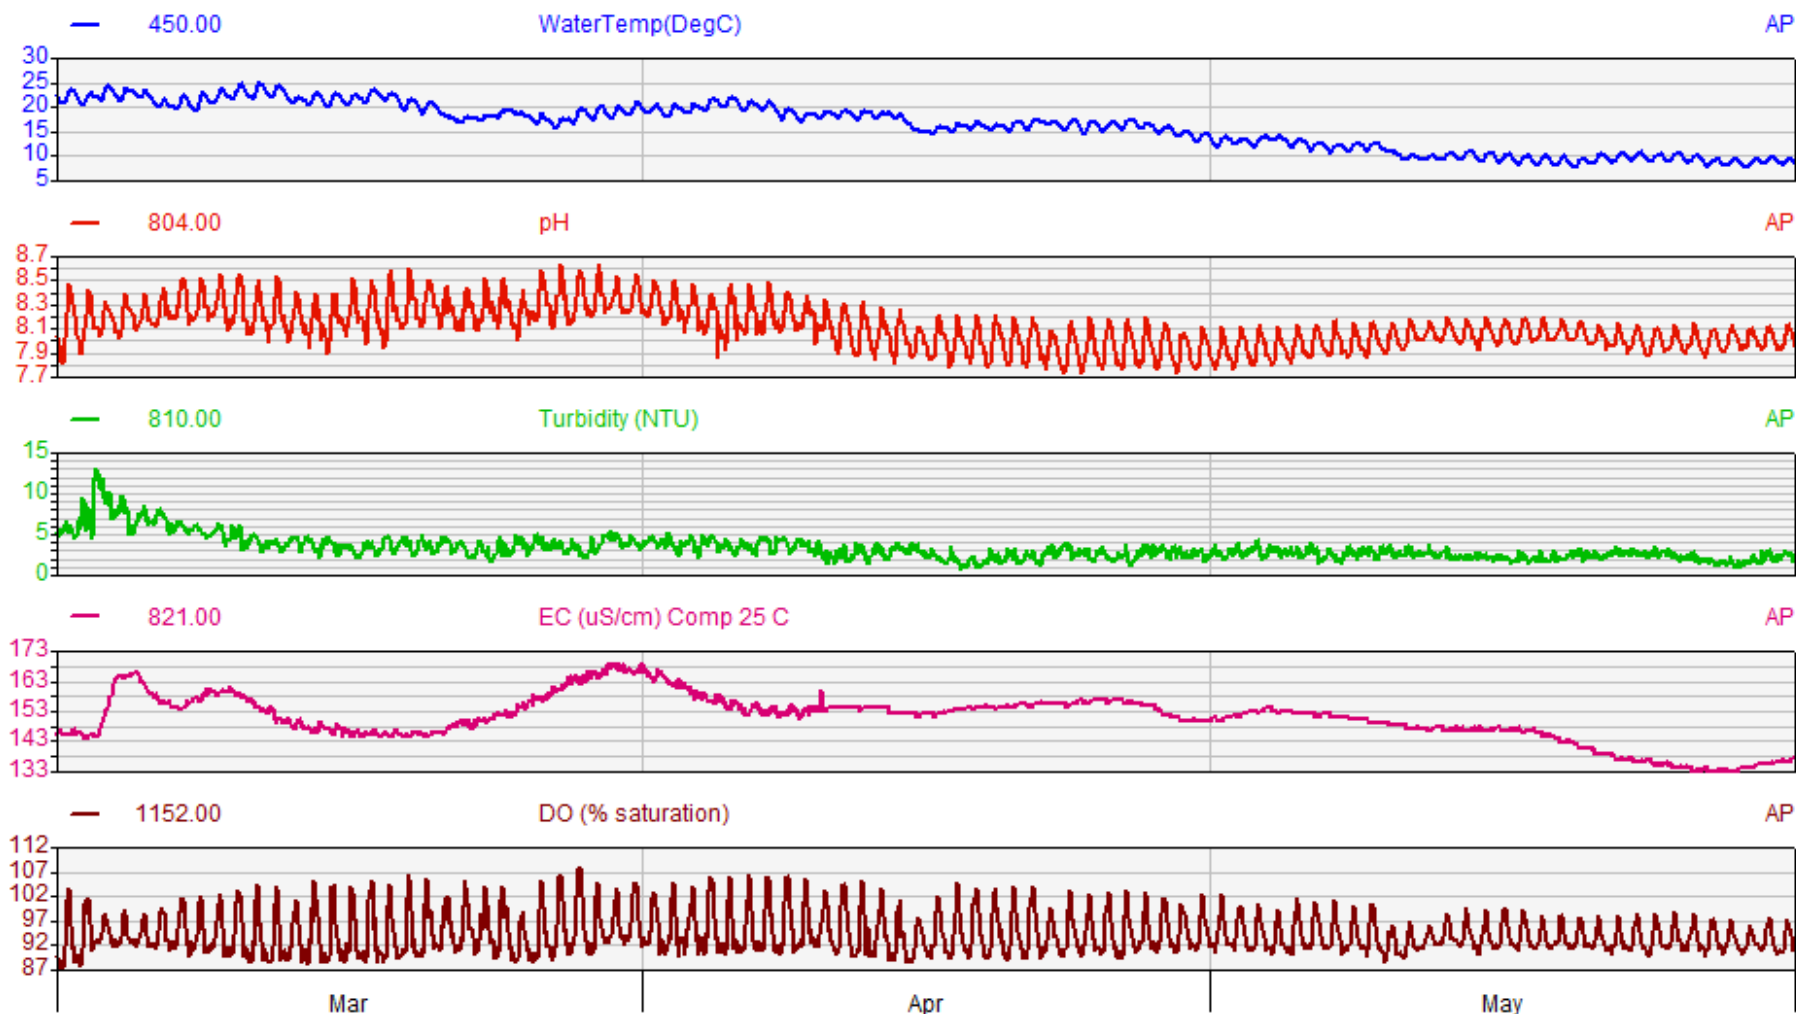
**Figure 3-3. Continuous water quality records from Lobb's Hole (410761) for autumn 2018**

The continuous water quality monitoring from Lobb's Hole (410761) and upstream Angle Crossing (41001702) are presented in Figure 3-3 and Figure 3-4 respectively. Turbidity at Lobb's Hole and upstream of Angle Crossing were relatively consistent during autumn. There was a spike in early March at Lobb's Hole, which was in response to the small rainfall event. There were no exceedances in turbidity at either location during autumn. pH was typically above the upper ANZECC value of 8.0 during autumn, with 62% of the daily mean values in exceedance of pH 8.0. There were no exceedances in electrical conductivity at either location. Dissolved oxygen was below the 90% saturation 50% of the time at the upstream site (based on daily means) and only 9% of the time at Lobb's Hole, which may be due to the location of the probes at either site because there was nothing observed on site which may have caused these differences.

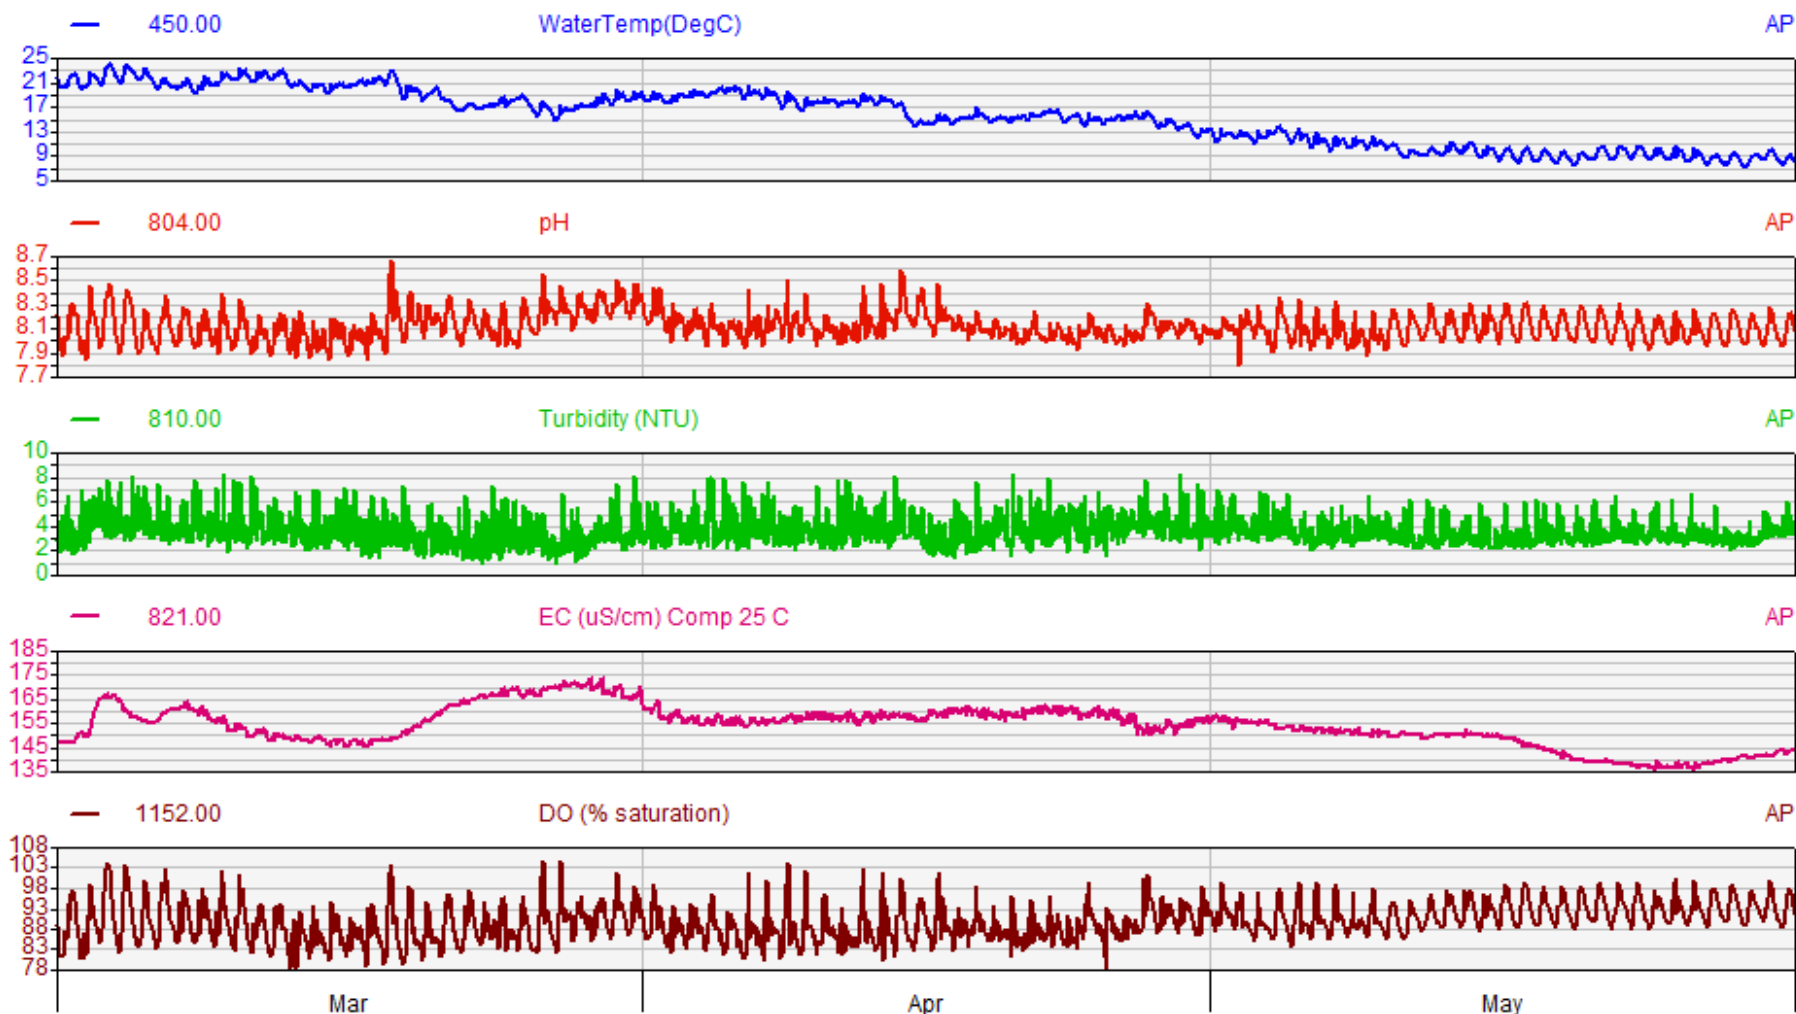
**Figure 3-4. Continuous water quality records from upstream Angle Crossing (41001702) for autumn 2018**

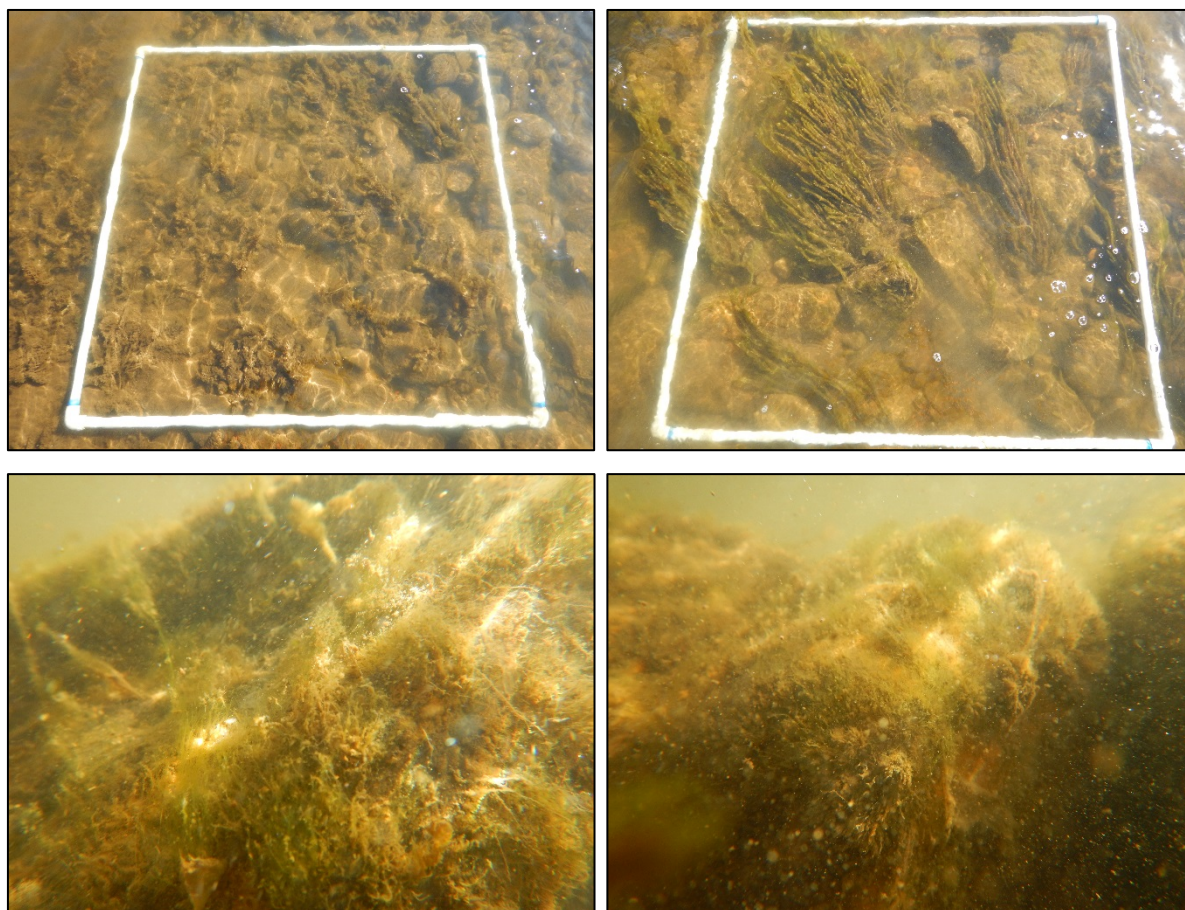
The periphyton coverage at MUR18 was approximately 35-65% for the reach and 65-90% for the riffle habitat based on the AUSRIVAS assessment method (Appendix C). There were large stands of the submerged macrophyte *Myriophyllum* sp. growing throughout the reach, particularly at the tail of the riffle habitat and along the river margins. The dominant substrate in the riffle habitat was cobble.

**Plate 3-2. Photos showing the periphyton and macrophyte coverage in the reach and riffle at MUR18**

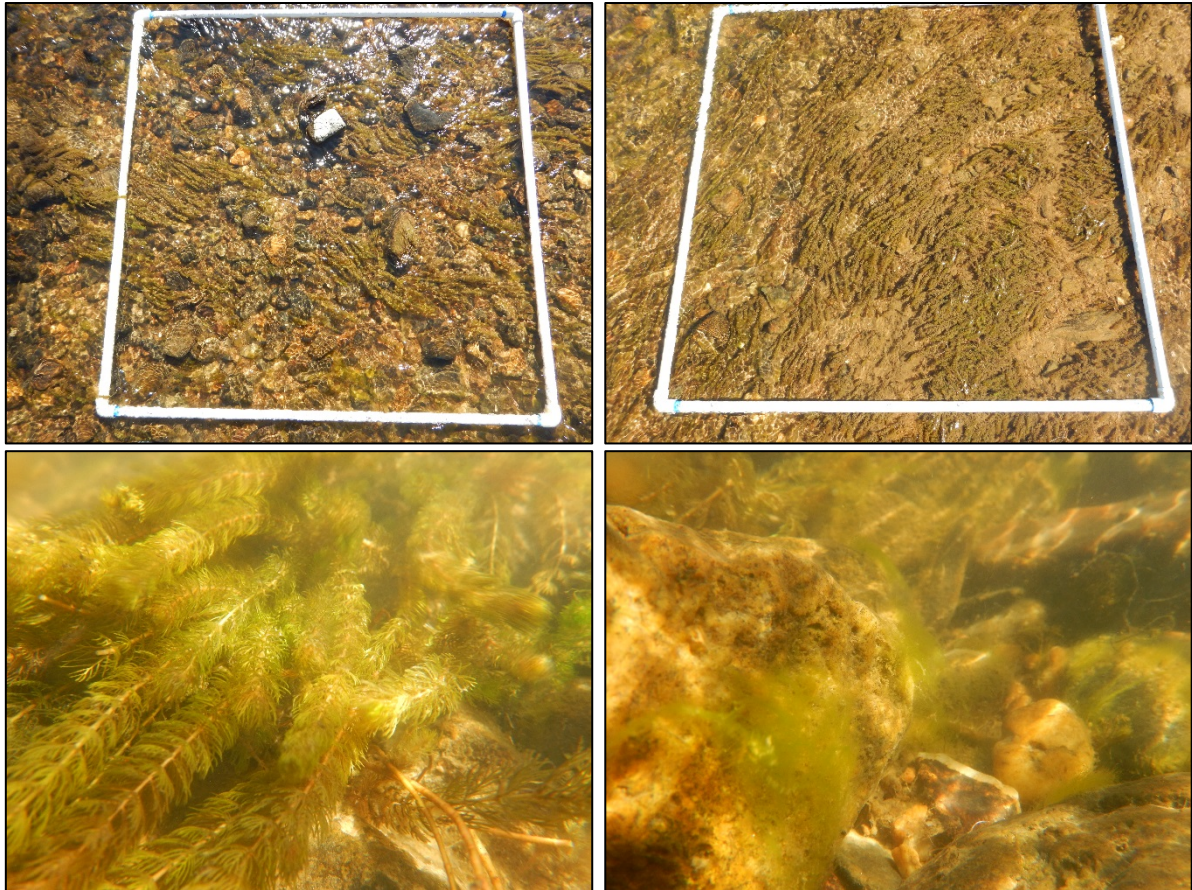
The periphyton coverage was approximately 35-65% at MUR19 for the riffle habitat (Plate 3-3). The cleanest substrate was located in the middle of the river. *Myriophyllum* sp. was dominant throughout the riffle habitat, particularly near the margins, and the dominant substrate types were cobble and pebble.

**Plate 3-3. Photos showing the periphyton coverage in the riffle at MUR19**

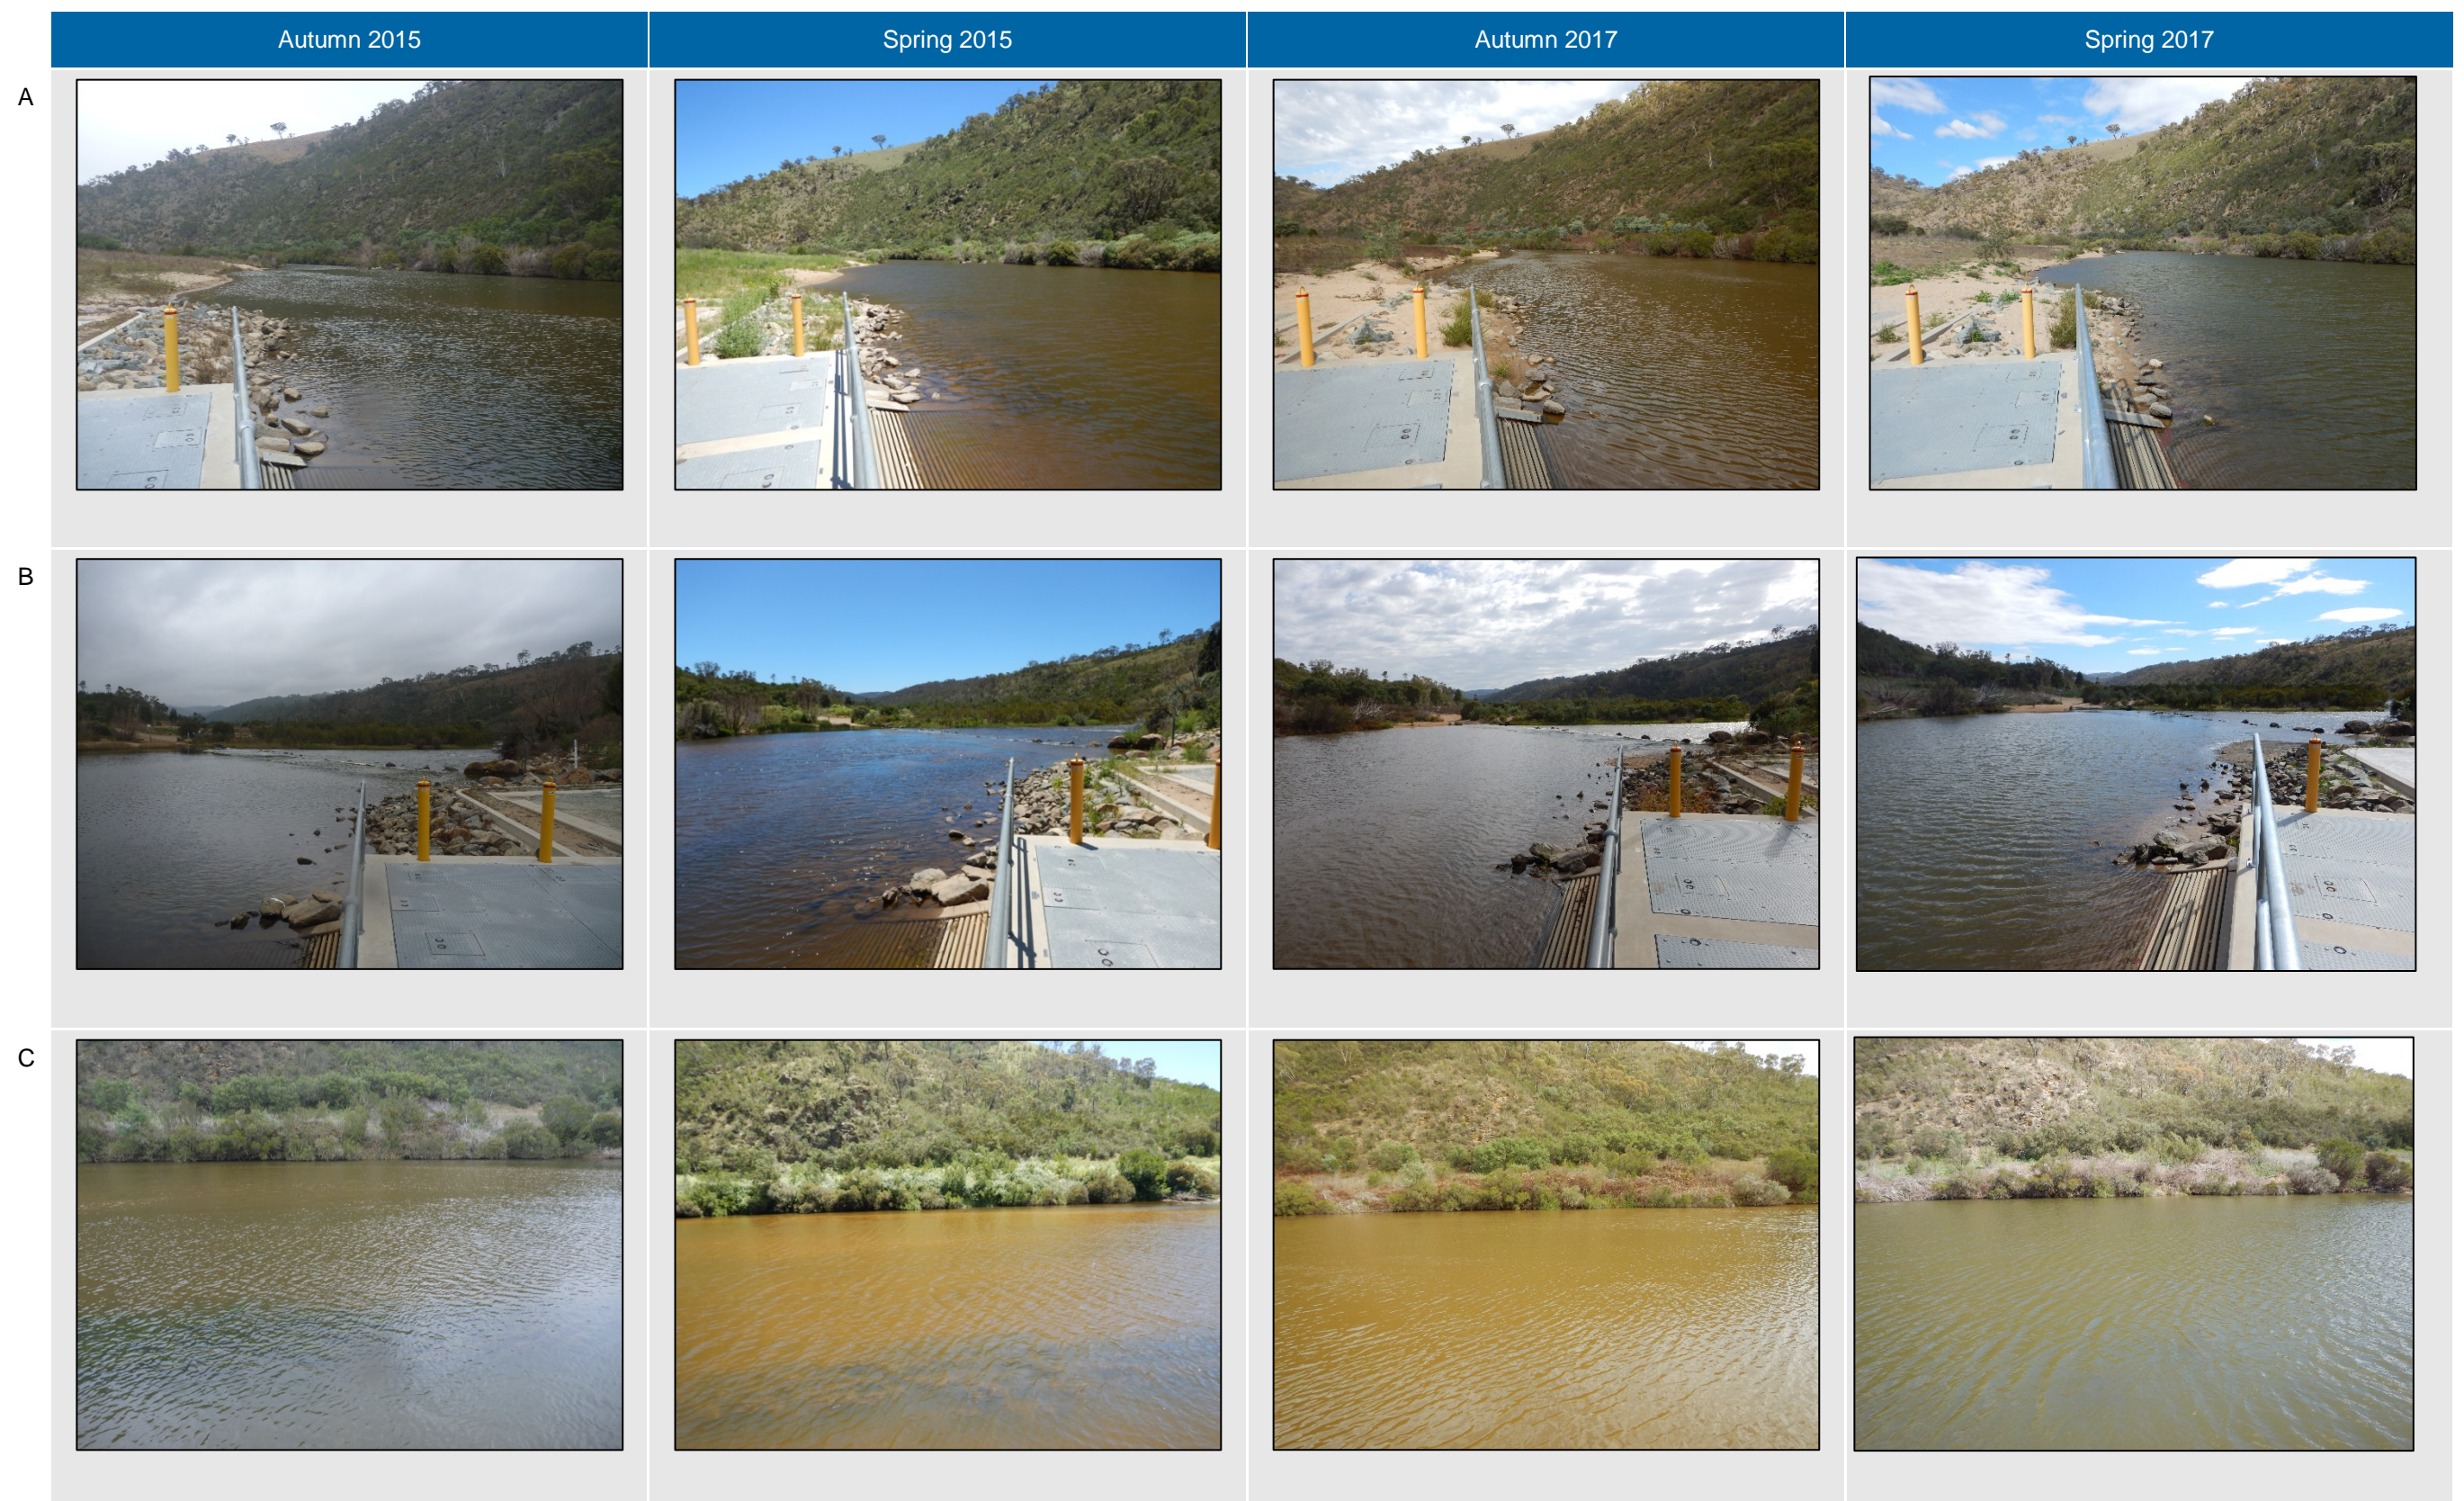
Overall, the key differences in geomorphological features in Plate 3-4 through to Plate 3-8 appear to be changes in bed and bar exposure due to changes in the water level since the last monitoring period; and various degrees of vegetation die back and recruitment due to the seasonal comparisons being made. The river banks appear stable at each of the photo points.

**Plate 3-4 Geomorphology photo point 1 at Angle Crossing showing upstream (a), downstream (b) and across the channel (c) from autumn 2015 to spring 2017**

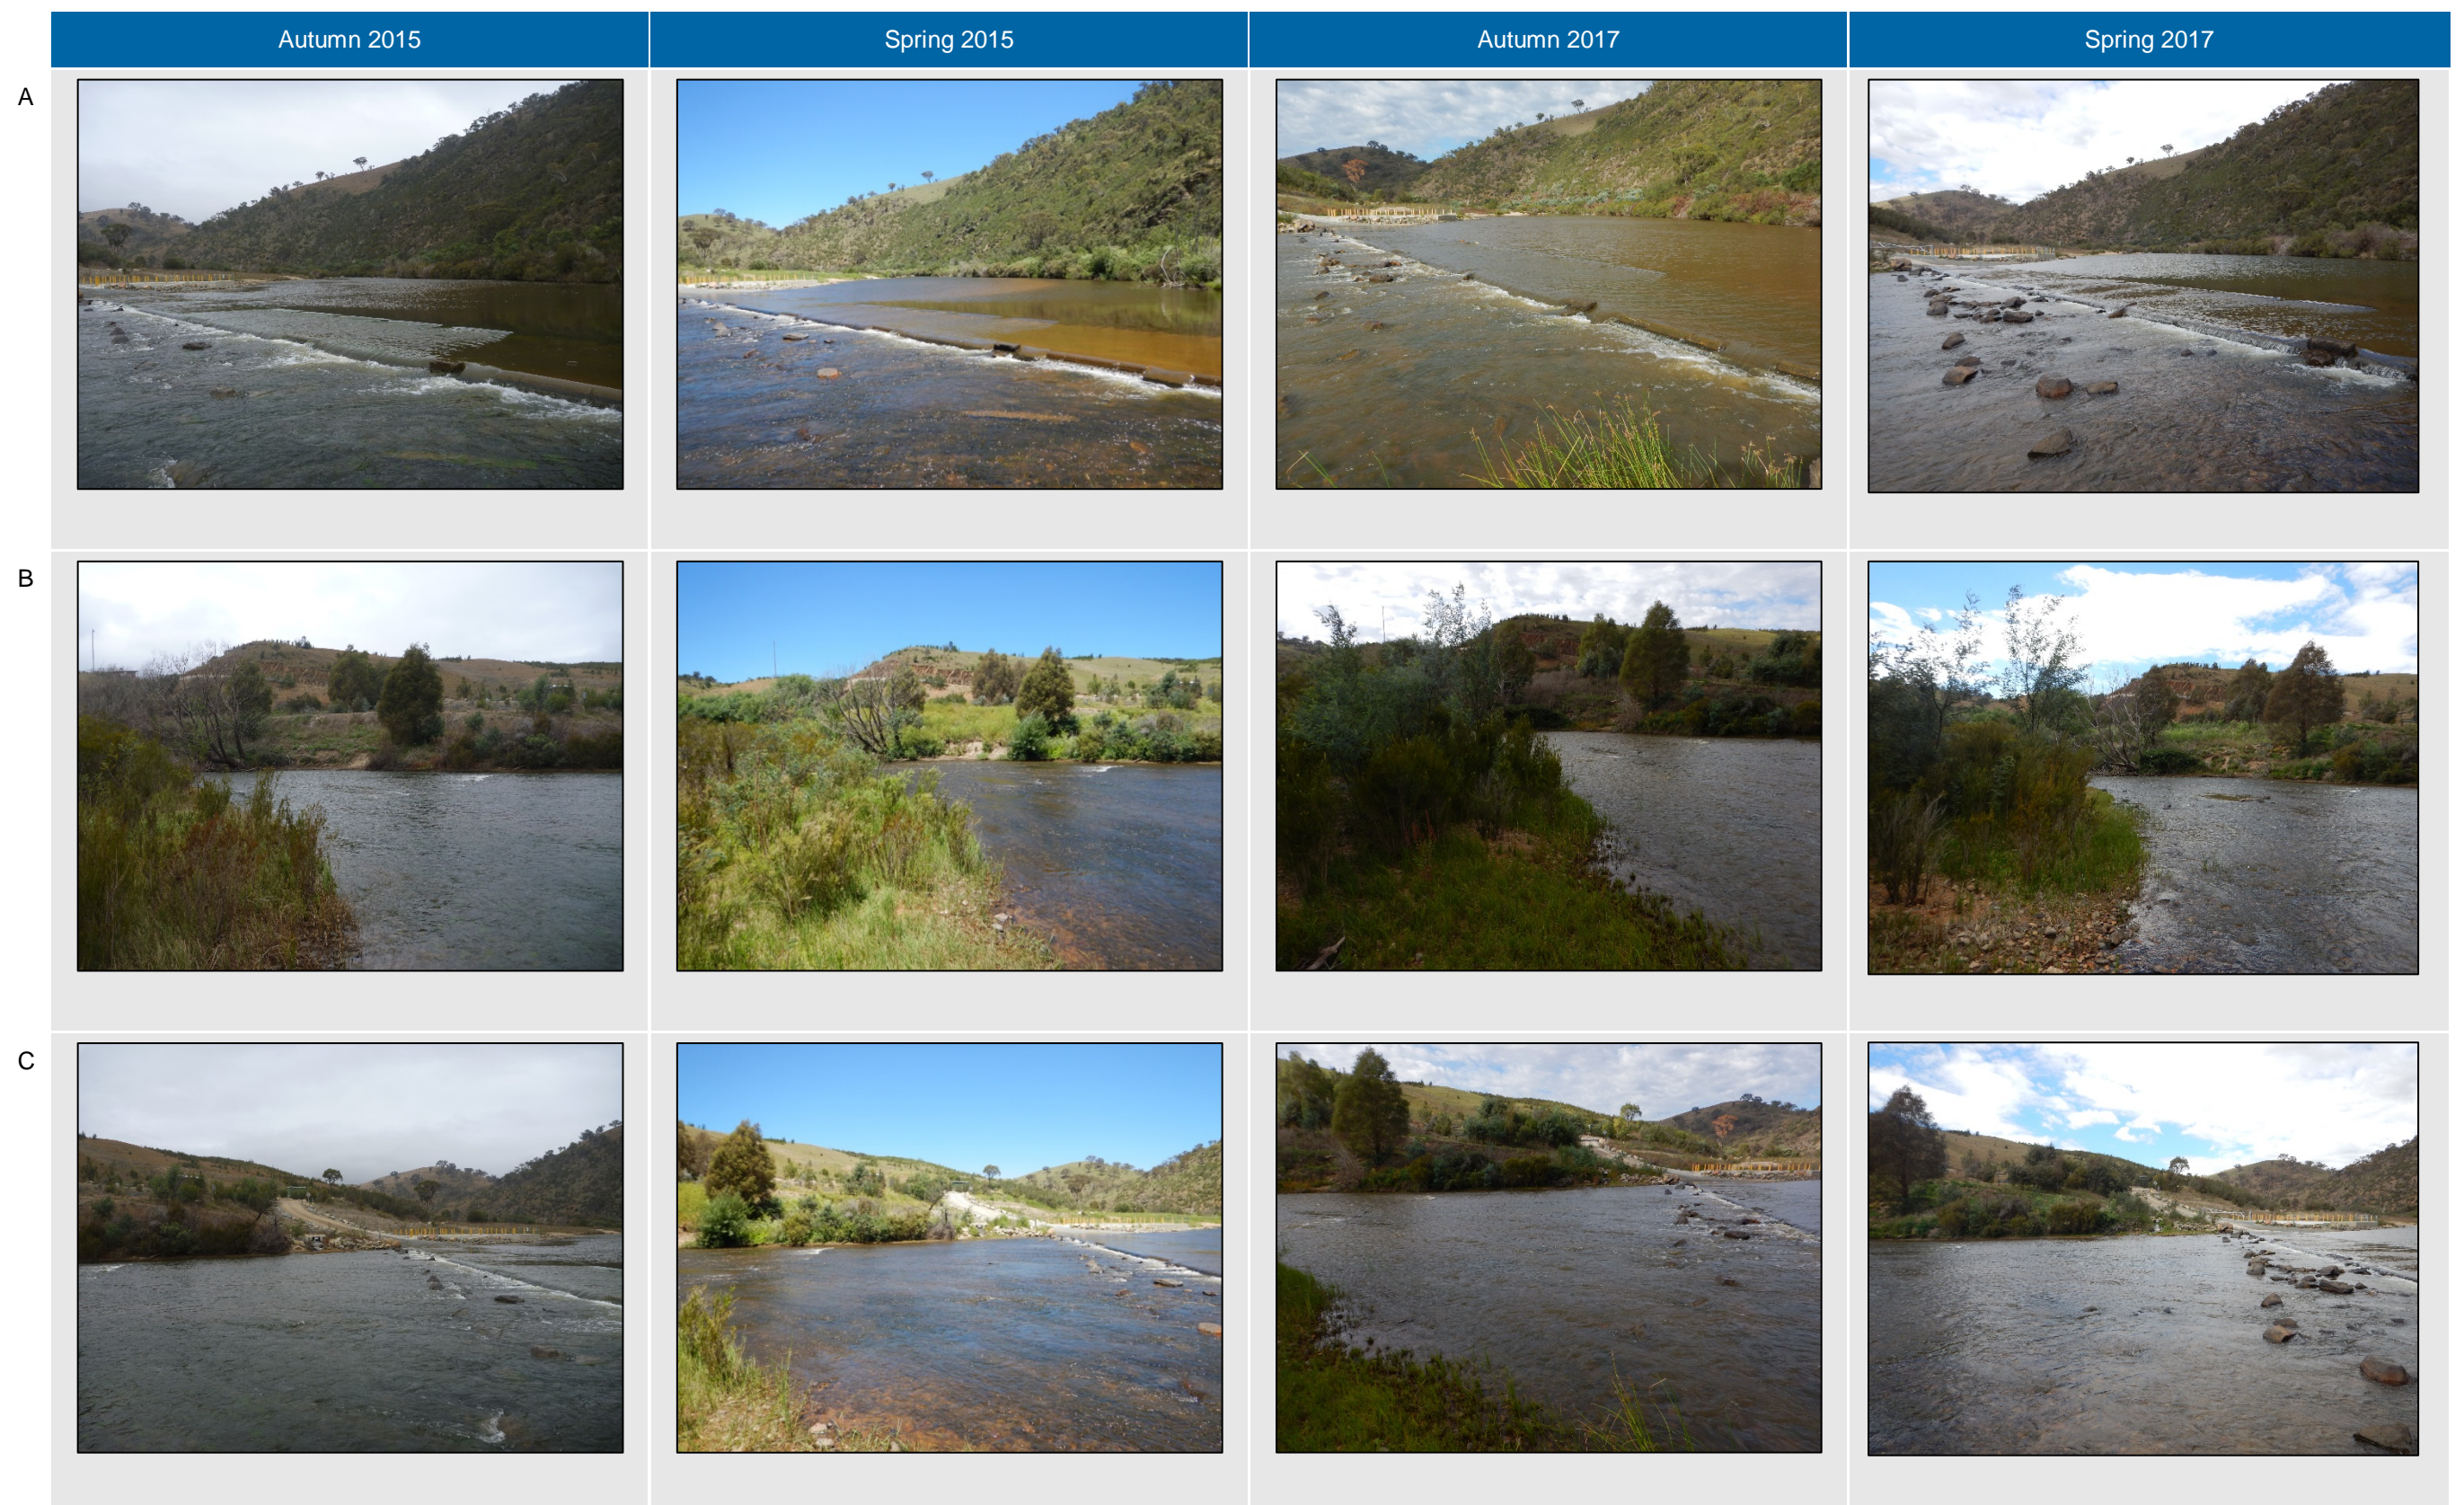
**Plate 3-5 Geomorphology photo point 2 at Angle Crossing showing upstream (a), downstream (b) and across the channel (c) from autumn 2015 to spring 2017**
