## **Icon Water**

# **Murrumbidgee Ecological Monitoring Program 2015-21 Sentinel Monitoring - Autumn 2018**

September 2018

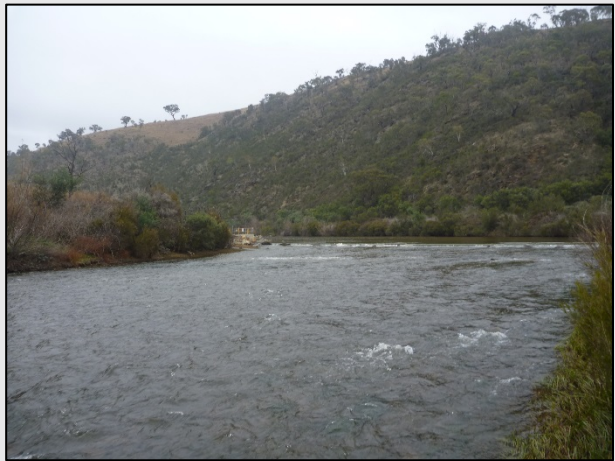
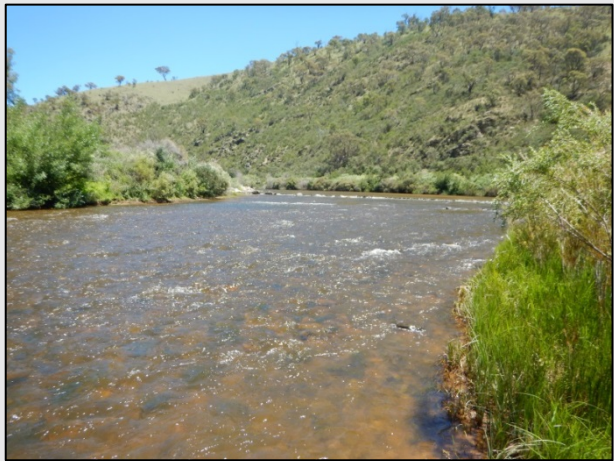
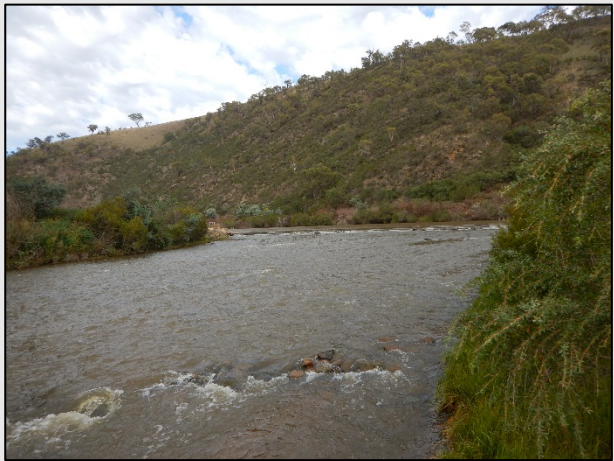
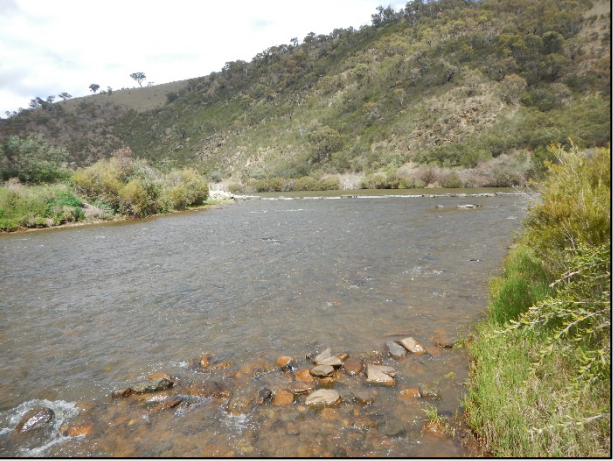
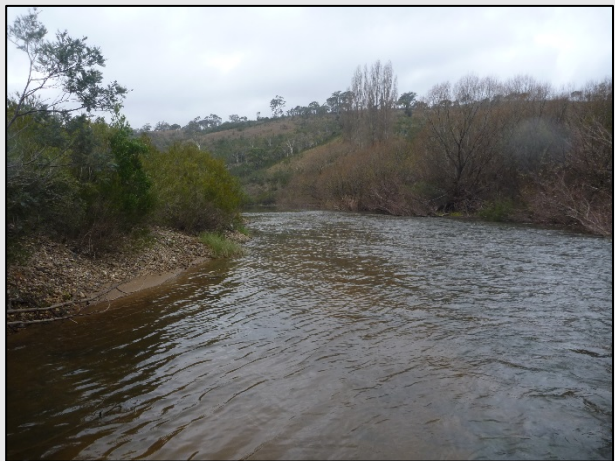
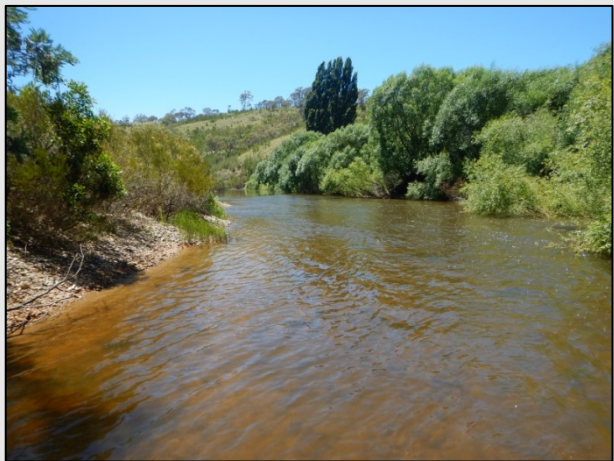
**Plate 3-5 Geomorphology photo point 2 at Angle Crossing showing upstream (a), downstream (b) and across the channel (c) from autumn 2015 to spring 2017**

The current photographs show areas of exposed river margins from the declining water level and some newly exposed sand bars and bedrock. These features are linked to the ongoing low rainfall period throughout much of the upper Murrumbidgee River Catchment at present and is not considered to be related to M2G. There is no photographic evidence of bank erosion, incising or scouring that may be considered to be caused by the M2G project.

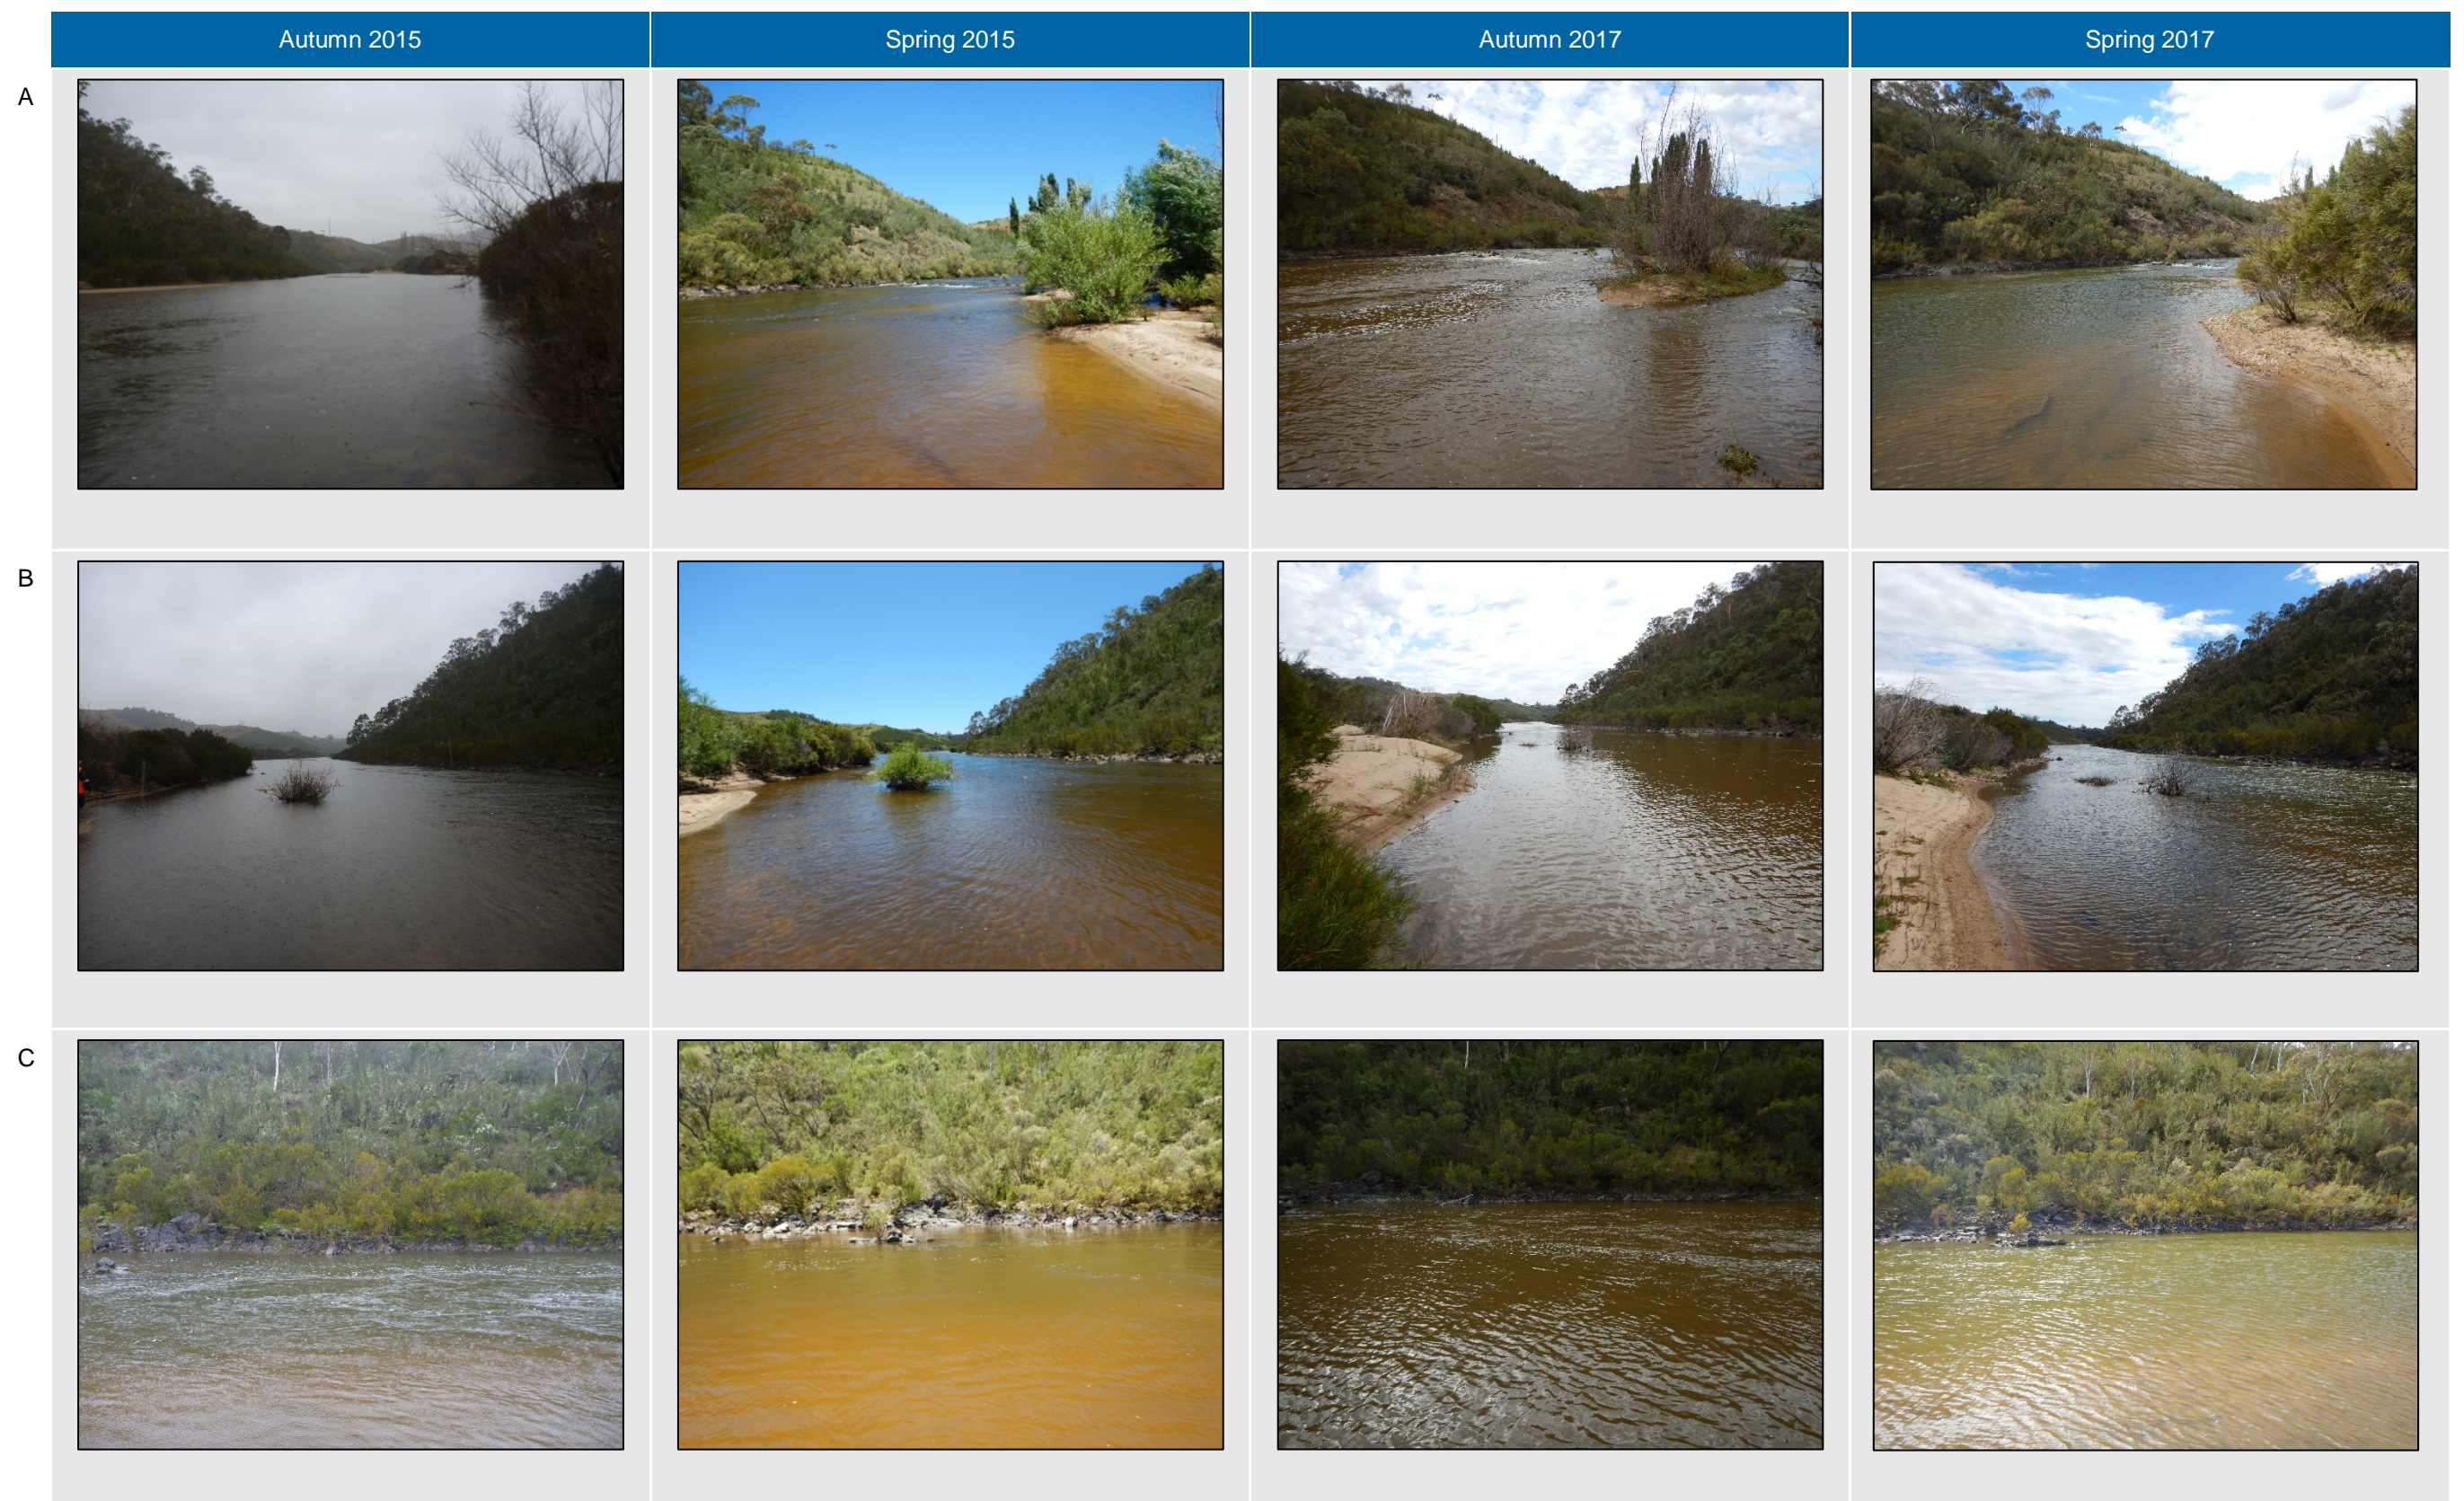
Overall, the key differences in geomorphological features in Plate 3-4 through to Plate 3-8 appear to be changes in bed and bar exposure due to changes in the water level since the last monitoring period; and various degrees of vegetation die back and recruitment due to the seasonal comparisons being made. The river banks appear stable at each of the photo points.

**Plate 3-7 Geomorphology photo point 4 at Angle Crossing showing upstream (a), downstream (b) and across the channel (c) from autumn 2015 to spring 2017**

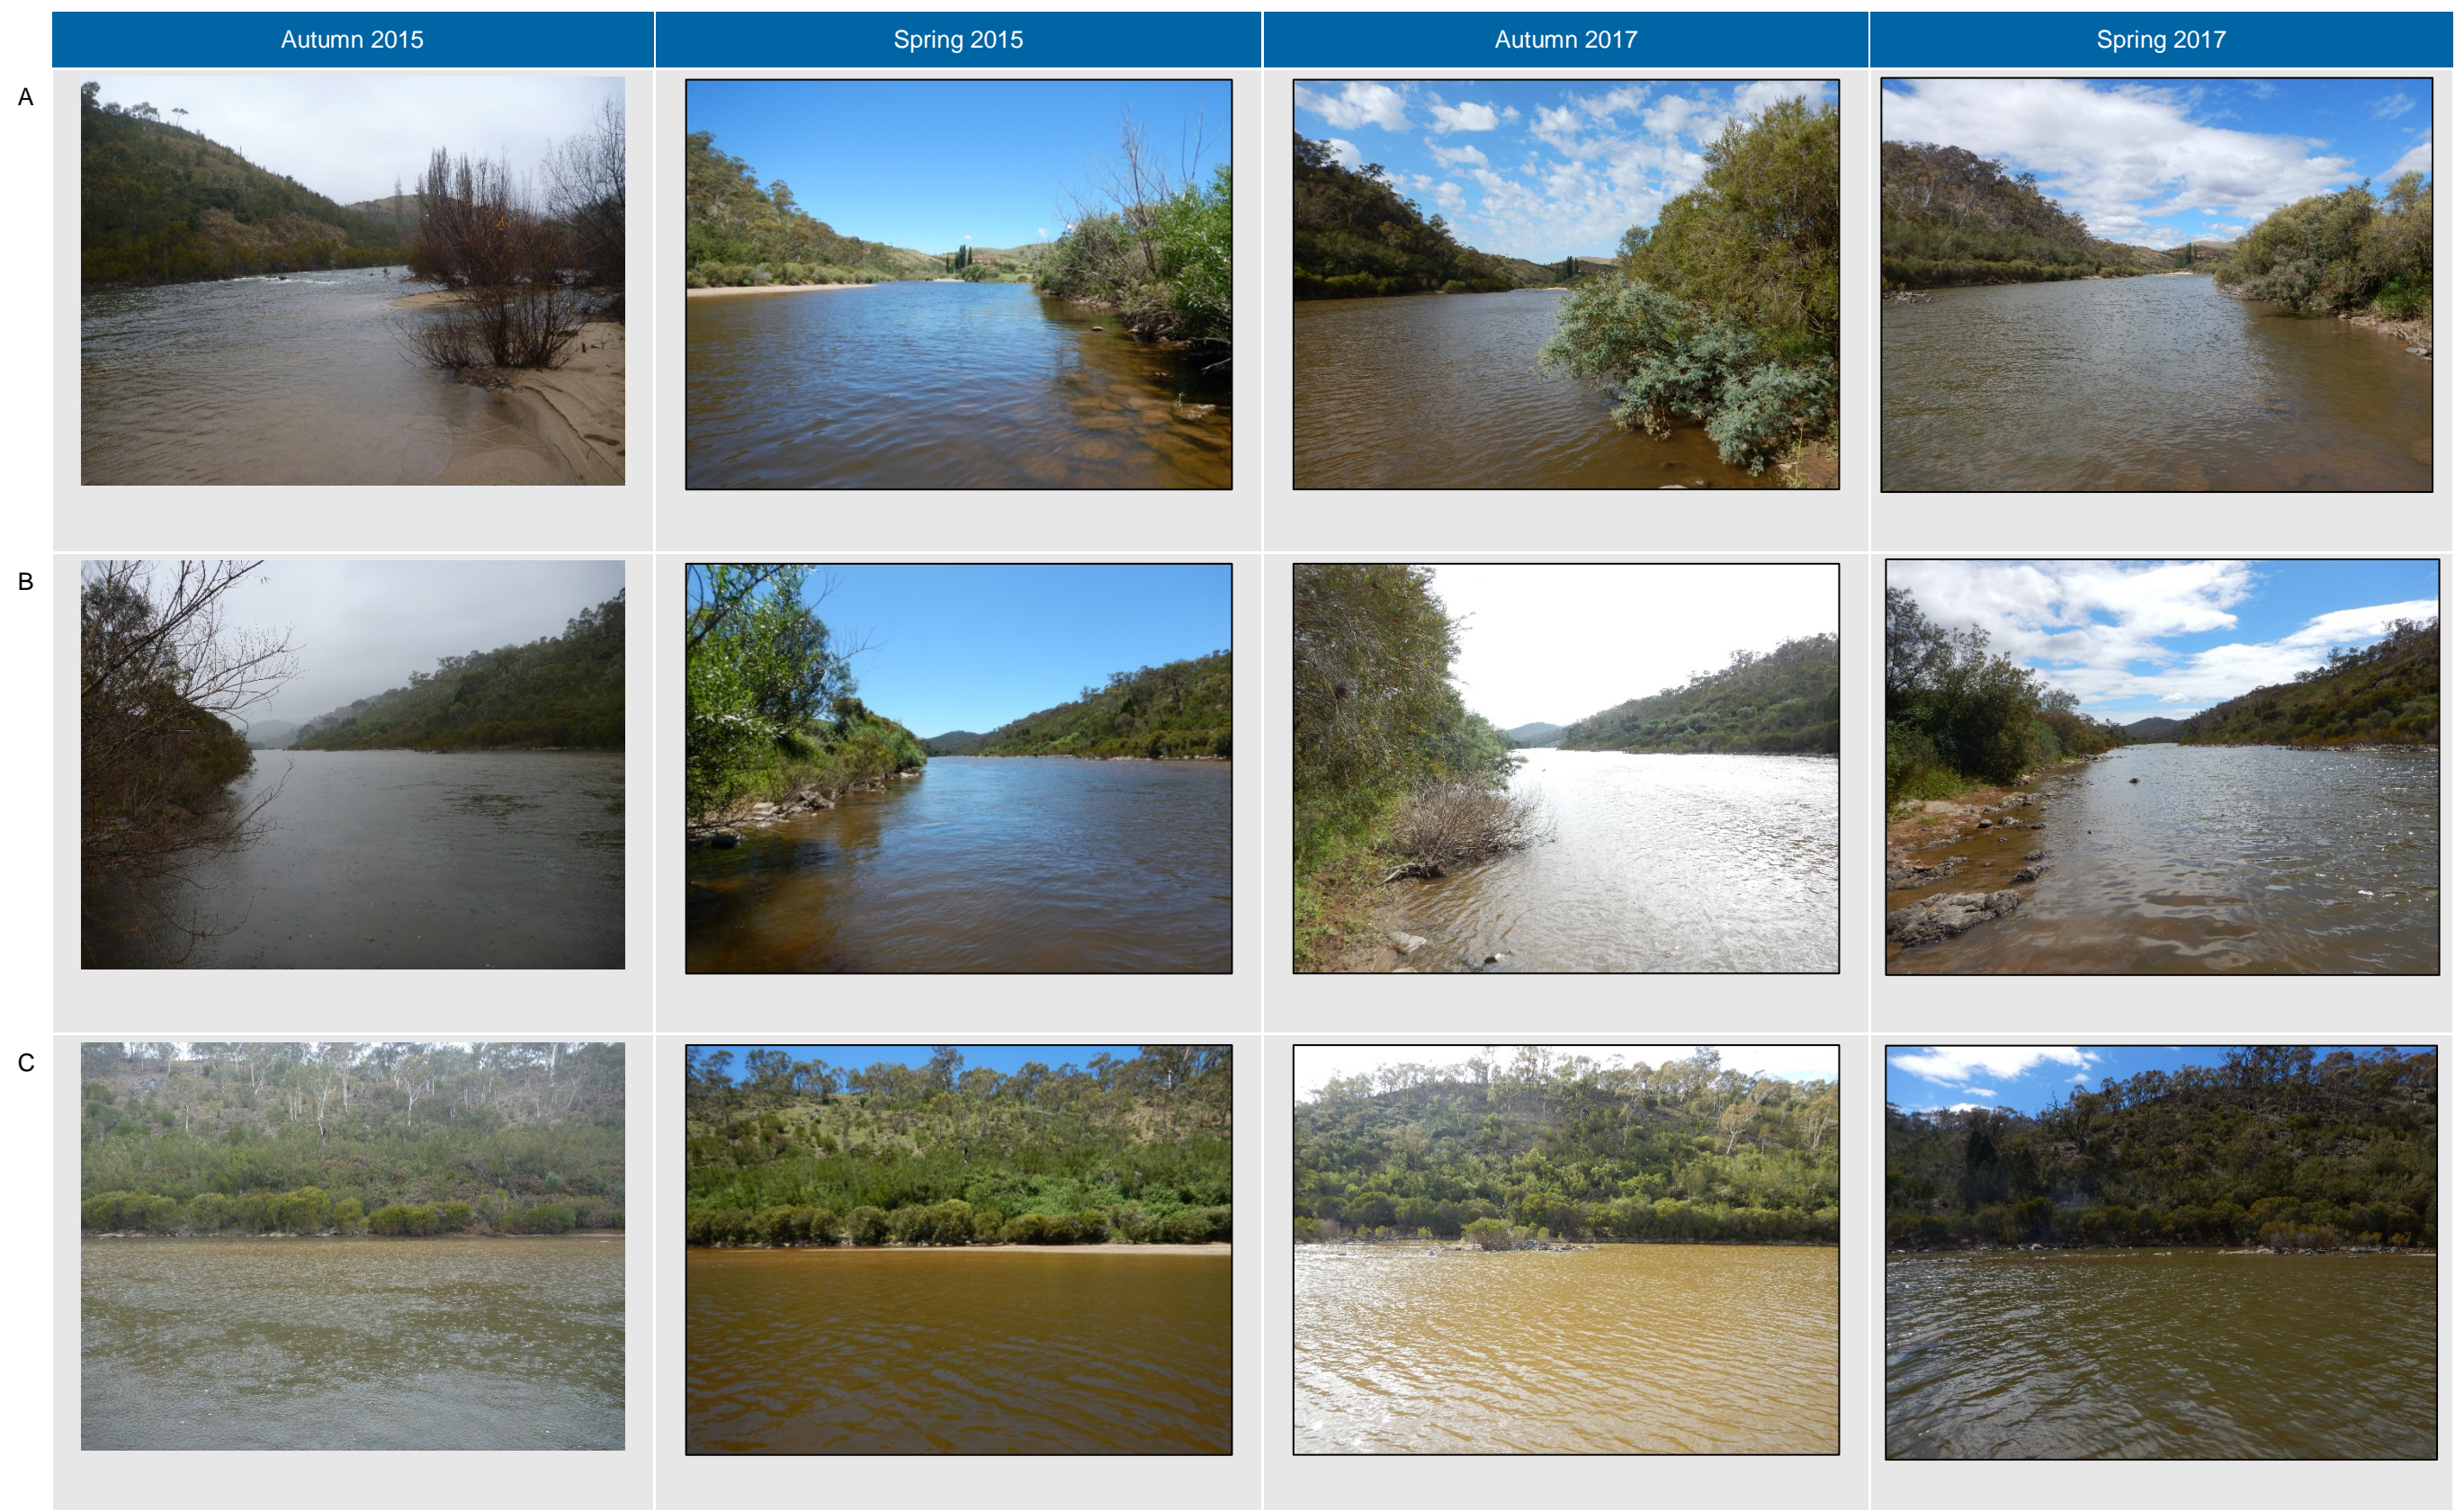
**Plate 3-8 Geomorphology photo point 5 at Angle Crossing showing upstream (a), downstream (b) and across the channel (c) from autumn 2015 to spring 2017**

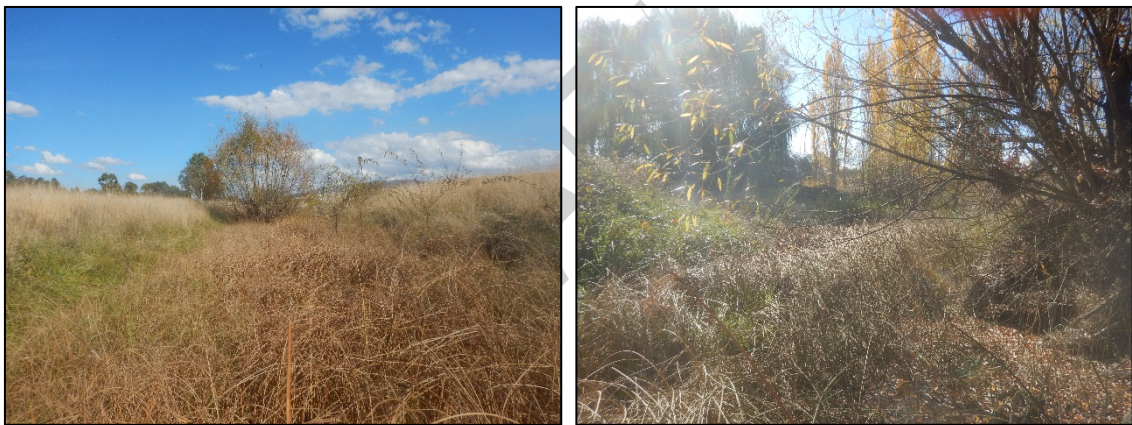
The riffle habitats at both sites were almost dry, highly silted and overgrown with macrophytes which equated to very poor habitat quality and ultimately meant that samples could not be collected. Site summaries can be found in Appendix B, while site habitat data is given in Appendix C.

BUR1c: Looking upstream (left) and looking downstream (right)

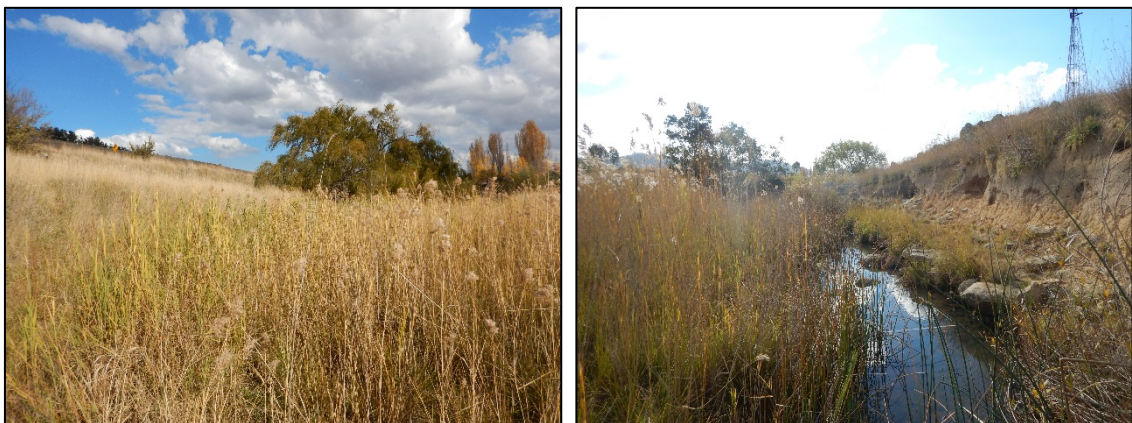
BUR2a: Looking upstream (left) and looking downstream (right)

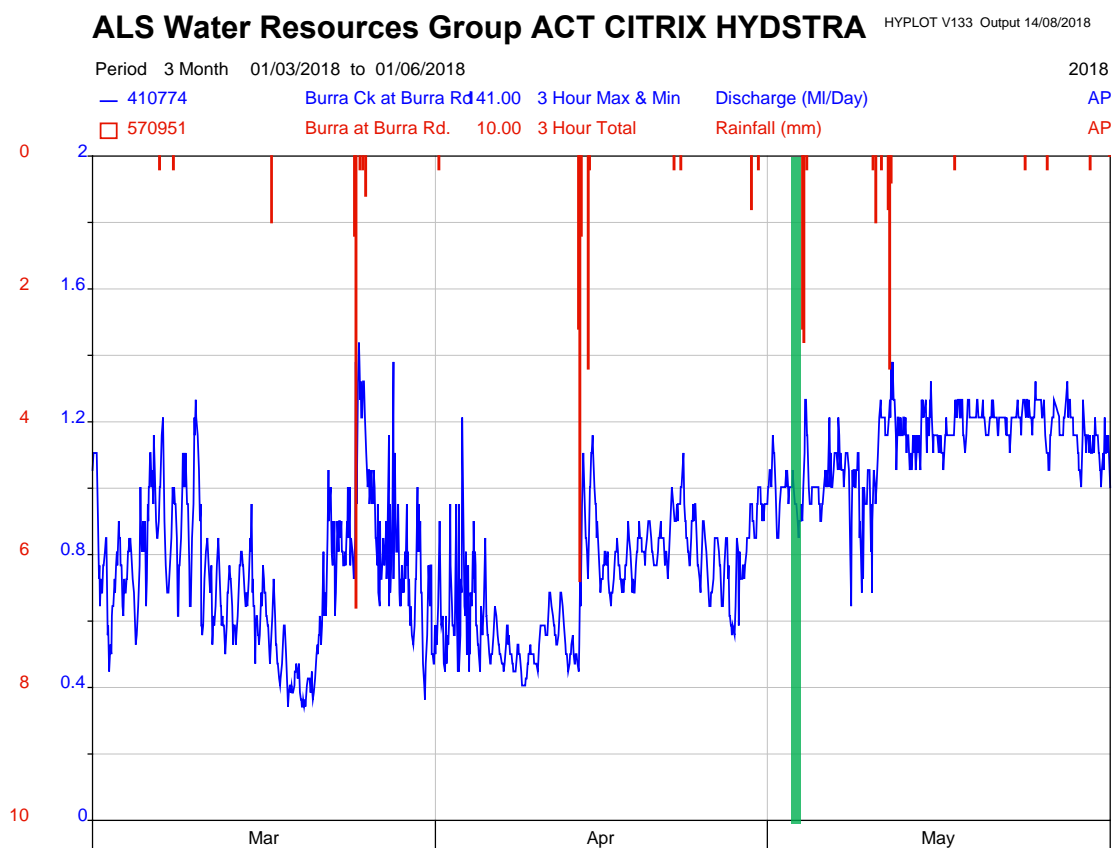
Surface flow in Burra Creek during autumn was low, typically ranging between 0.3 – 1.5 ML/d (Figure 4-1). For the majority of autumn (71%), the mean daily flow was below 1 ML/d. Most of the readings above 1 ML/d (92%) occurred in May following an upward trend beginning in the middle of April (Figure 4-1). Rainfall during autumn was the lowest total recorded since 2008 (Figure 4-2) and for the first time since the beginning of this project fell below the autumn average of 43.4 mm (Figure 4-3).

**Figure 4-1. Hydrograph and rainfall from Burra Creek (410774) during autumn 2018**

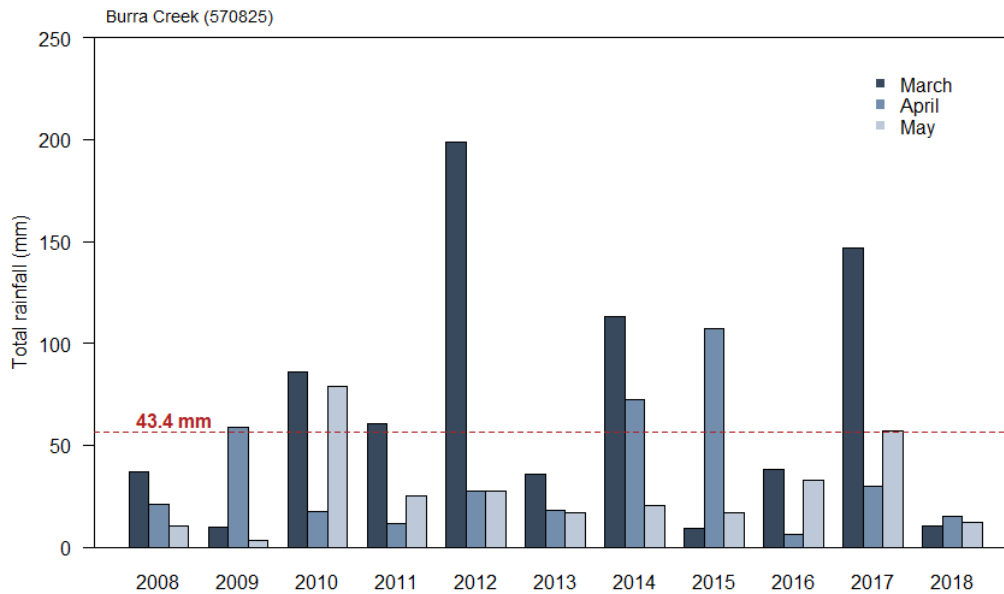
**Figure 4-2. Annual comparisons of autumn rainfall (mm) recorded at Burra Creek (570951)**

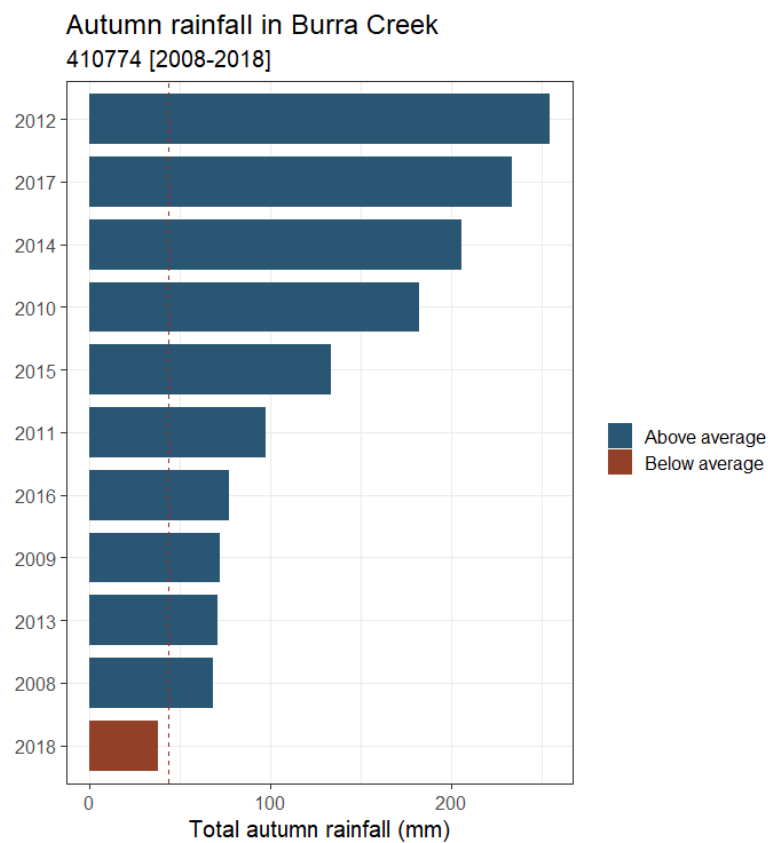
**Figure 4-3 Ranked total autumn rainfall at station 410774 for the period 2008-2018**

\*Note that the vertical red line indicates the average total autumn rainfall for the period of record

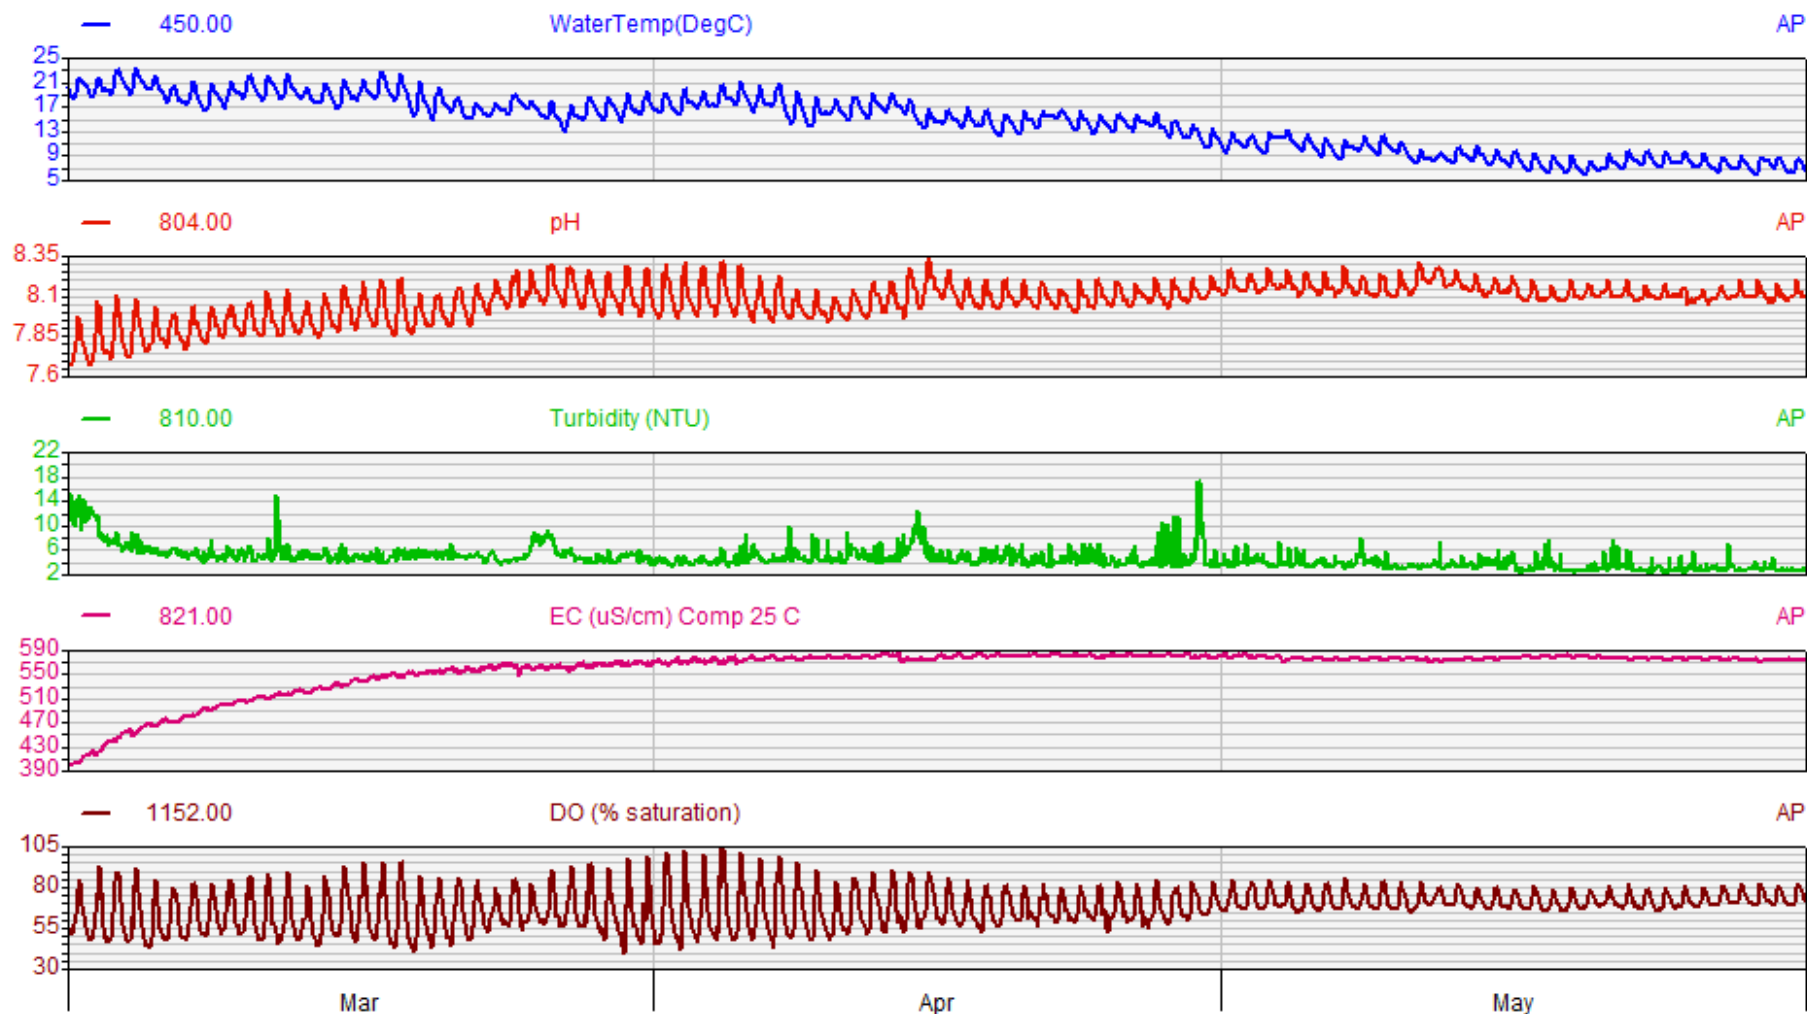
**Figure 4-4. Continuous water quality recorded at Burra Creek (410774) during autumn 2018**

The continuous water quality data recorded at the Burra Weir (410774) is presented in Figure 4-4. Mean pH increased over the autumn period, though the daily variation decreased throughout most of May as the average daily discharge increased (Table 4-2).

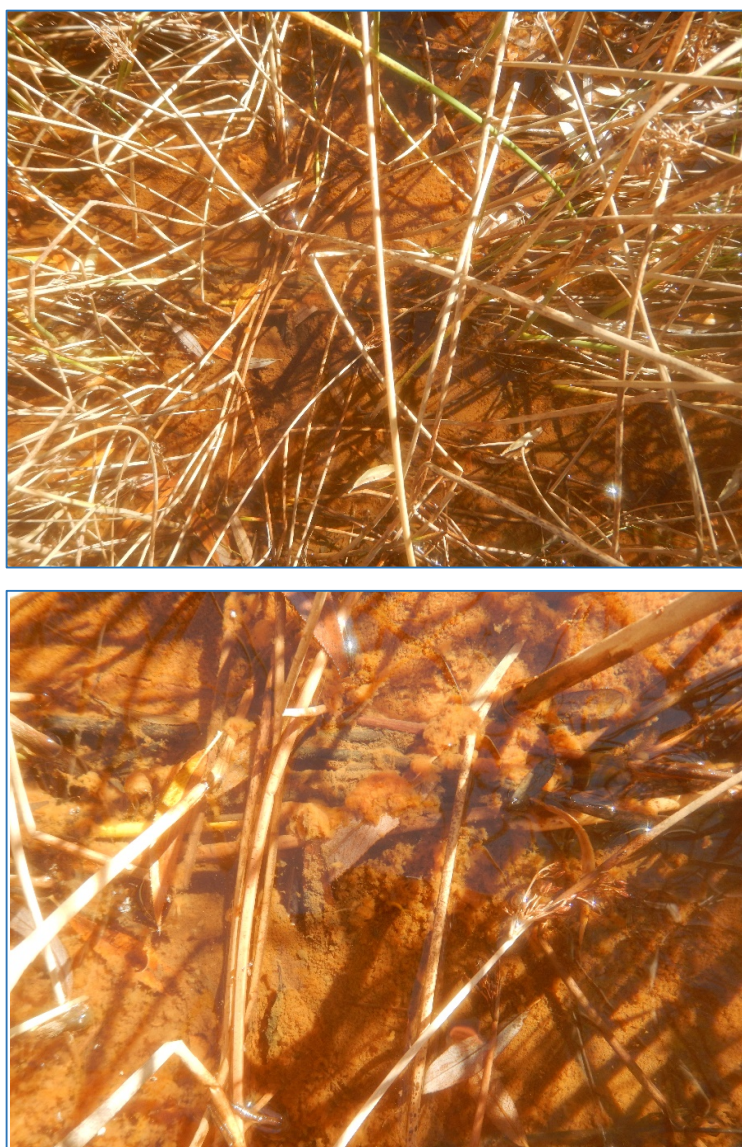
**Plate 4-2. Periphyton coverage at BUR1c**

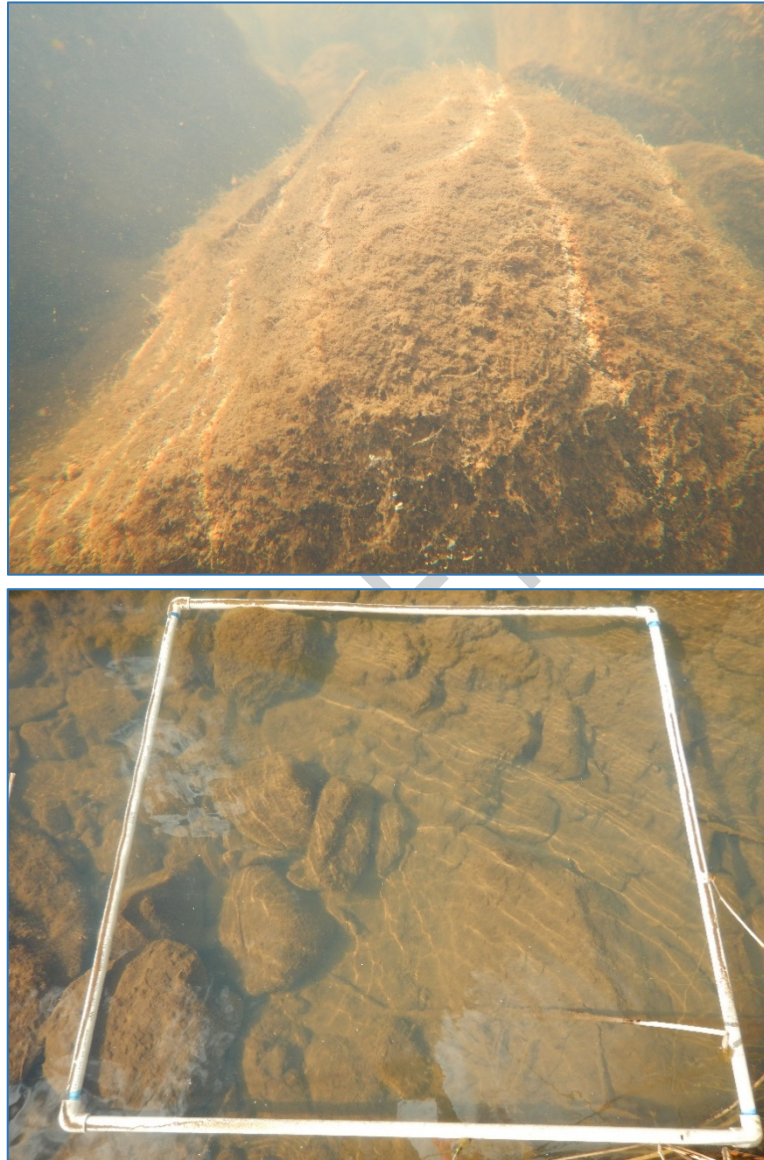
**Plate 4-3. Periphyton coverage at BUR2a**

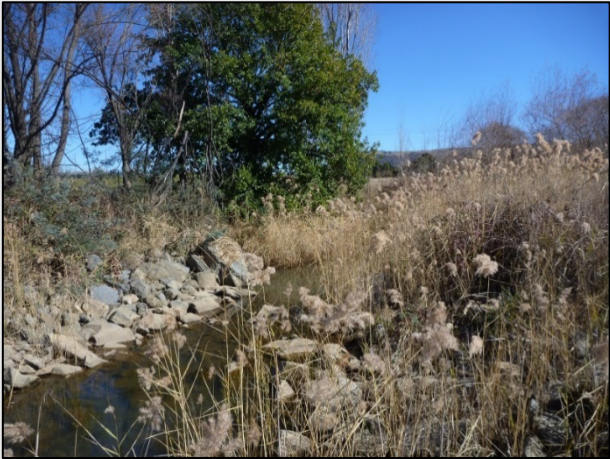
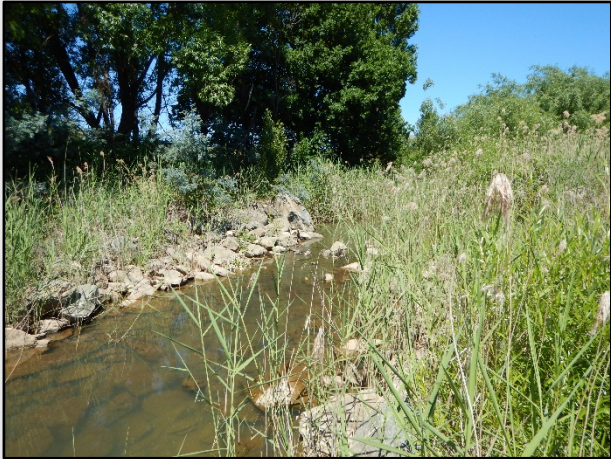
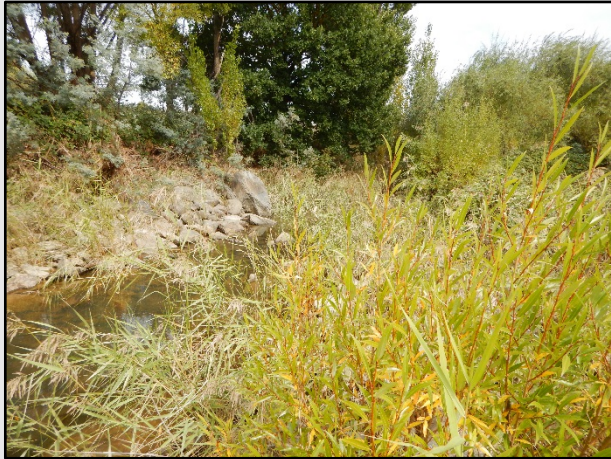
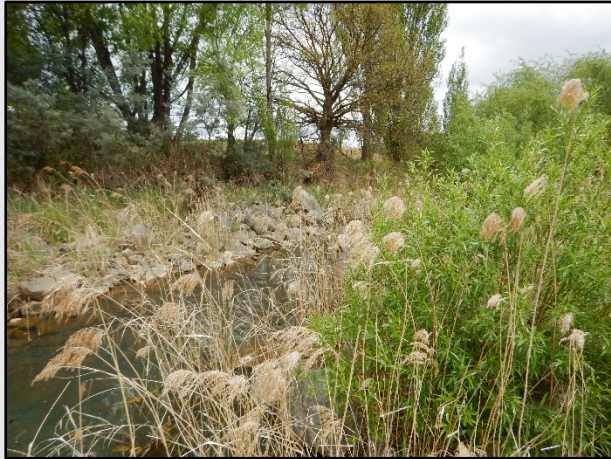
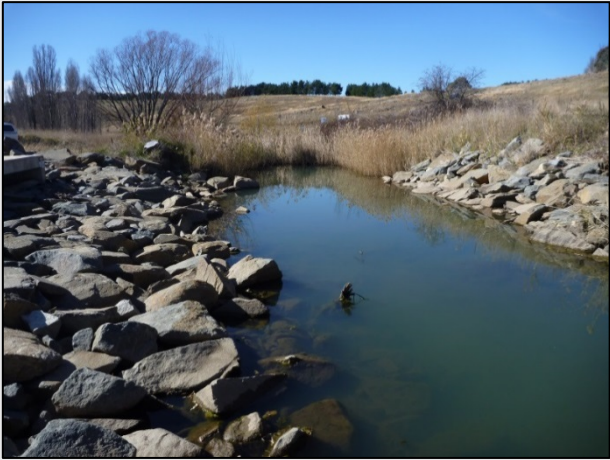
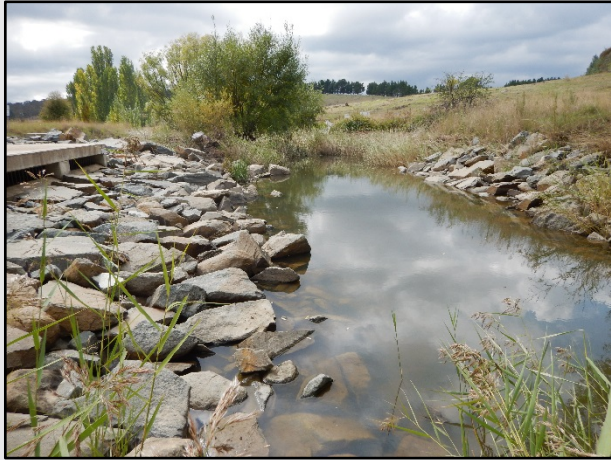
As with the previous locations on Burra Creek, there were no obvious compositional changes, or changes to the distribution of the surveyed vegetation since spring 2015.

**Plate 4-4 Vegetation extent photo at BUR2 showing upstream (a), downstream (b) and across the channel (c) from autumn 2015 to spring 2017**

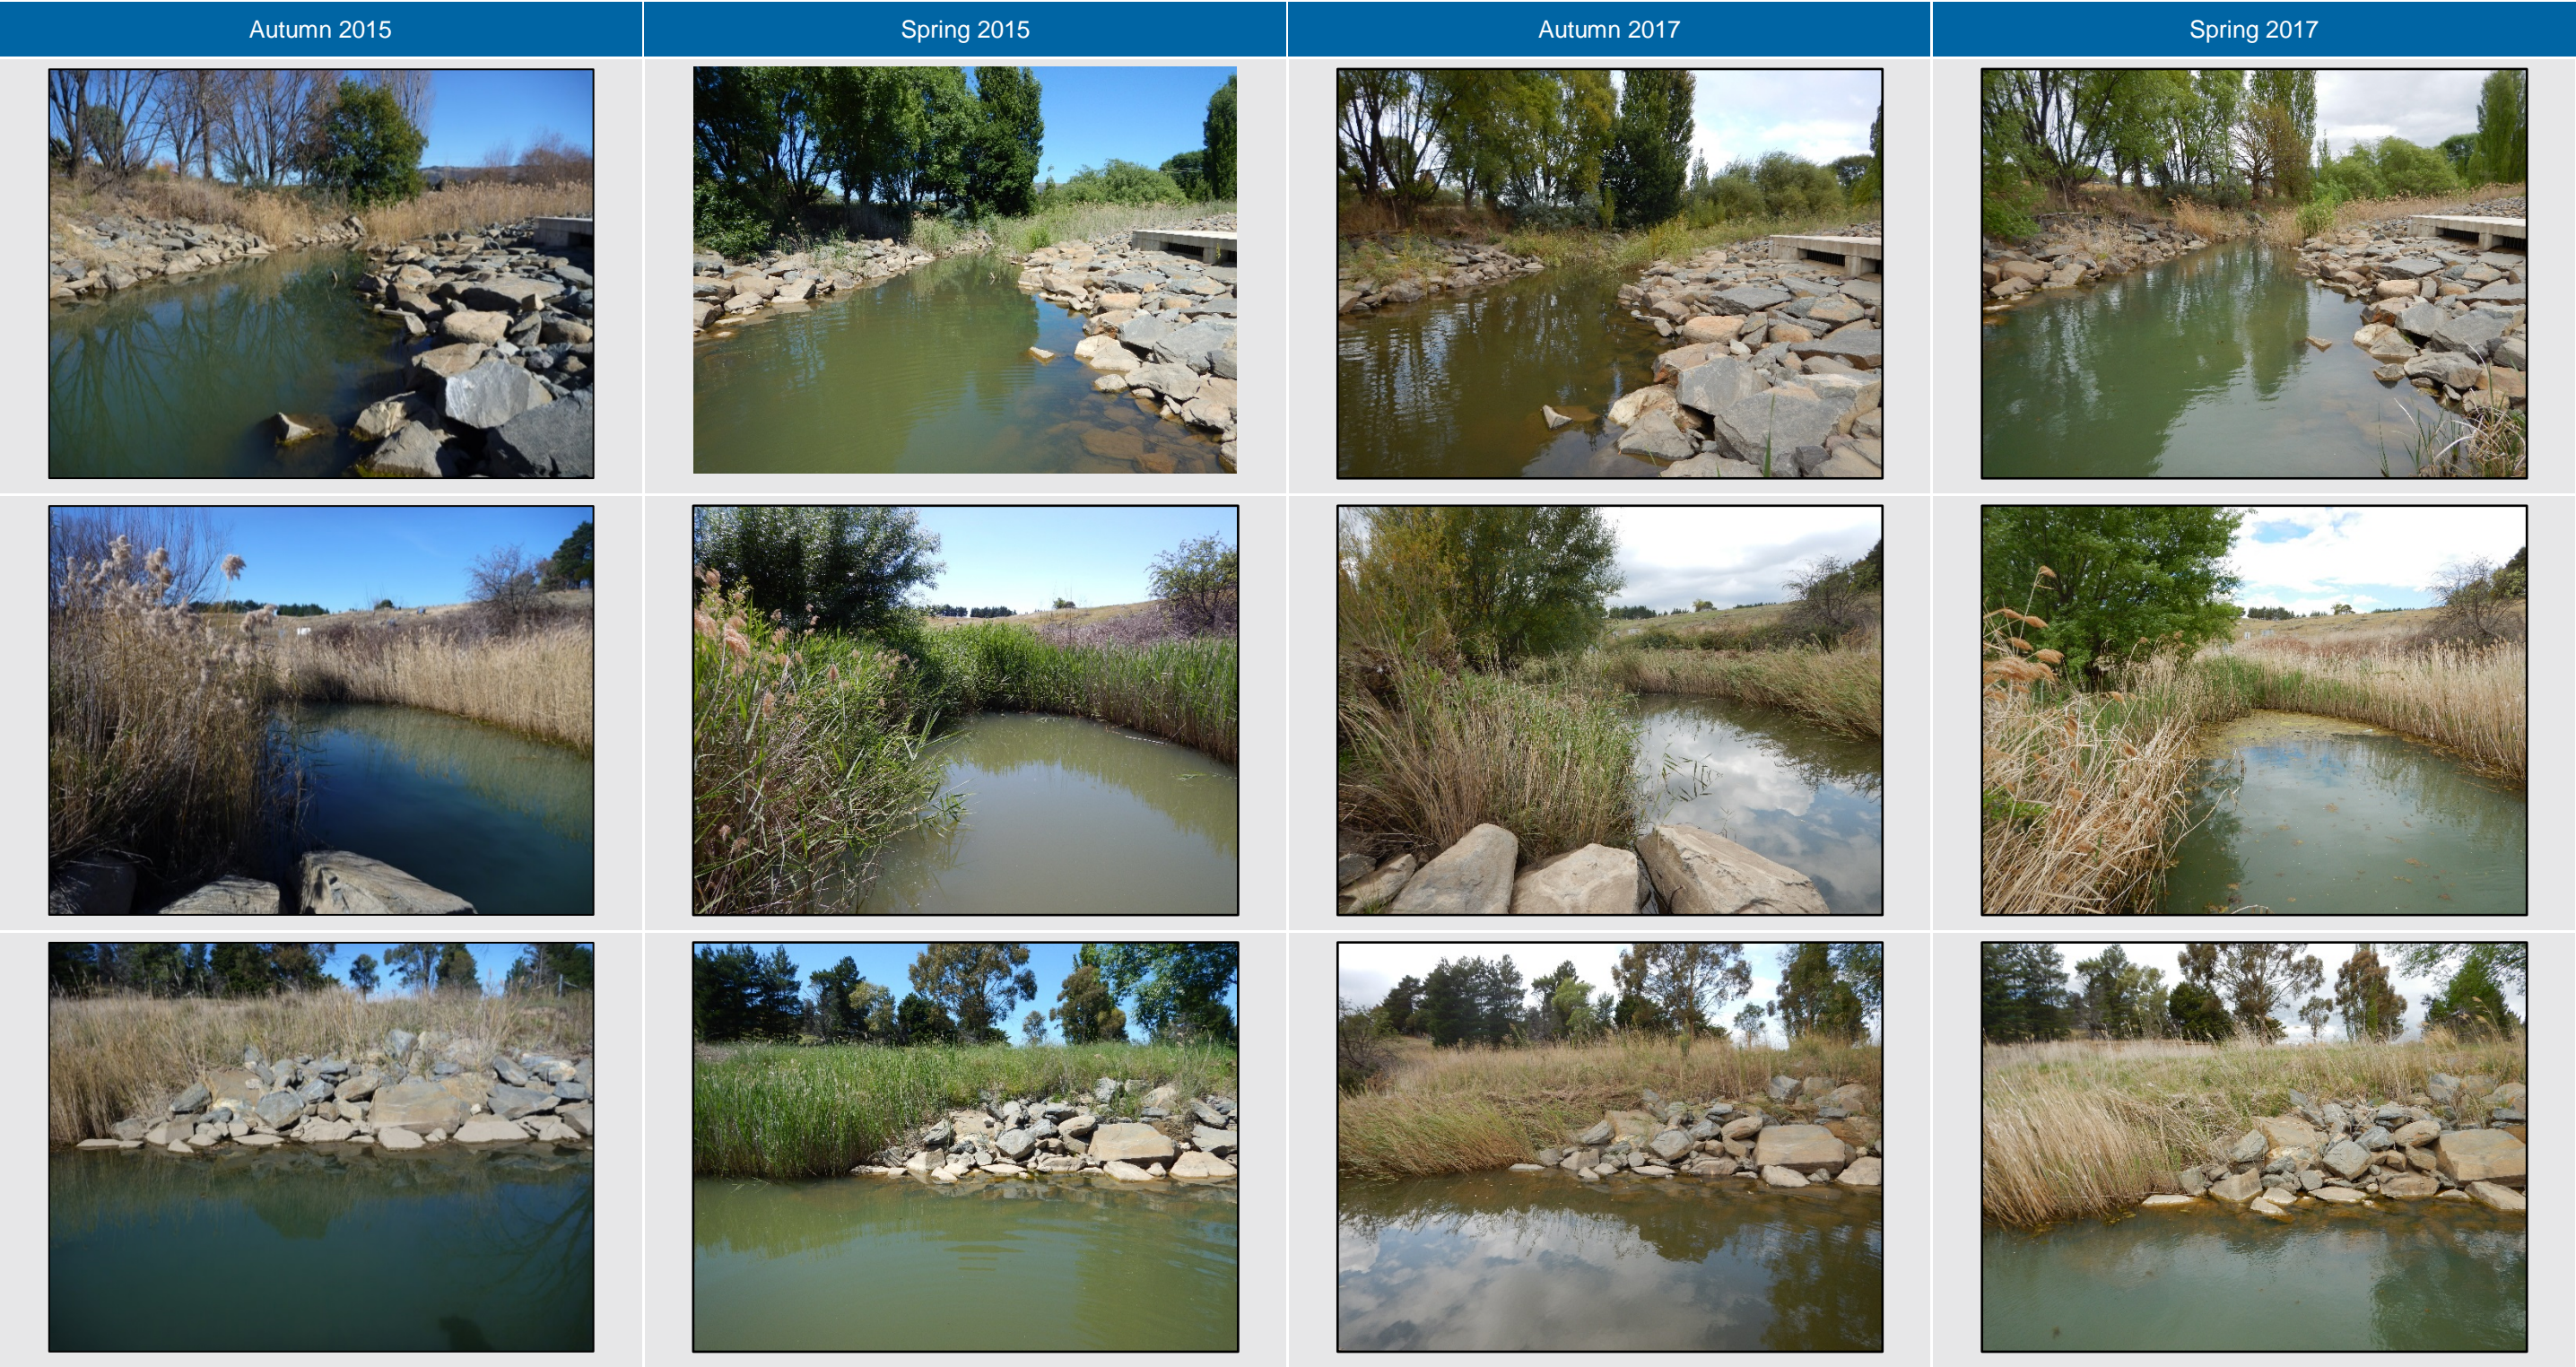
**Plate 4-5 Vegetation extent photo point 2 at BUR2 showing upstream (a), downstream (b) and across the channel (c) from autumn 2015 (left) to spring 2017 (right)**
