## **Icon Water**

# **Murrumbidgee Ecological Monitoring Program 2015-21 Sentinel Monitoring - Autumn 2018**

September 2018

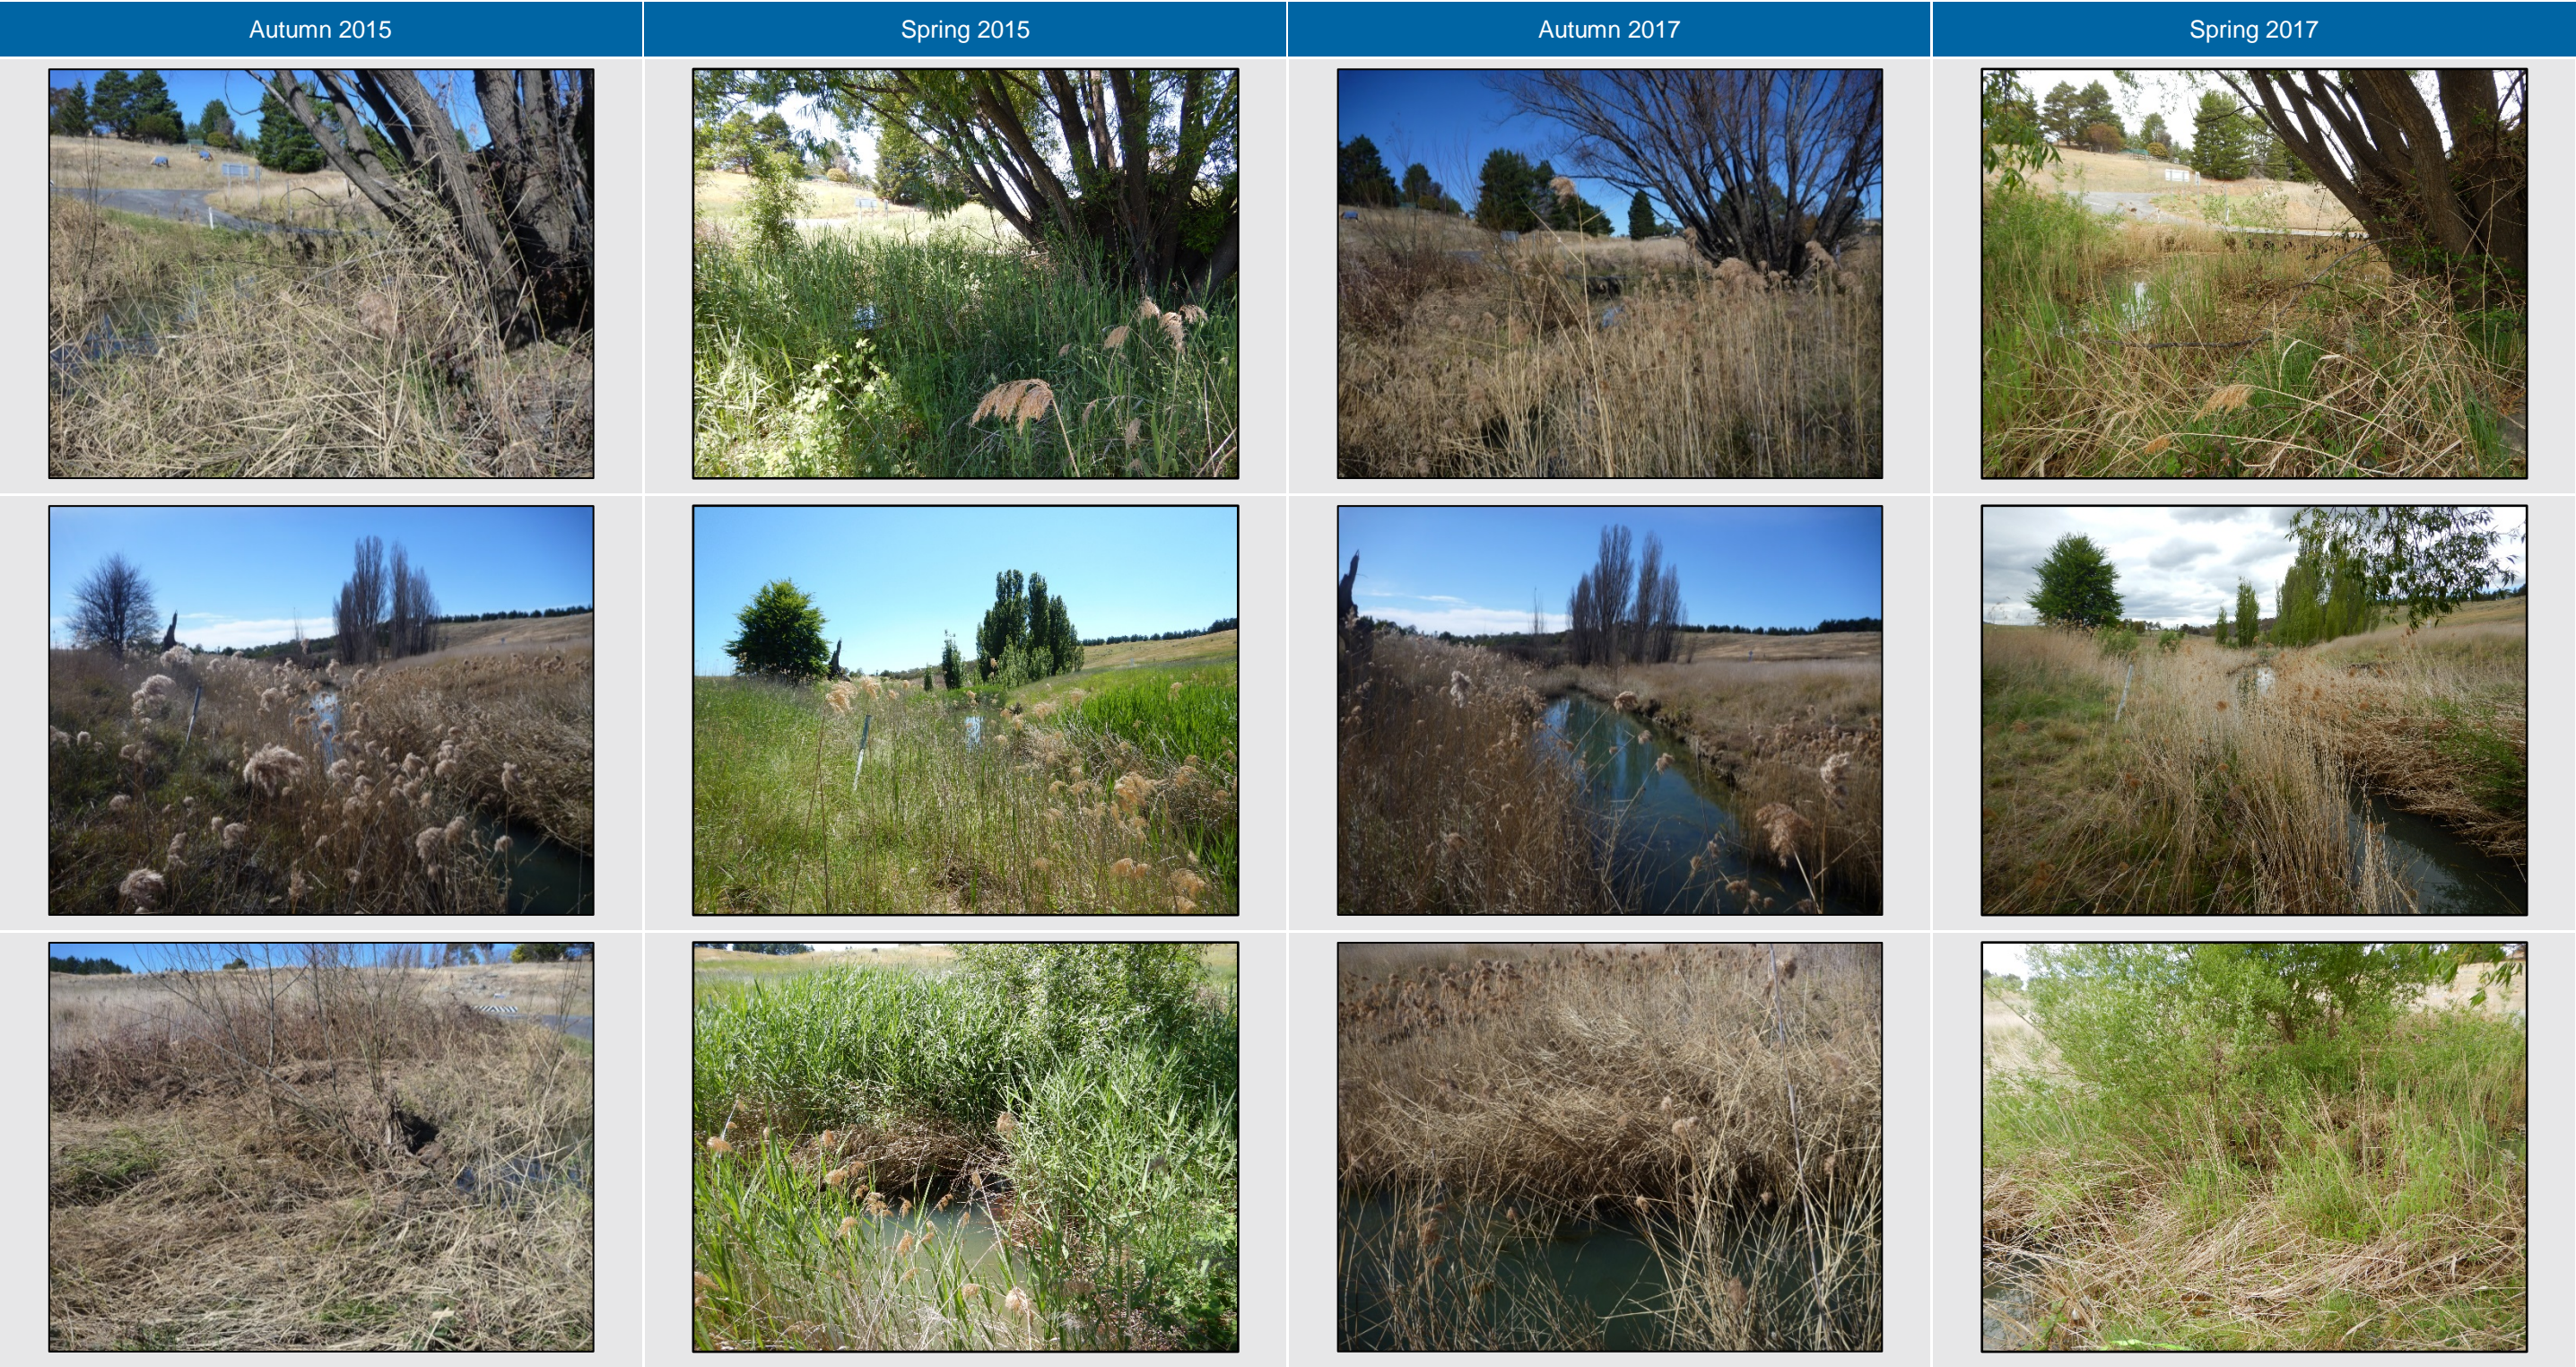
**Plate 4-6 Vegetation extent photo point 3 at BUR2 showing upstream (a), downstream (b) and across the channel (c) from autumn 2015 (left) to spring 2017 (right)**

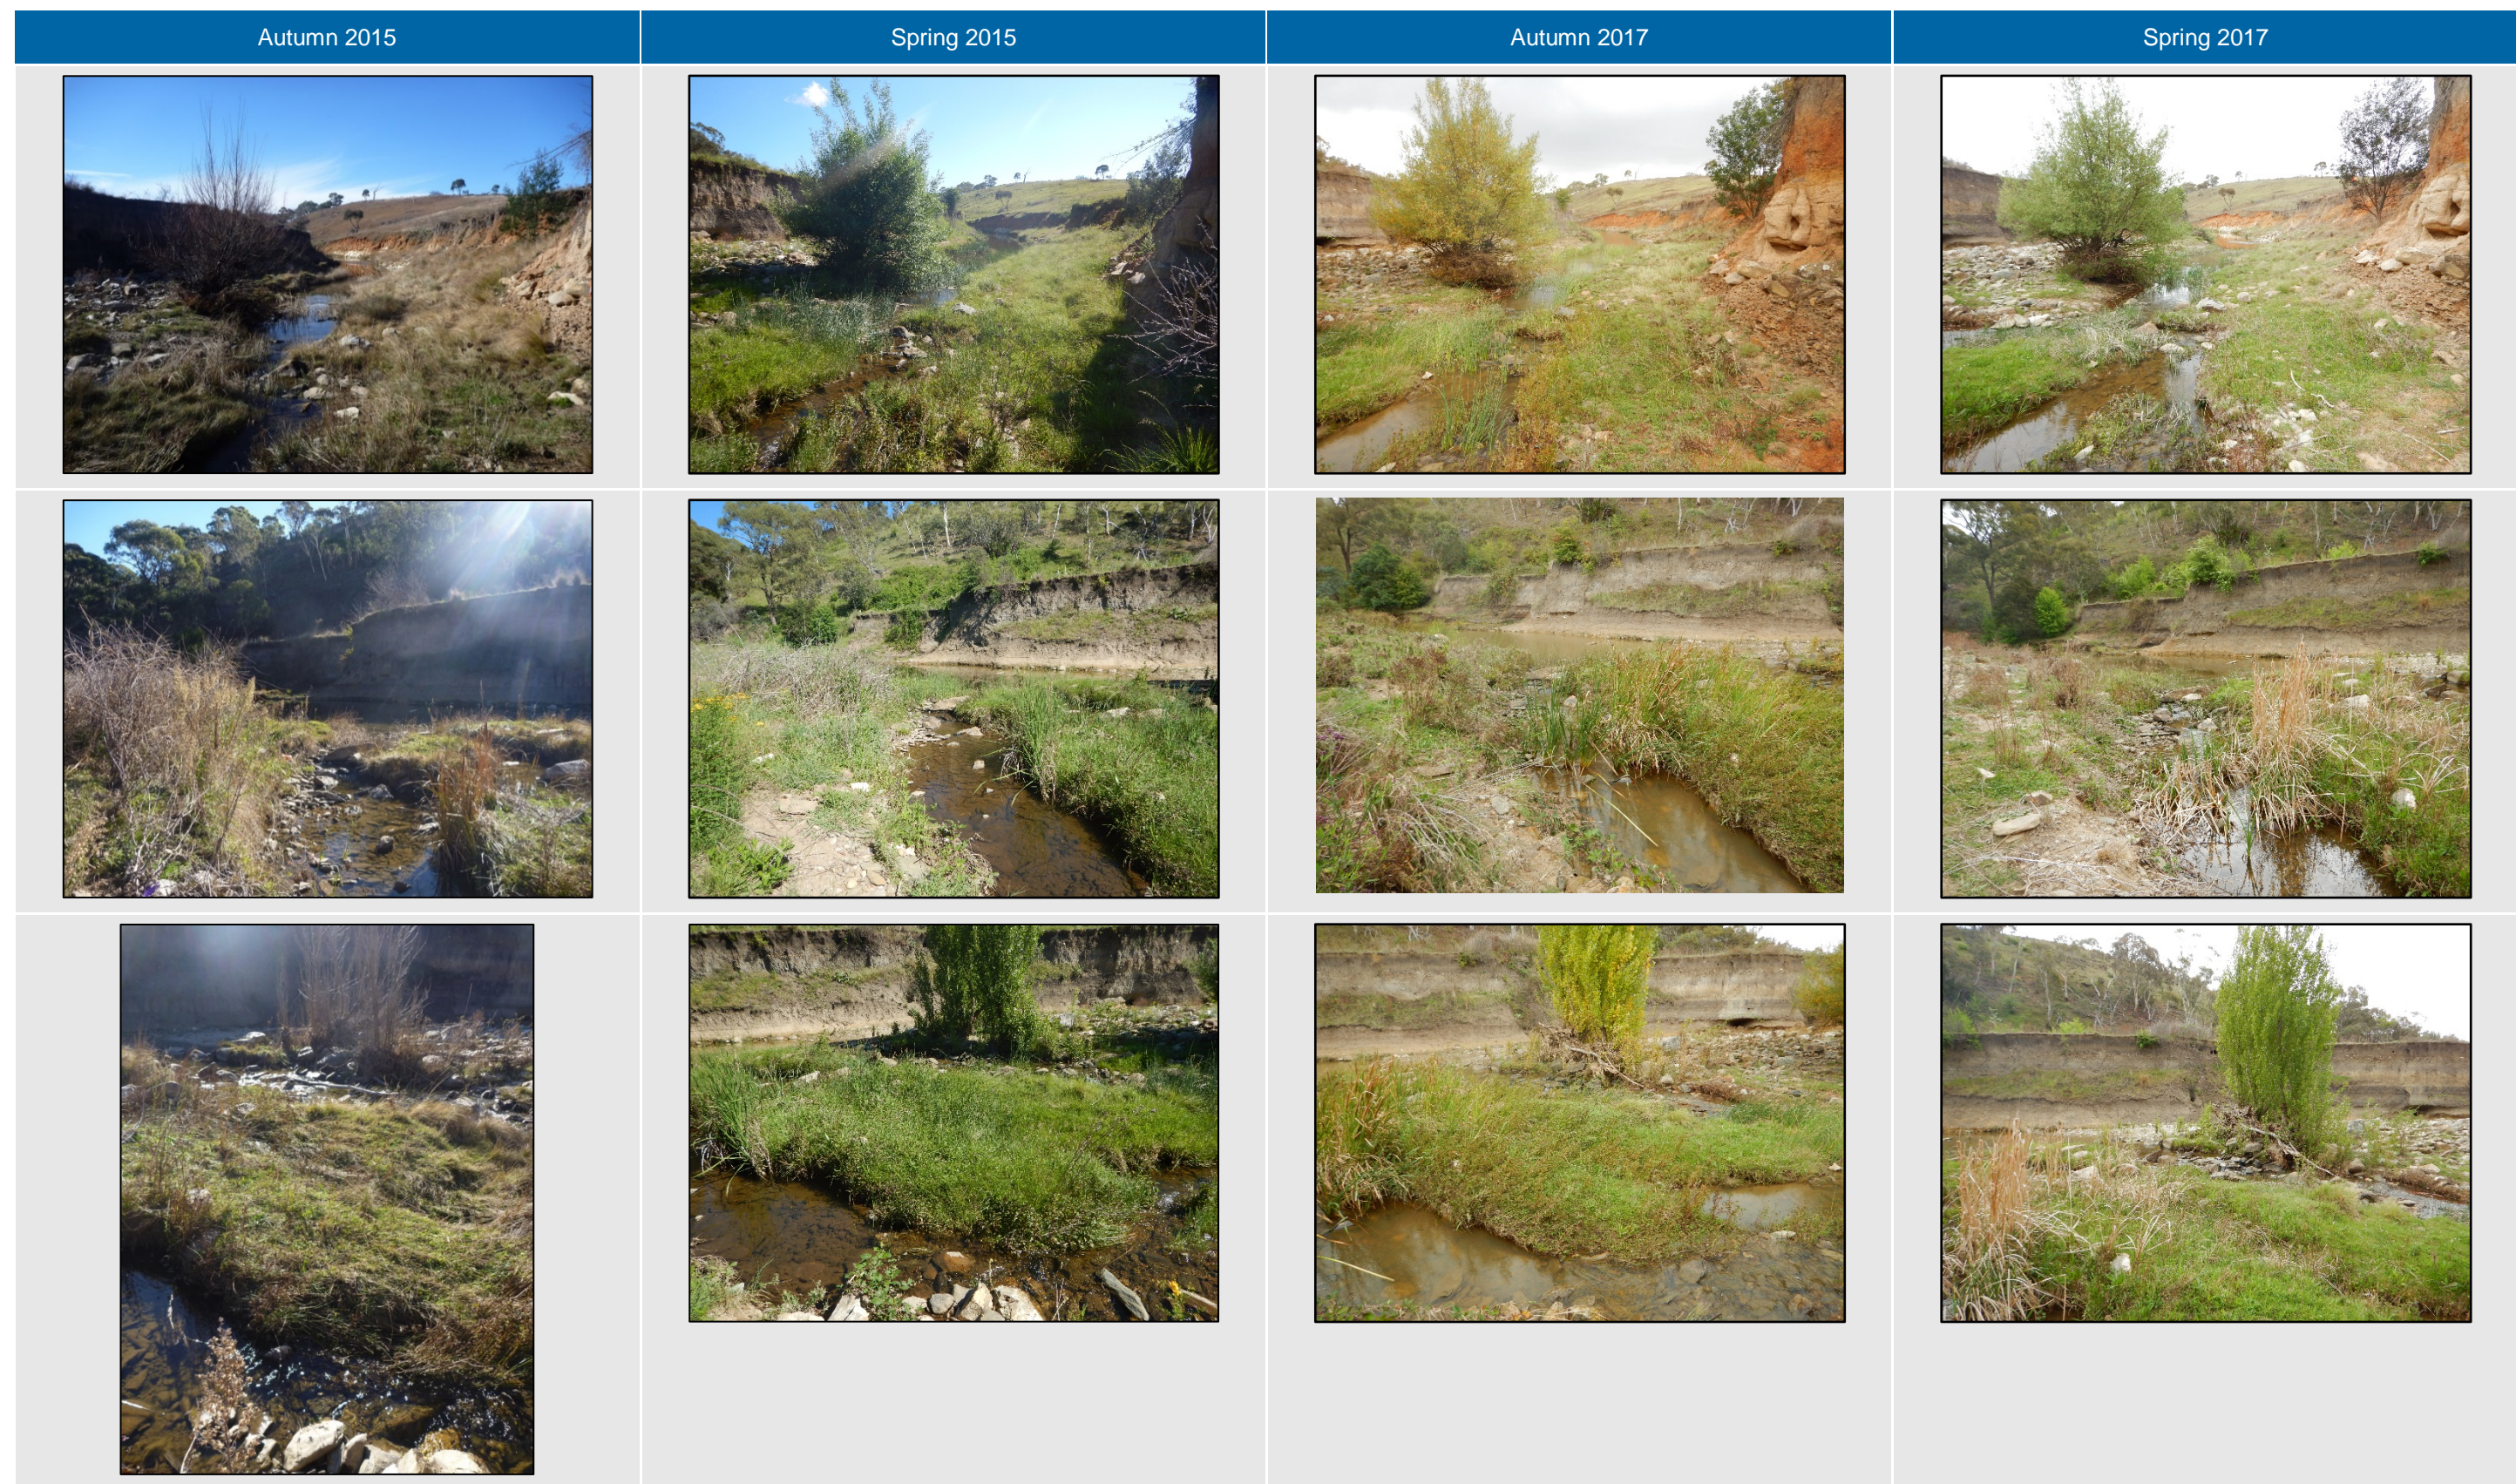
**Plate 4-7 Vegetation extent photo point 1 downstream of pool 29 showing upstream (a), downstream (b) and across the channel (c) from autumn 2015 (left) to spring 2017 (right)**

*In the MEMP **geomorphology** report it was pointed out that the area of greatest concern along Burra Creek is the downstream reach at BUR2c. There were no signs of any significant geomorphological changes at the photo monitoring locations in Burra Creek between spring 2015 and the current monitoring period. The creek channel appeared to be stable as did the creek banks, with no obvious slumping or collapse observed from the photographs – even at the most vulnerable sites (i.e. Pool 29 and BUR2c).*

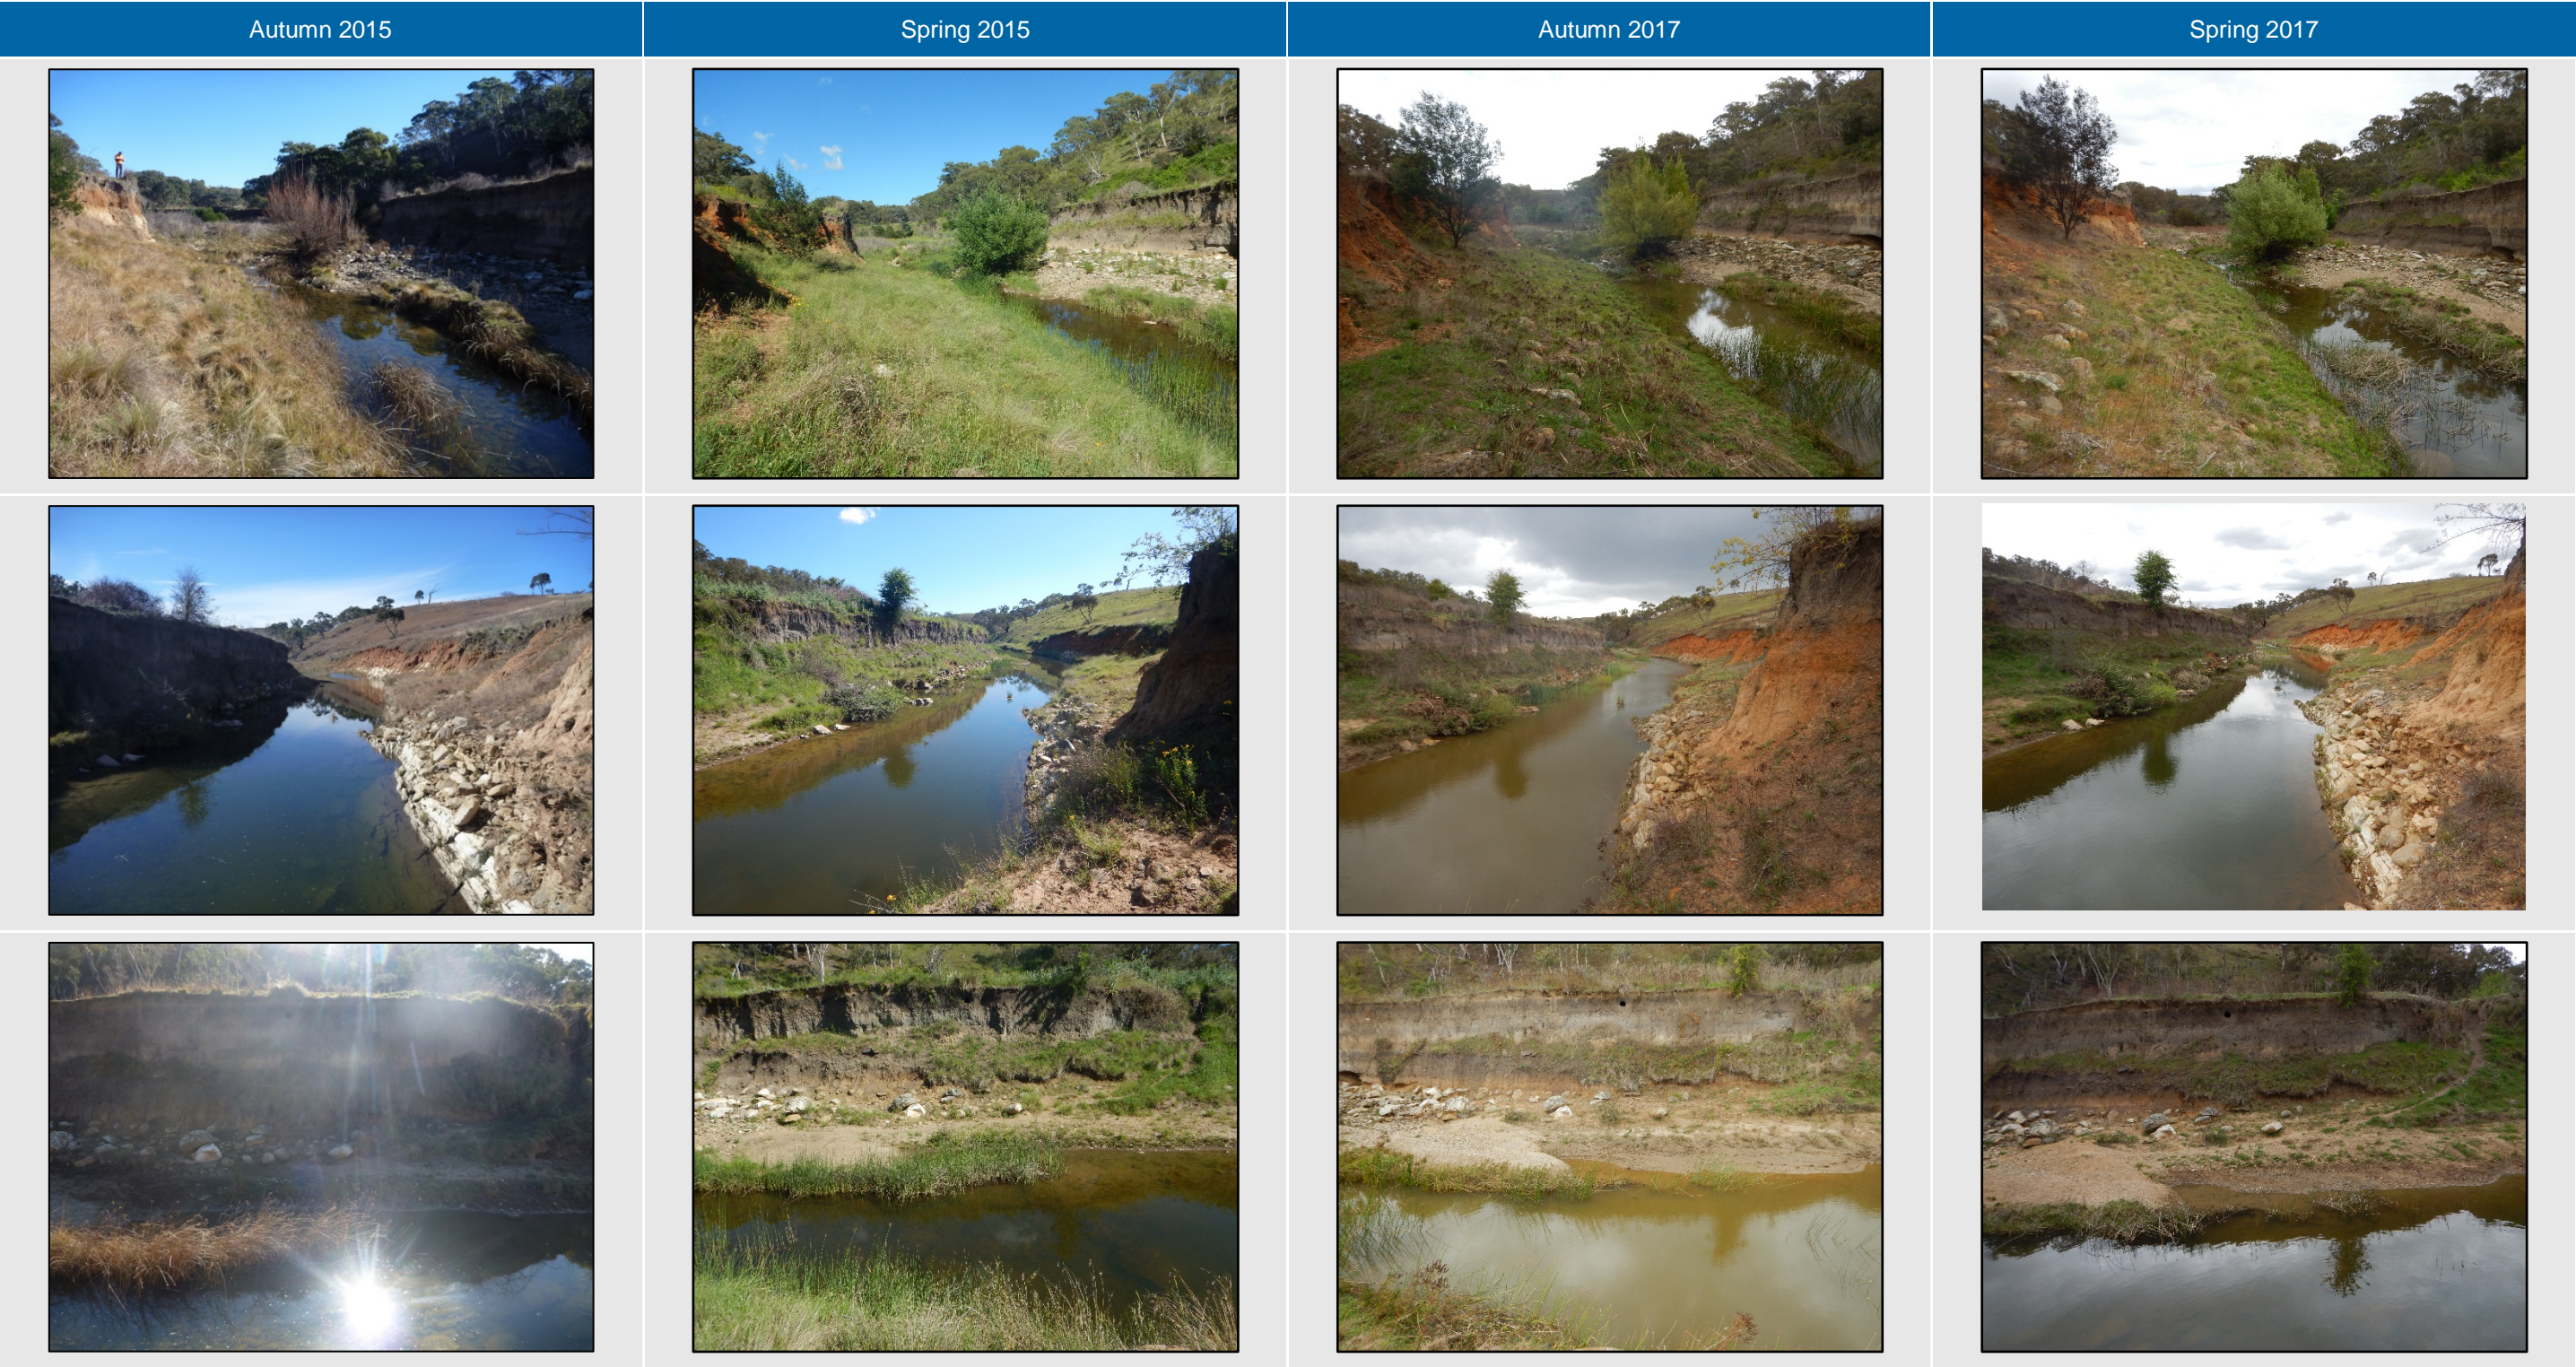
**Plate 4-8 Vegetation extent photo point 2 downstream of pool 29 showing upstream (a), downstream (b) and across the channel (c) from autumn 2015 (left) to spring 2017 (right)**

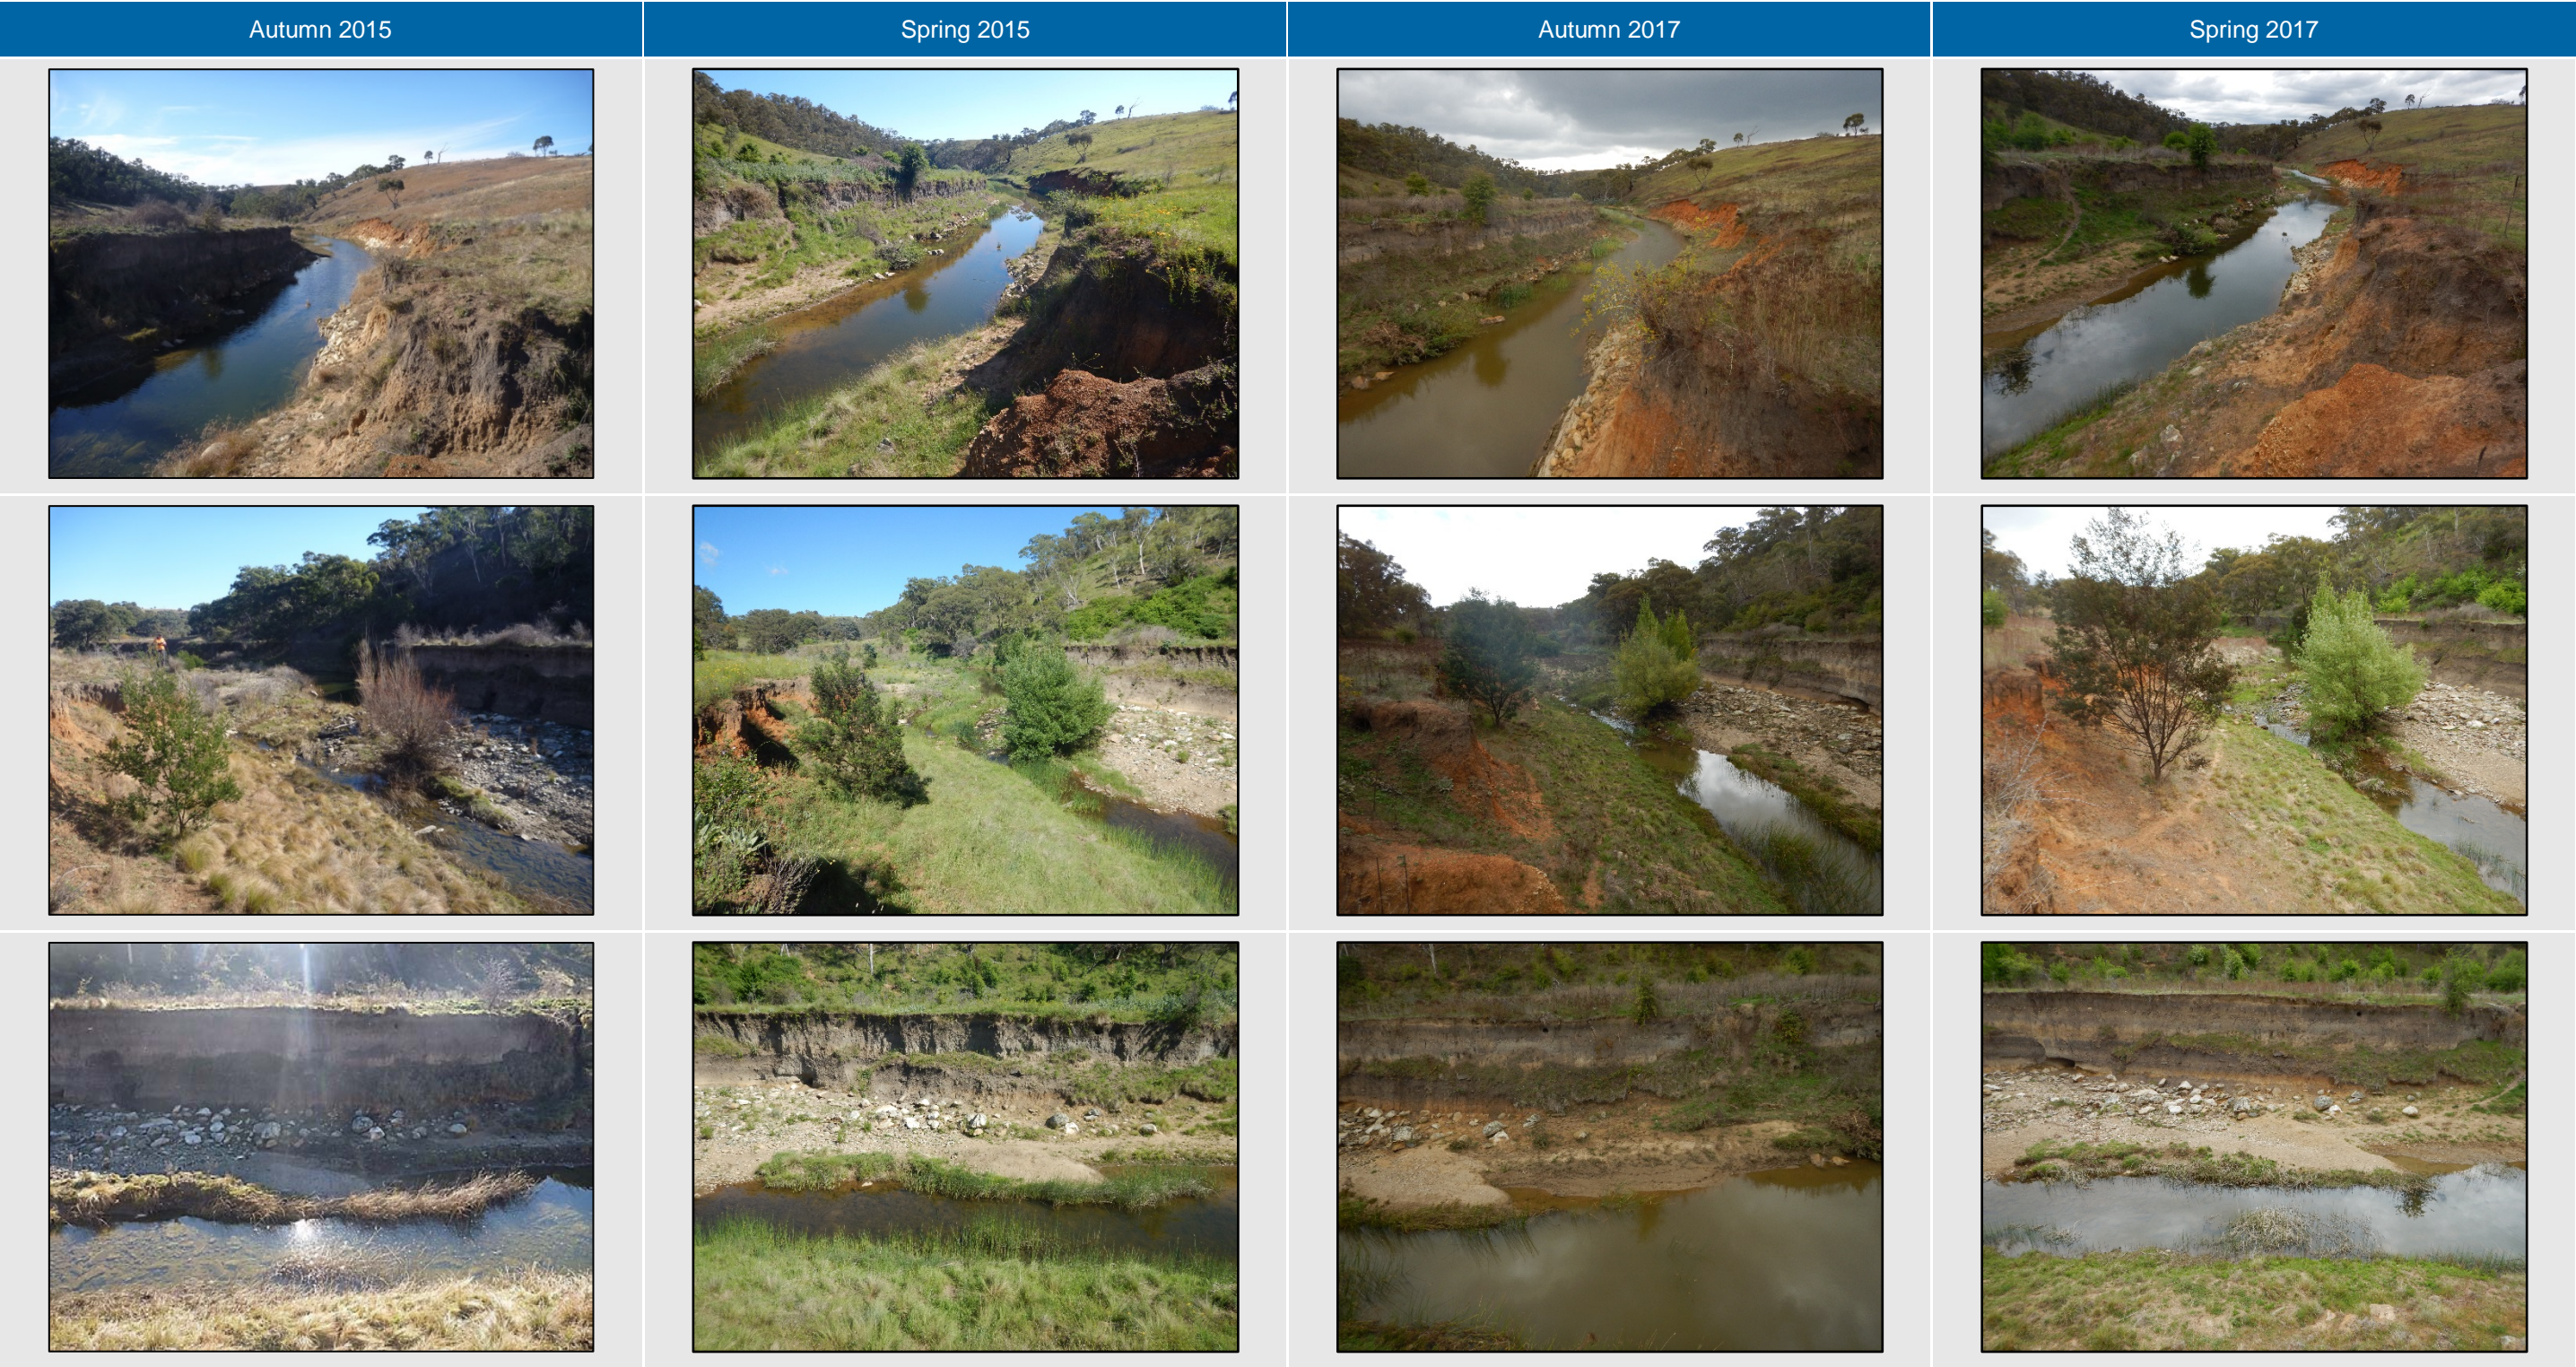
**Plate 4-9 Vegetation extent photo point 3 downstream of pool 29 showing upstream (a), downstream (b) and across the channel (c) from autumn 2015 (left) to spring 2017 (right)**

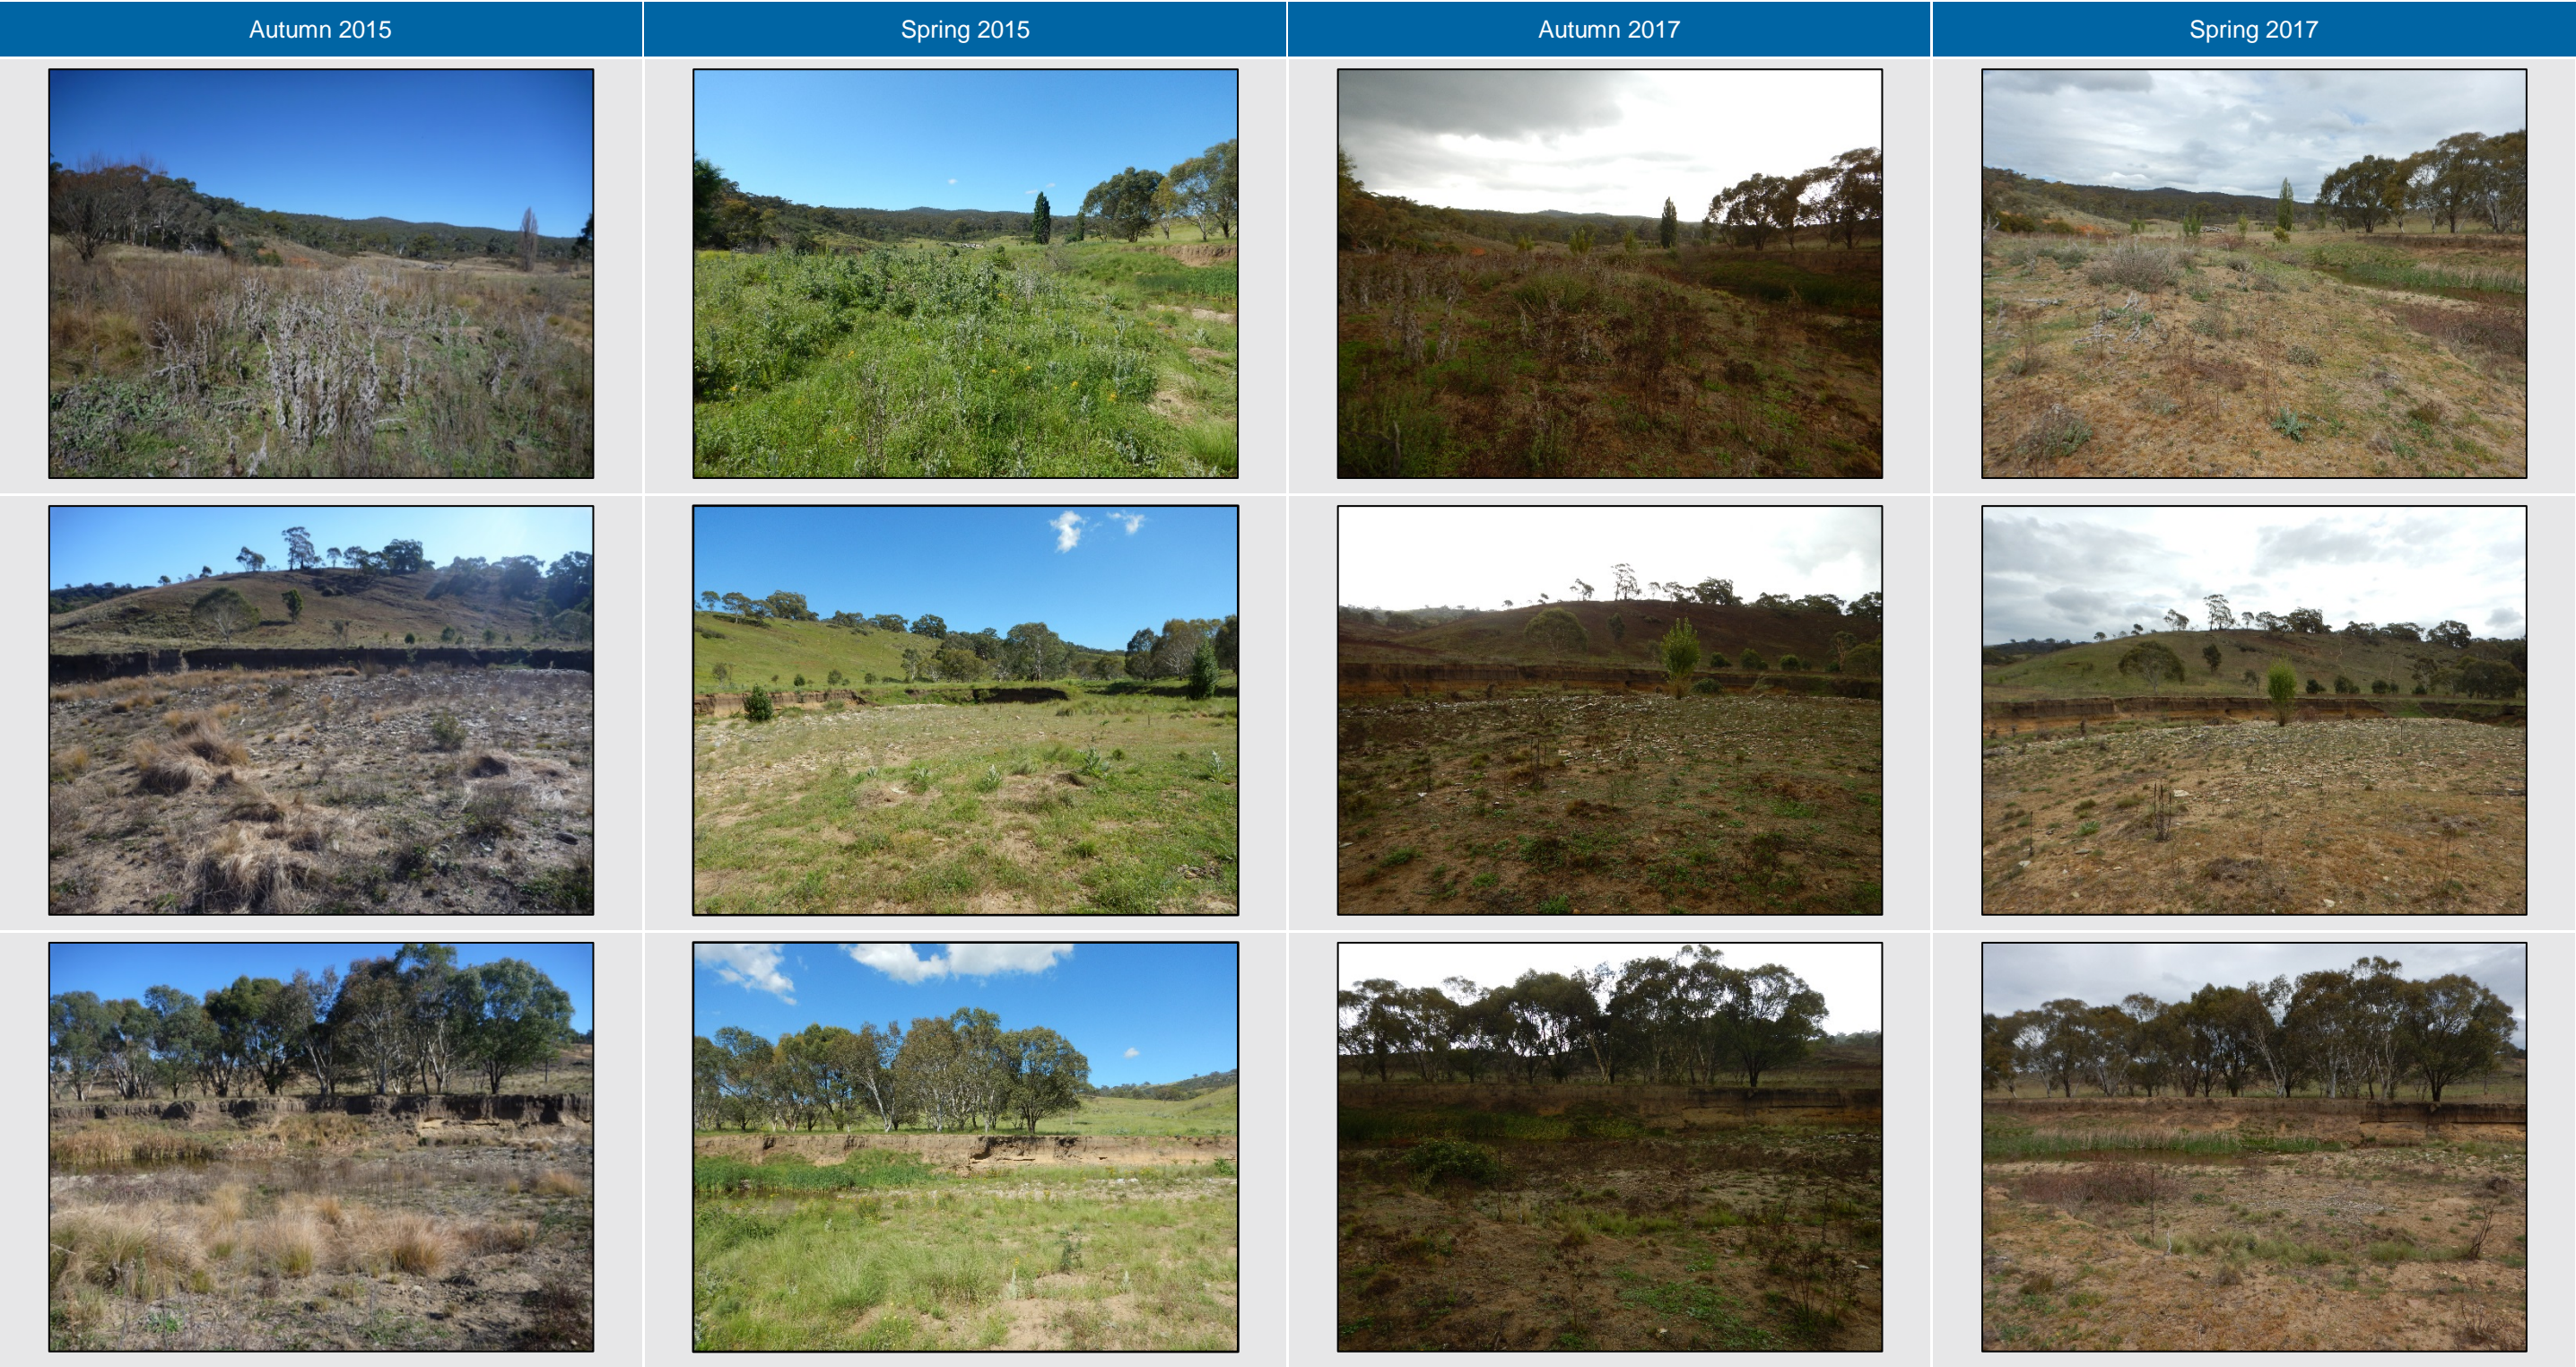
**Plate 4-10 Vegetation extent photo point 1 at BUR2c showing upstream (a), downstream (b) and across the channel (c) from autumn 2015 (left) to spring 2017 (right)**

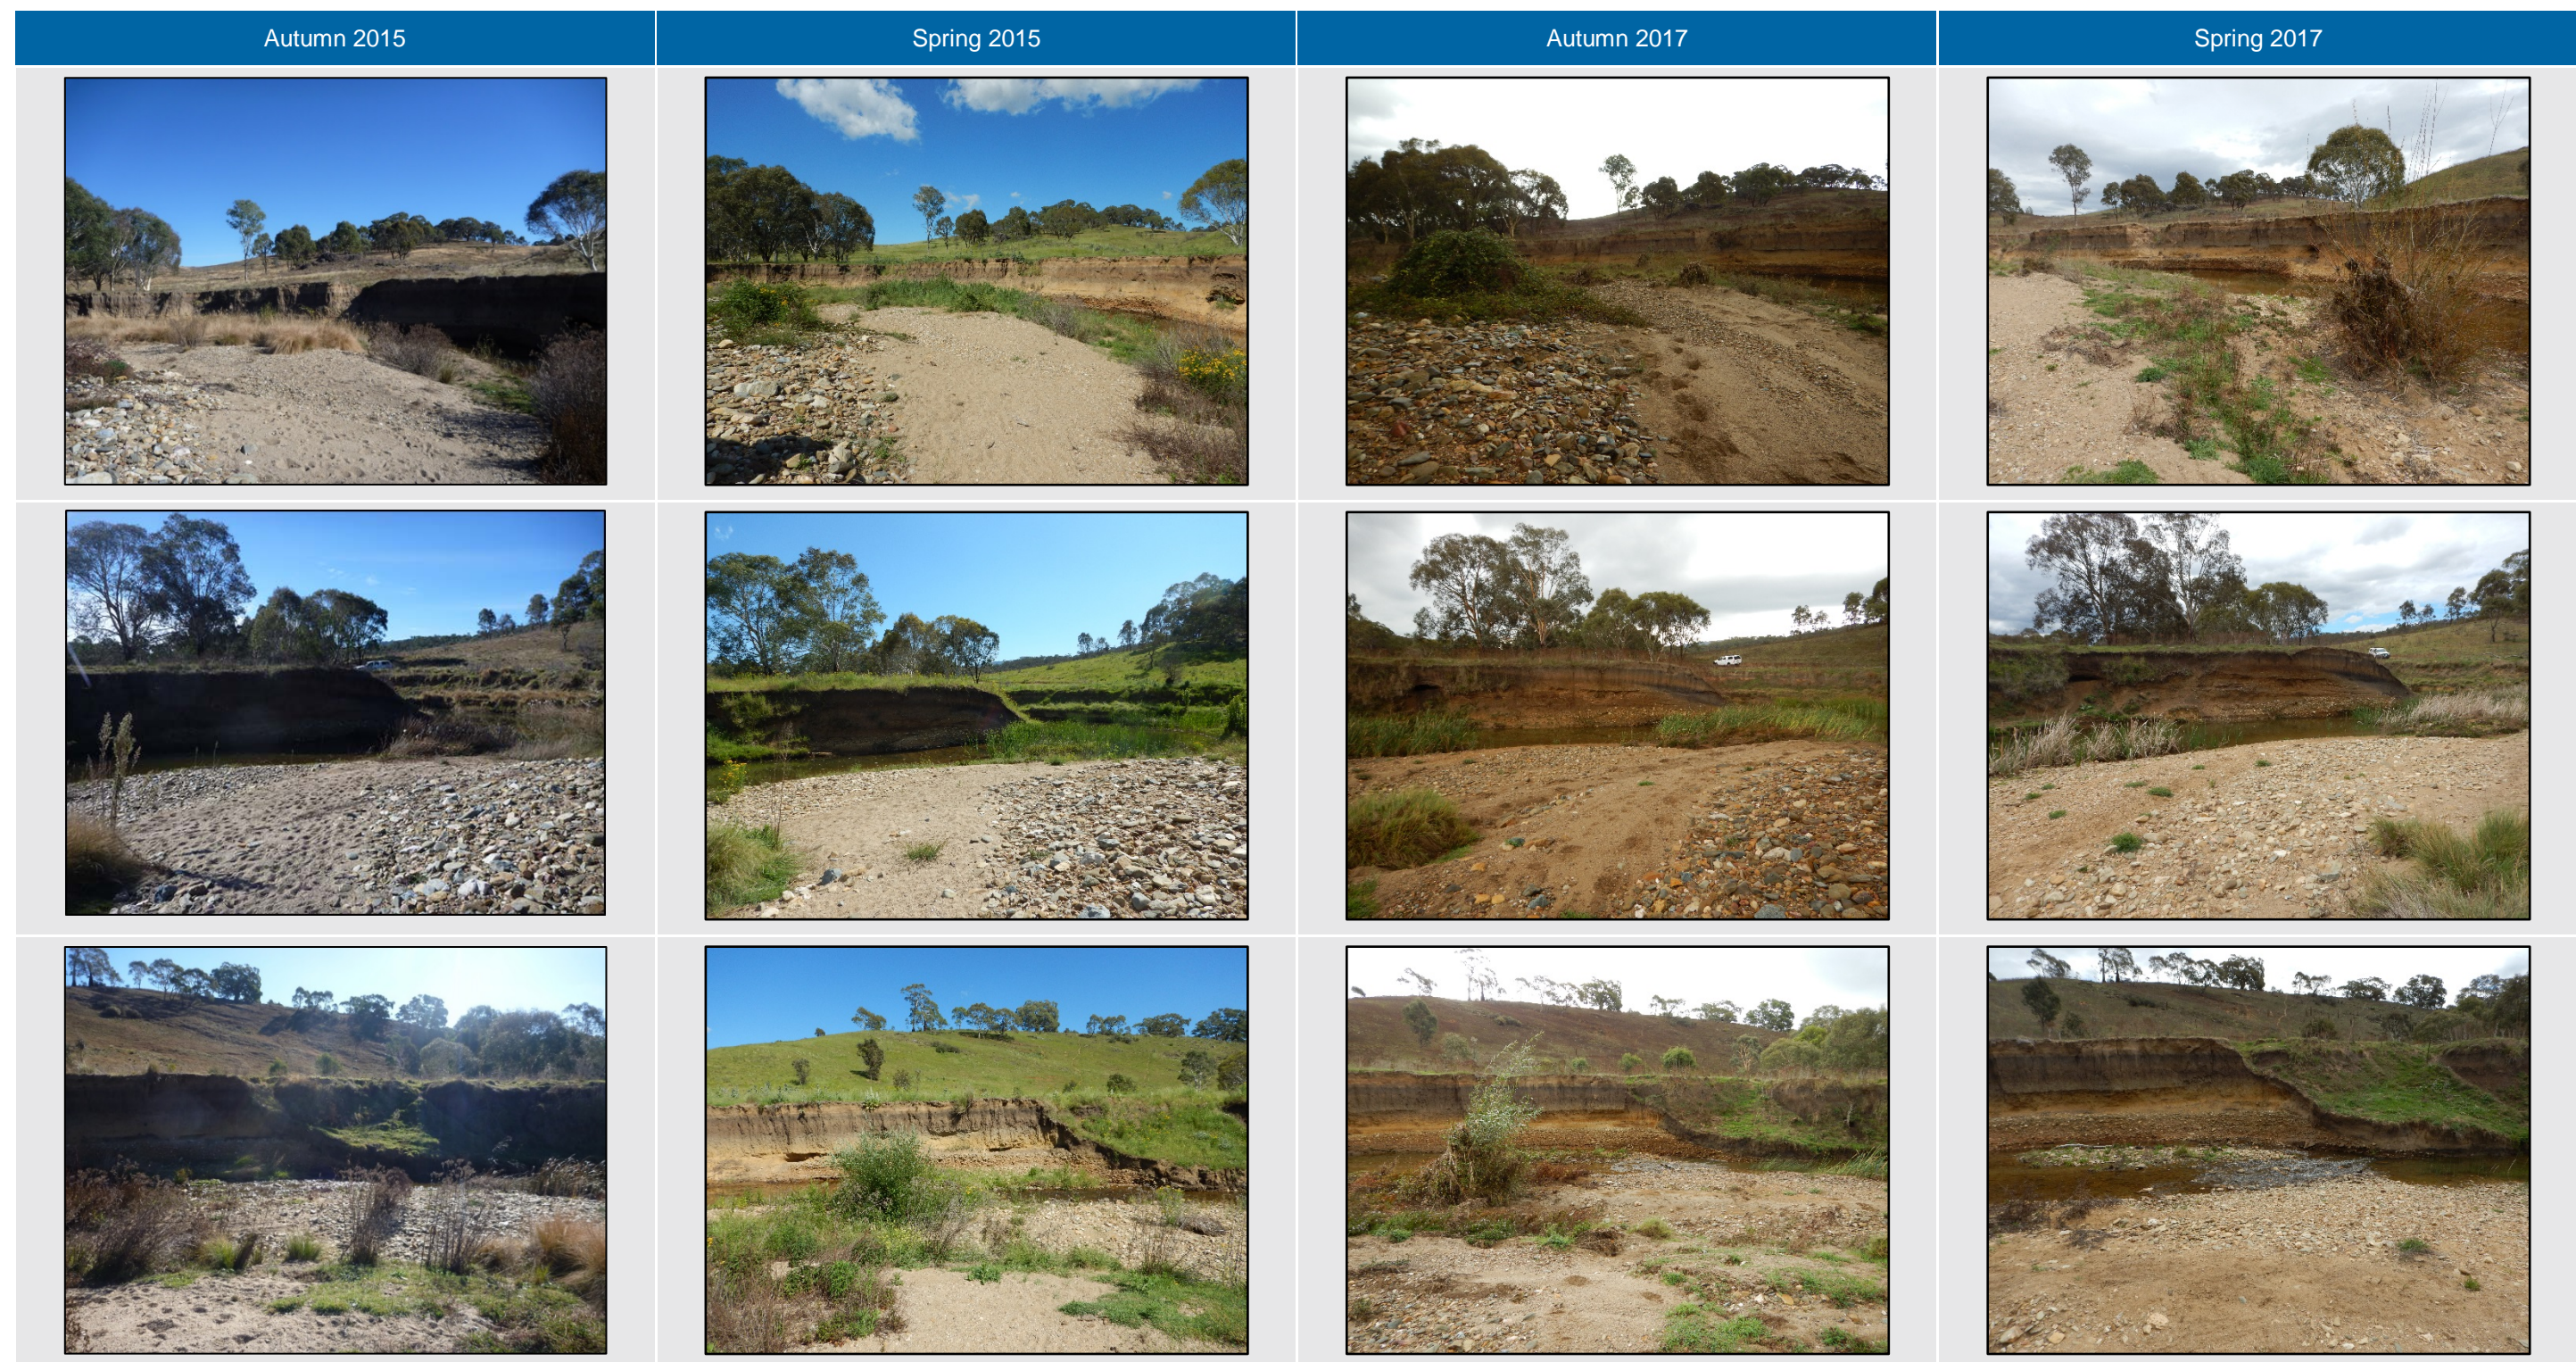
**Plate 4-11 Vegetation extent photo point 2 at BUR2c showing upstream (a), downstream (b) and across the channel (c) from autumn 2015 (left) to spring 2017 (right)**
