## **Icon Water**

# **Murrumbidgee Ecological Monitoring Program 2015-21 Sentinel Monitoring - Autumn 2018**

September 2018

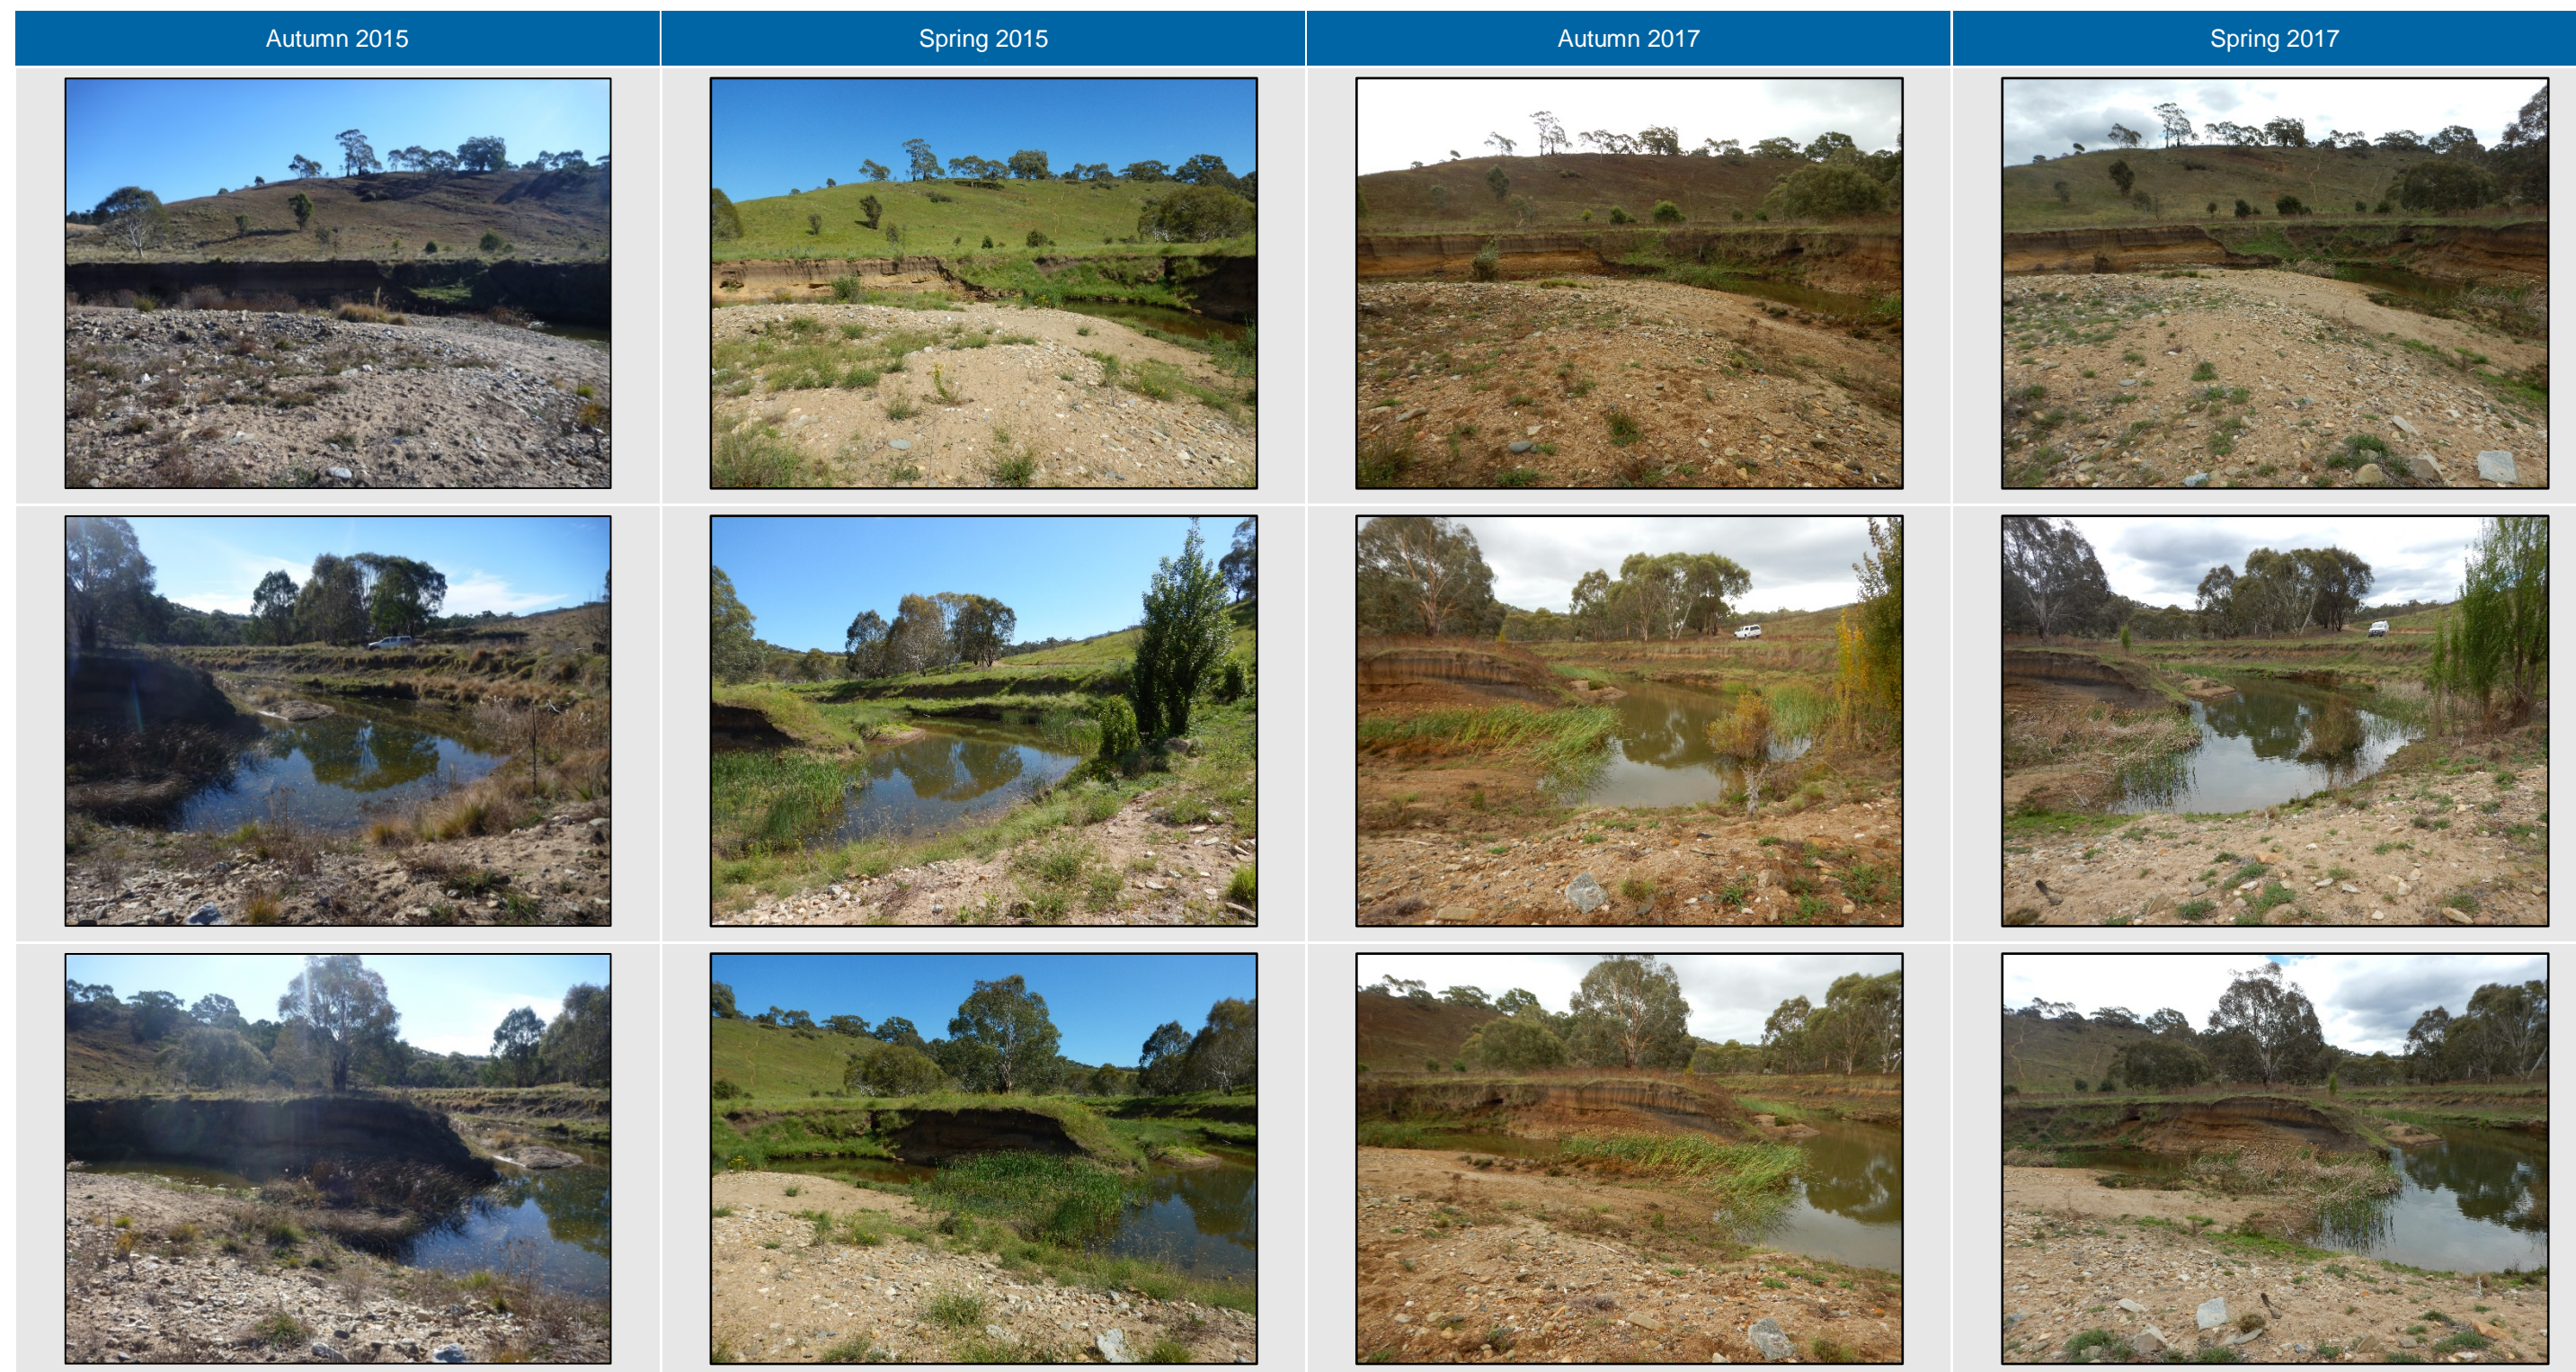
**Plate 4-12 Vegetation extent photo point 3 at BUR2c showing upstream (a), downstream (b) and across the channel (c) from autumn 2015 (left) to spring 2017 (right)**

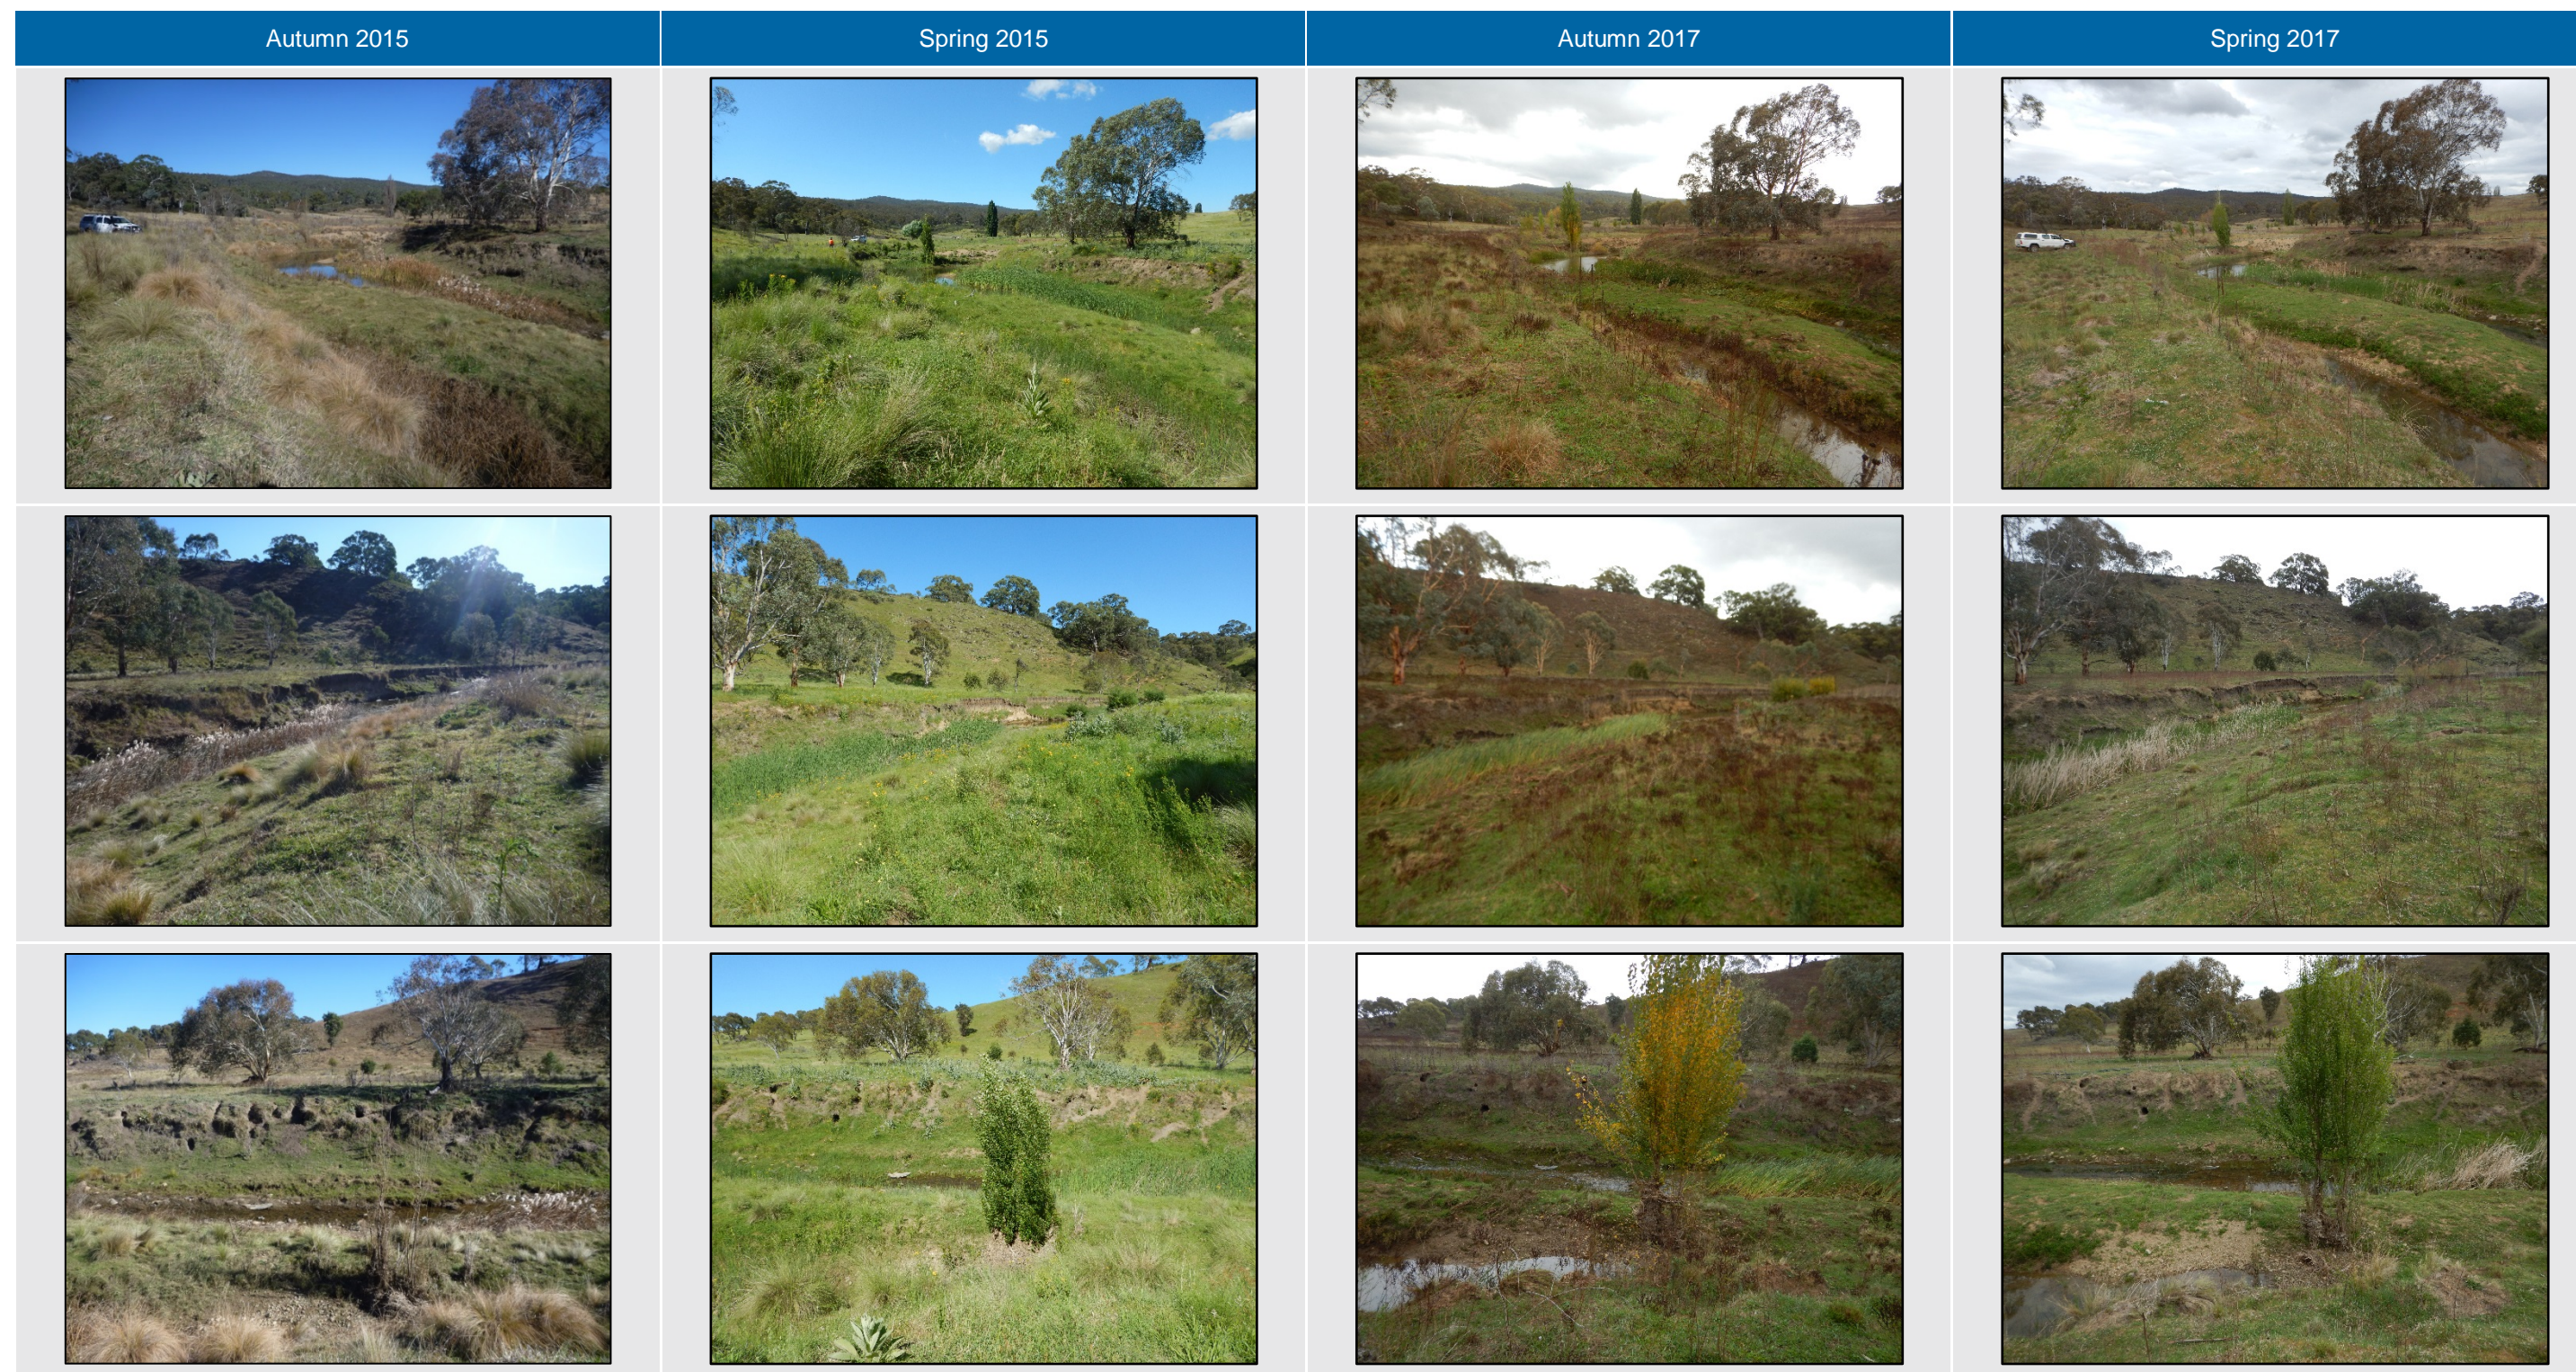
**Plate 4-13 Vegetation extent photo point 4 at BUR2c showing upstream (a), downstream (b) and across the channel (c) from autumn 2015 (left) to spring 2017 (right)**

While BUR2c is surrounded by numerous large *Eucalyptus* spp. on the floodplain, there is minimal vegetation close to the creek to provide any shading (Plate 4-10). Within the macro channel there are large sections covered by grasses, mostly *Poa* spp., while weeds such as *Verbascum* sp. (Mullein), *Hypericum perforatum* (St. John's Wort), *Rubus fruticosus* (Blackberry) and various thistle species are also frequent. Several small *Populus* sp. (Poplar) and *Salix* sp. (Willow) are present within the macro channel as well as two larger *Populus* sp. (approximately 3-4 m tall), which are the tallest individuals within the channel. Instream vegetation is dominated by *Typha orientalis* (Broad leaf Cumbungi) with numerous large stands visible from all photo points (i.e. Plate 4-10 to Plate 4-13), while *Schoenoplectus validus* (Great Bulrush) is also present in smaller patches.

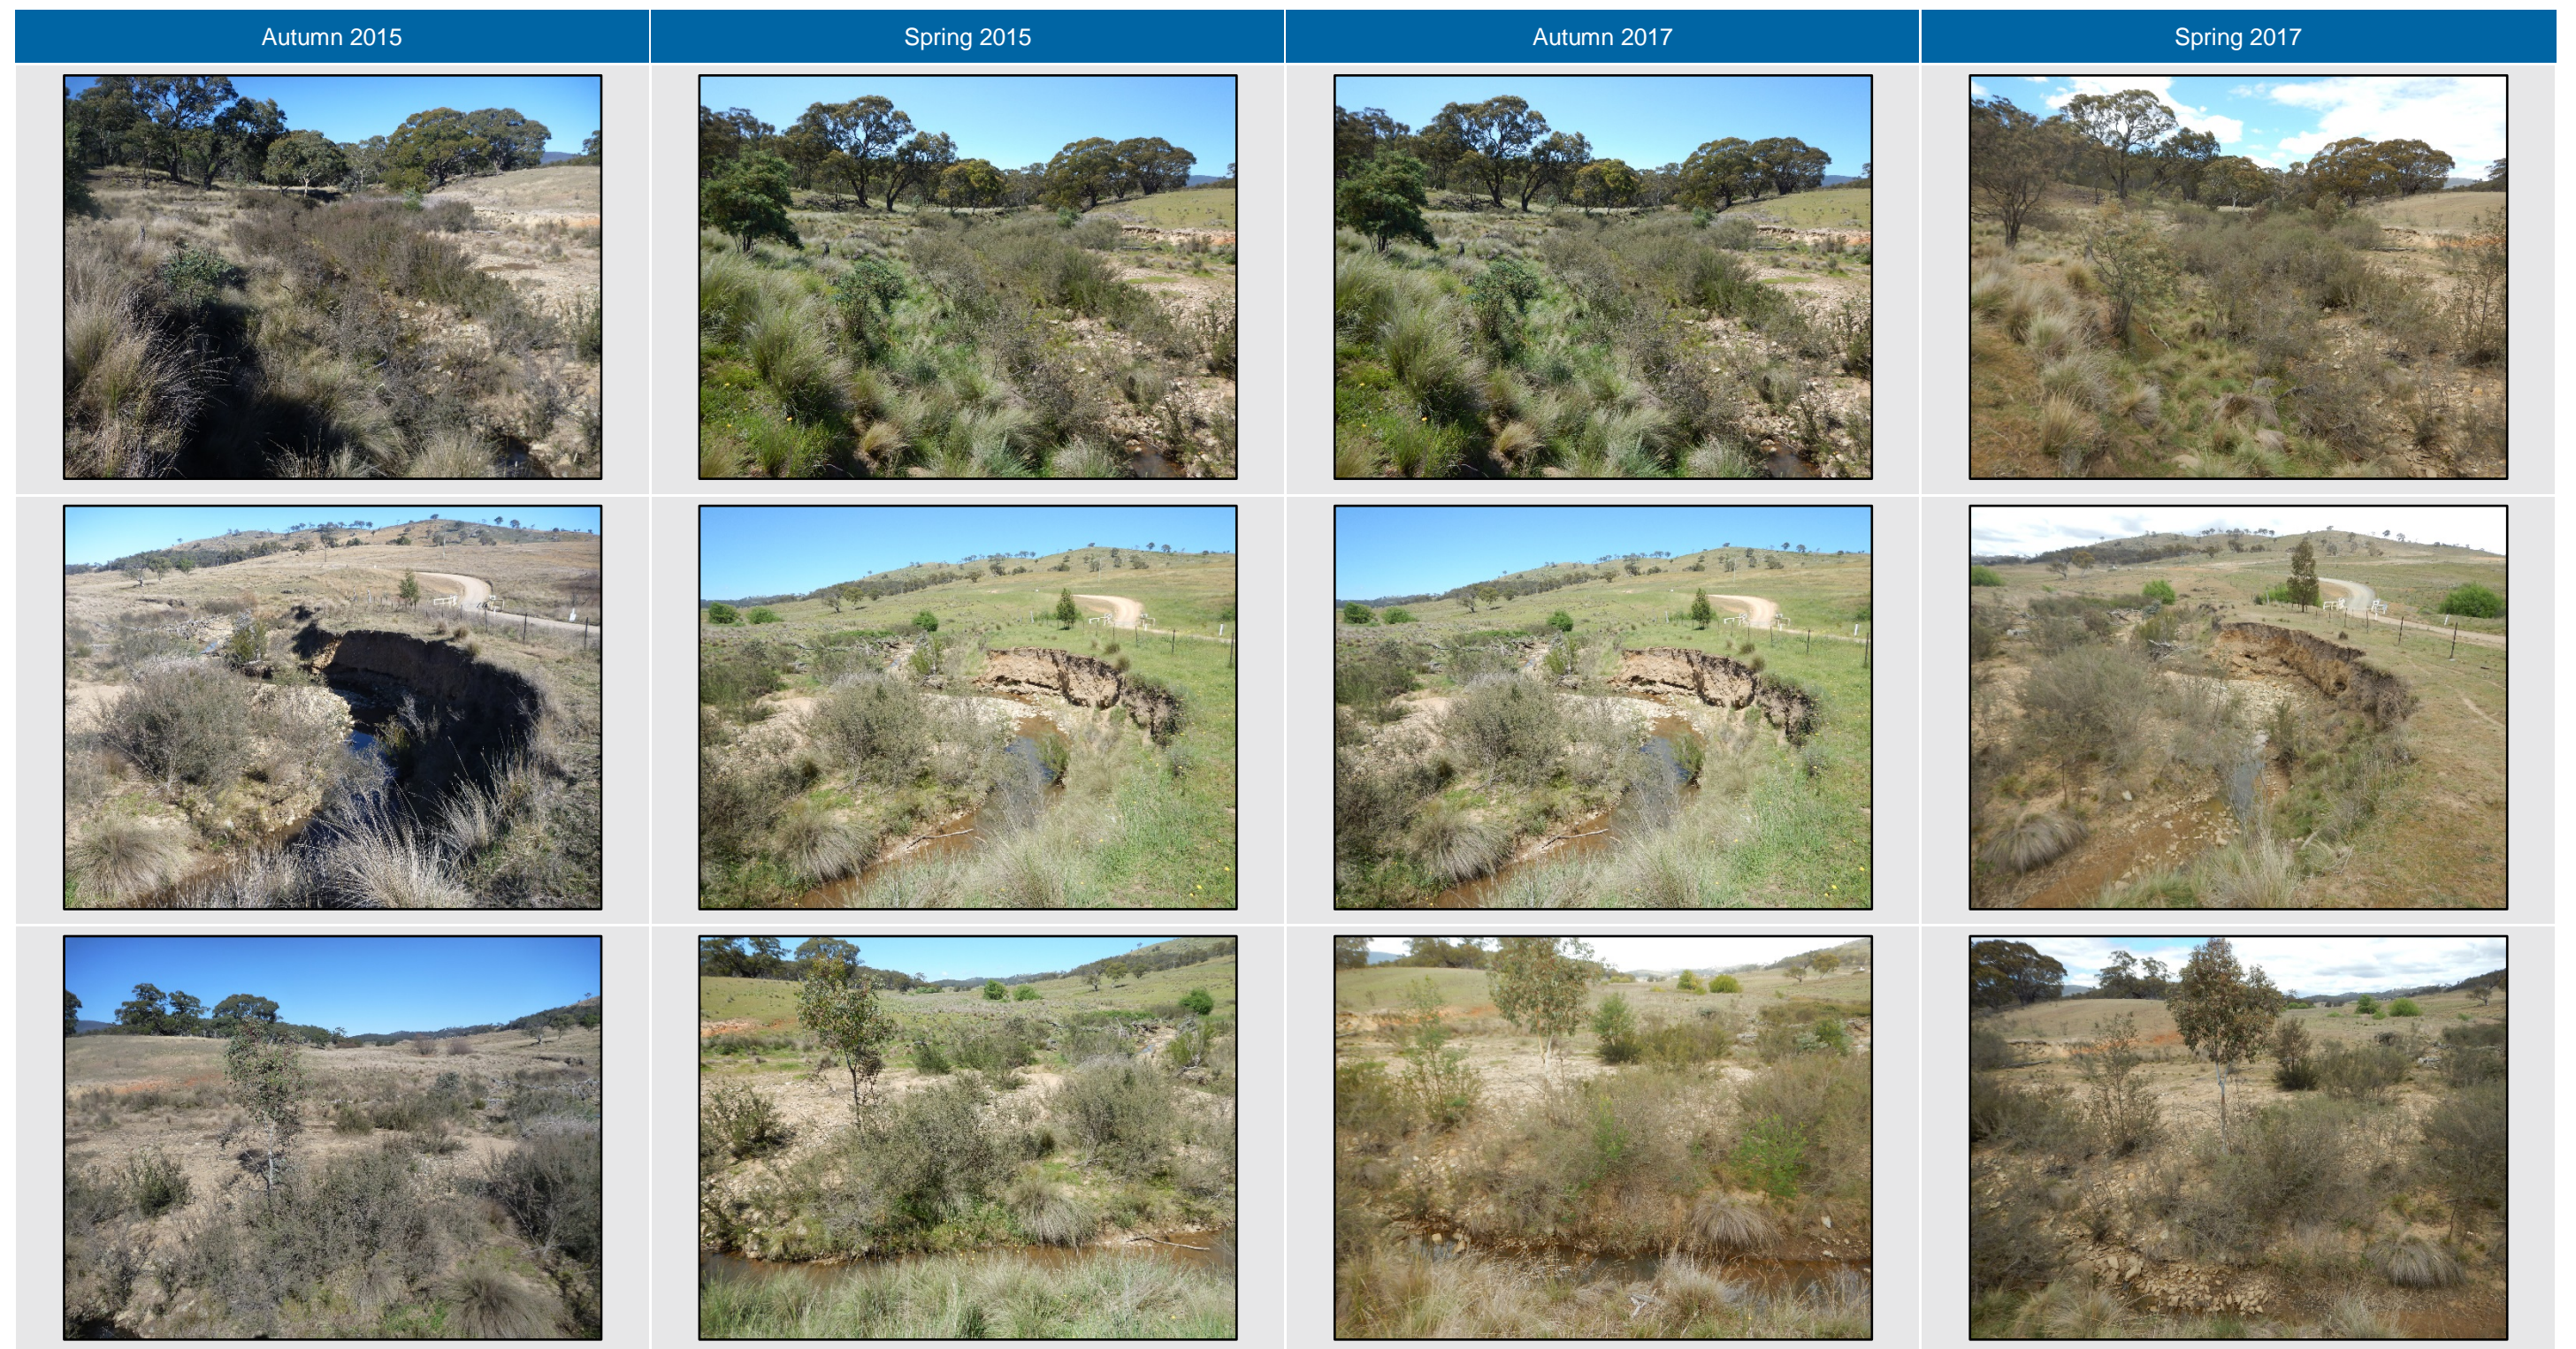
**Plate 4-14 Geomorphology photo point 1 at BUR 1a showing upstream (a), downstream (b) and across the channel (c) from autumn 2015 (left) to spring 2017 (right)**

The conditions at BUR 1a have remained relatively unchanged since spring 2015.

Vast sections of the site are subject to significant erosion and bank slumping (Plate 4-14); however since spring 2015, there has been no significant changes, based on the photo records Plate 4-14 to Plate 4-16.

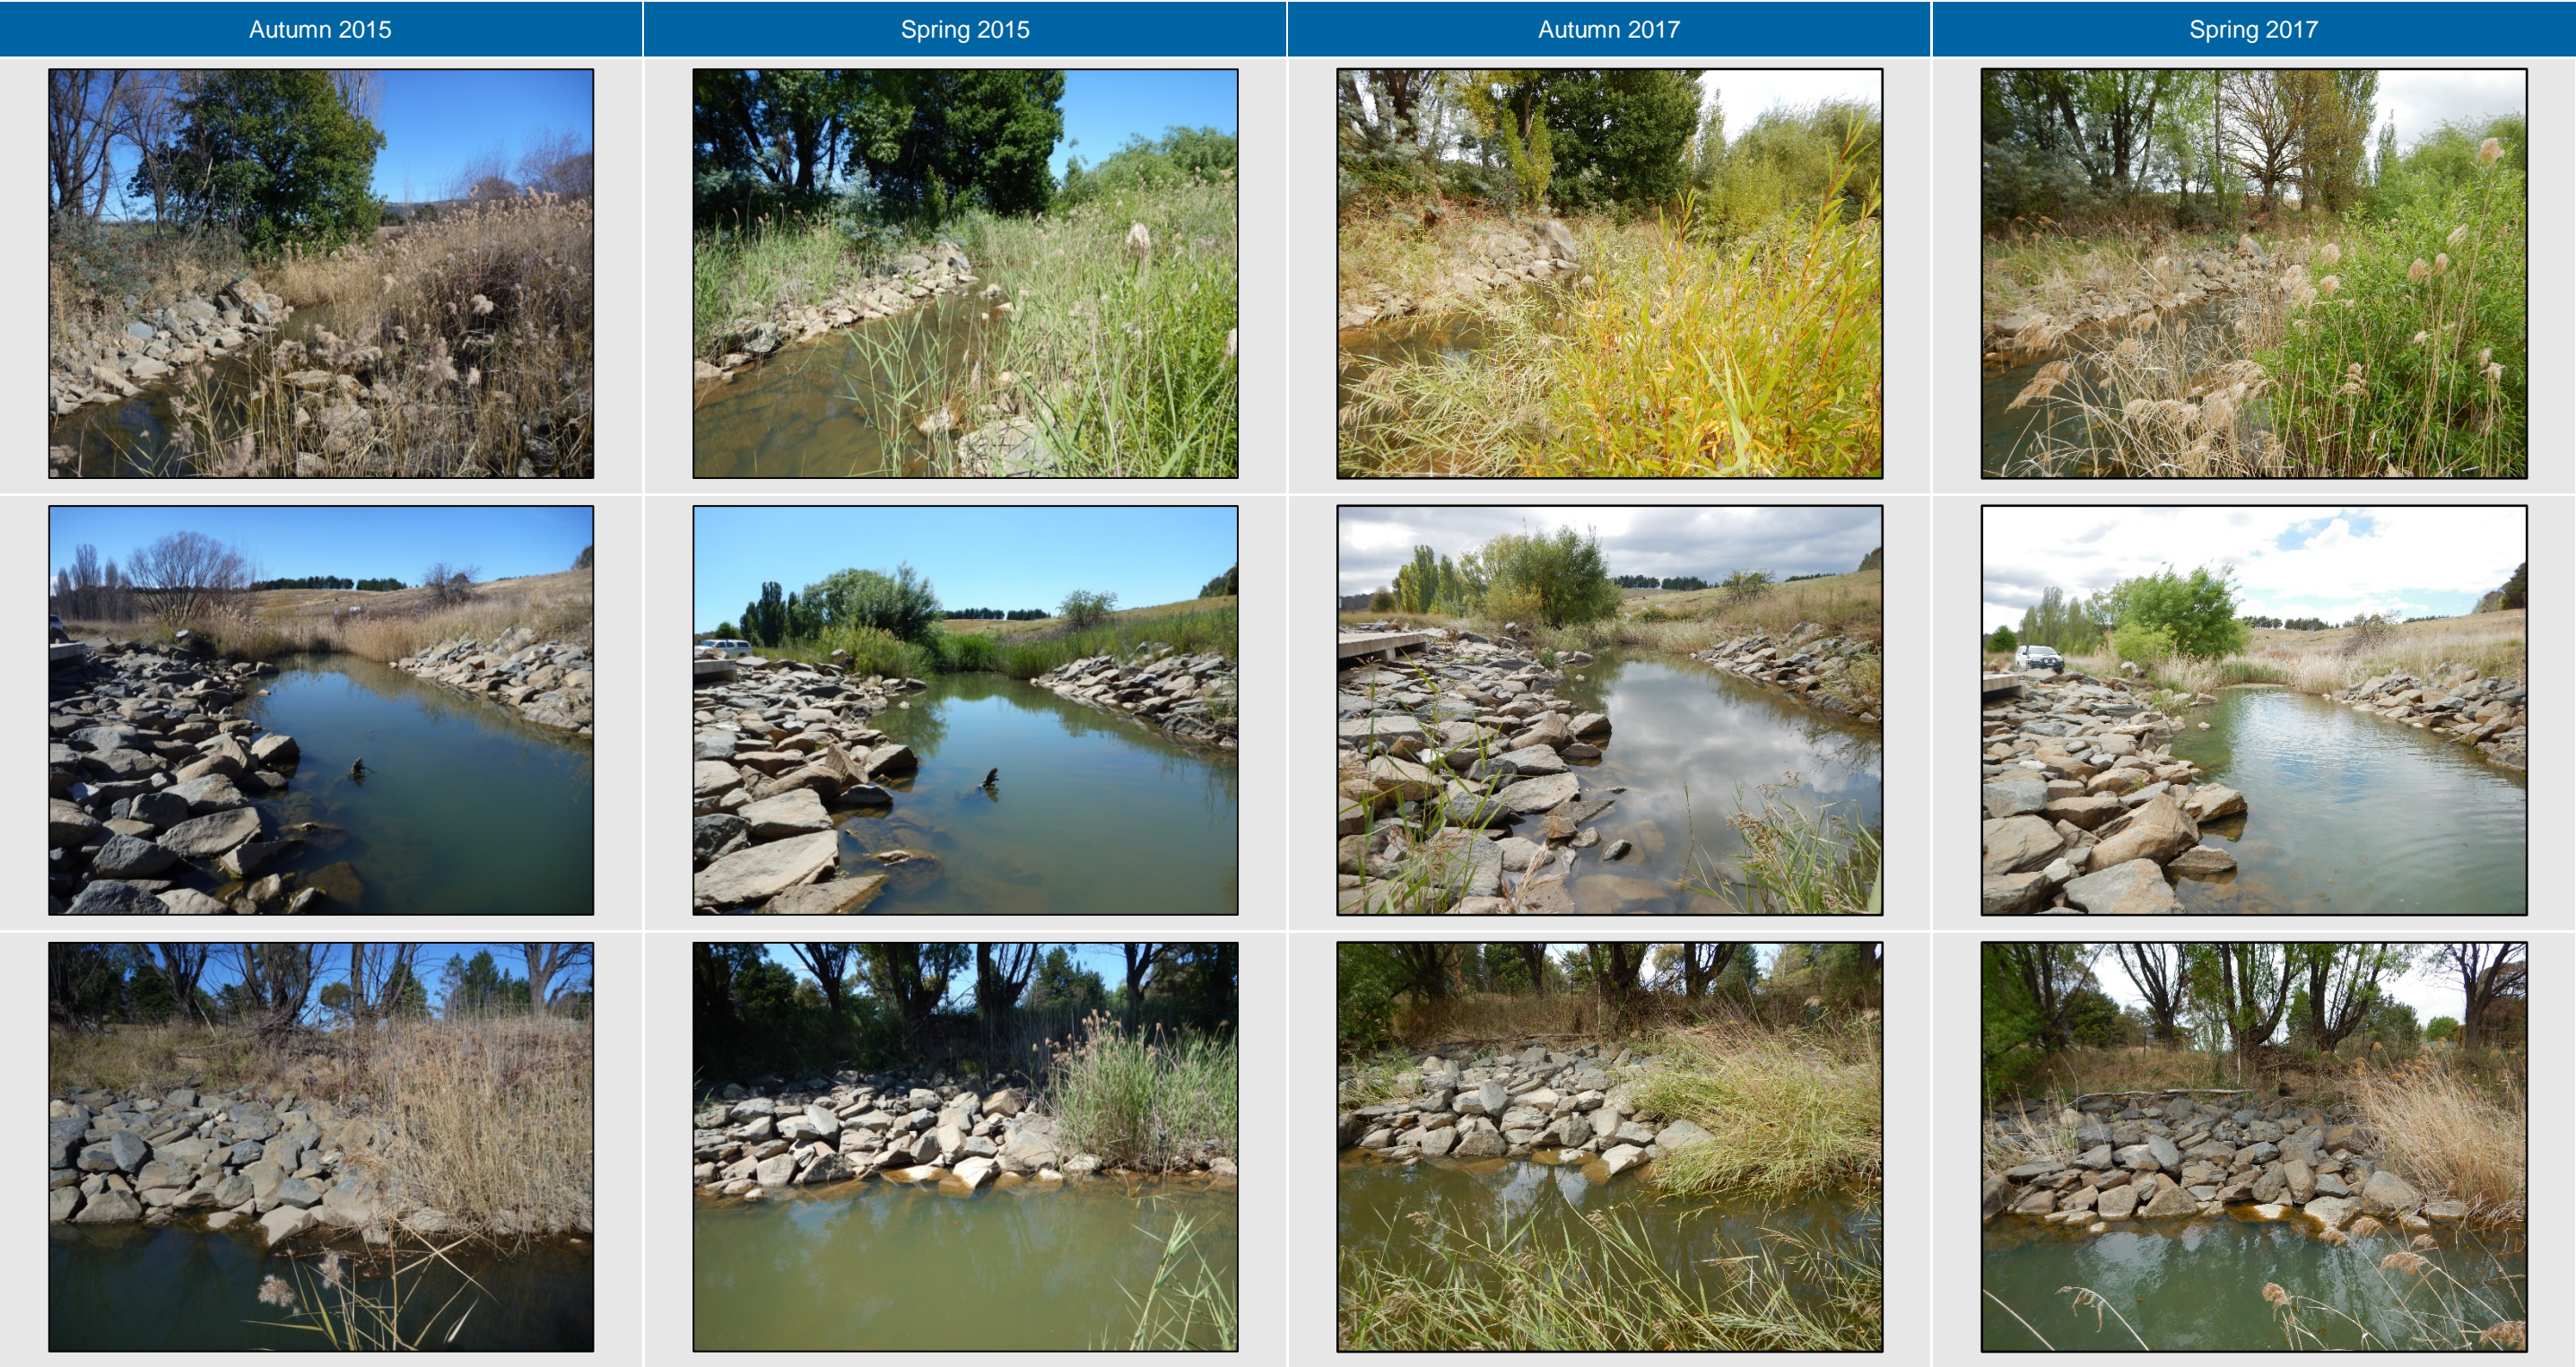
**Plate 4-19 Geomorphology photo point 1 at BUR2 showing upstream (a), downstream (b) and across the channel (c) from autumn 2015 (left) to spring 2017 (right)**

Downstream of the causeway the creek banks are well protected by the large established *Salix* sp. (Willow) (Plate 4-19). The discharge pool has shown no geomorphological changes since spring 2015. Four photo points were collected at BUR2 during spring 2015 and are presented in Plate 4-19 through to Plate 4-22

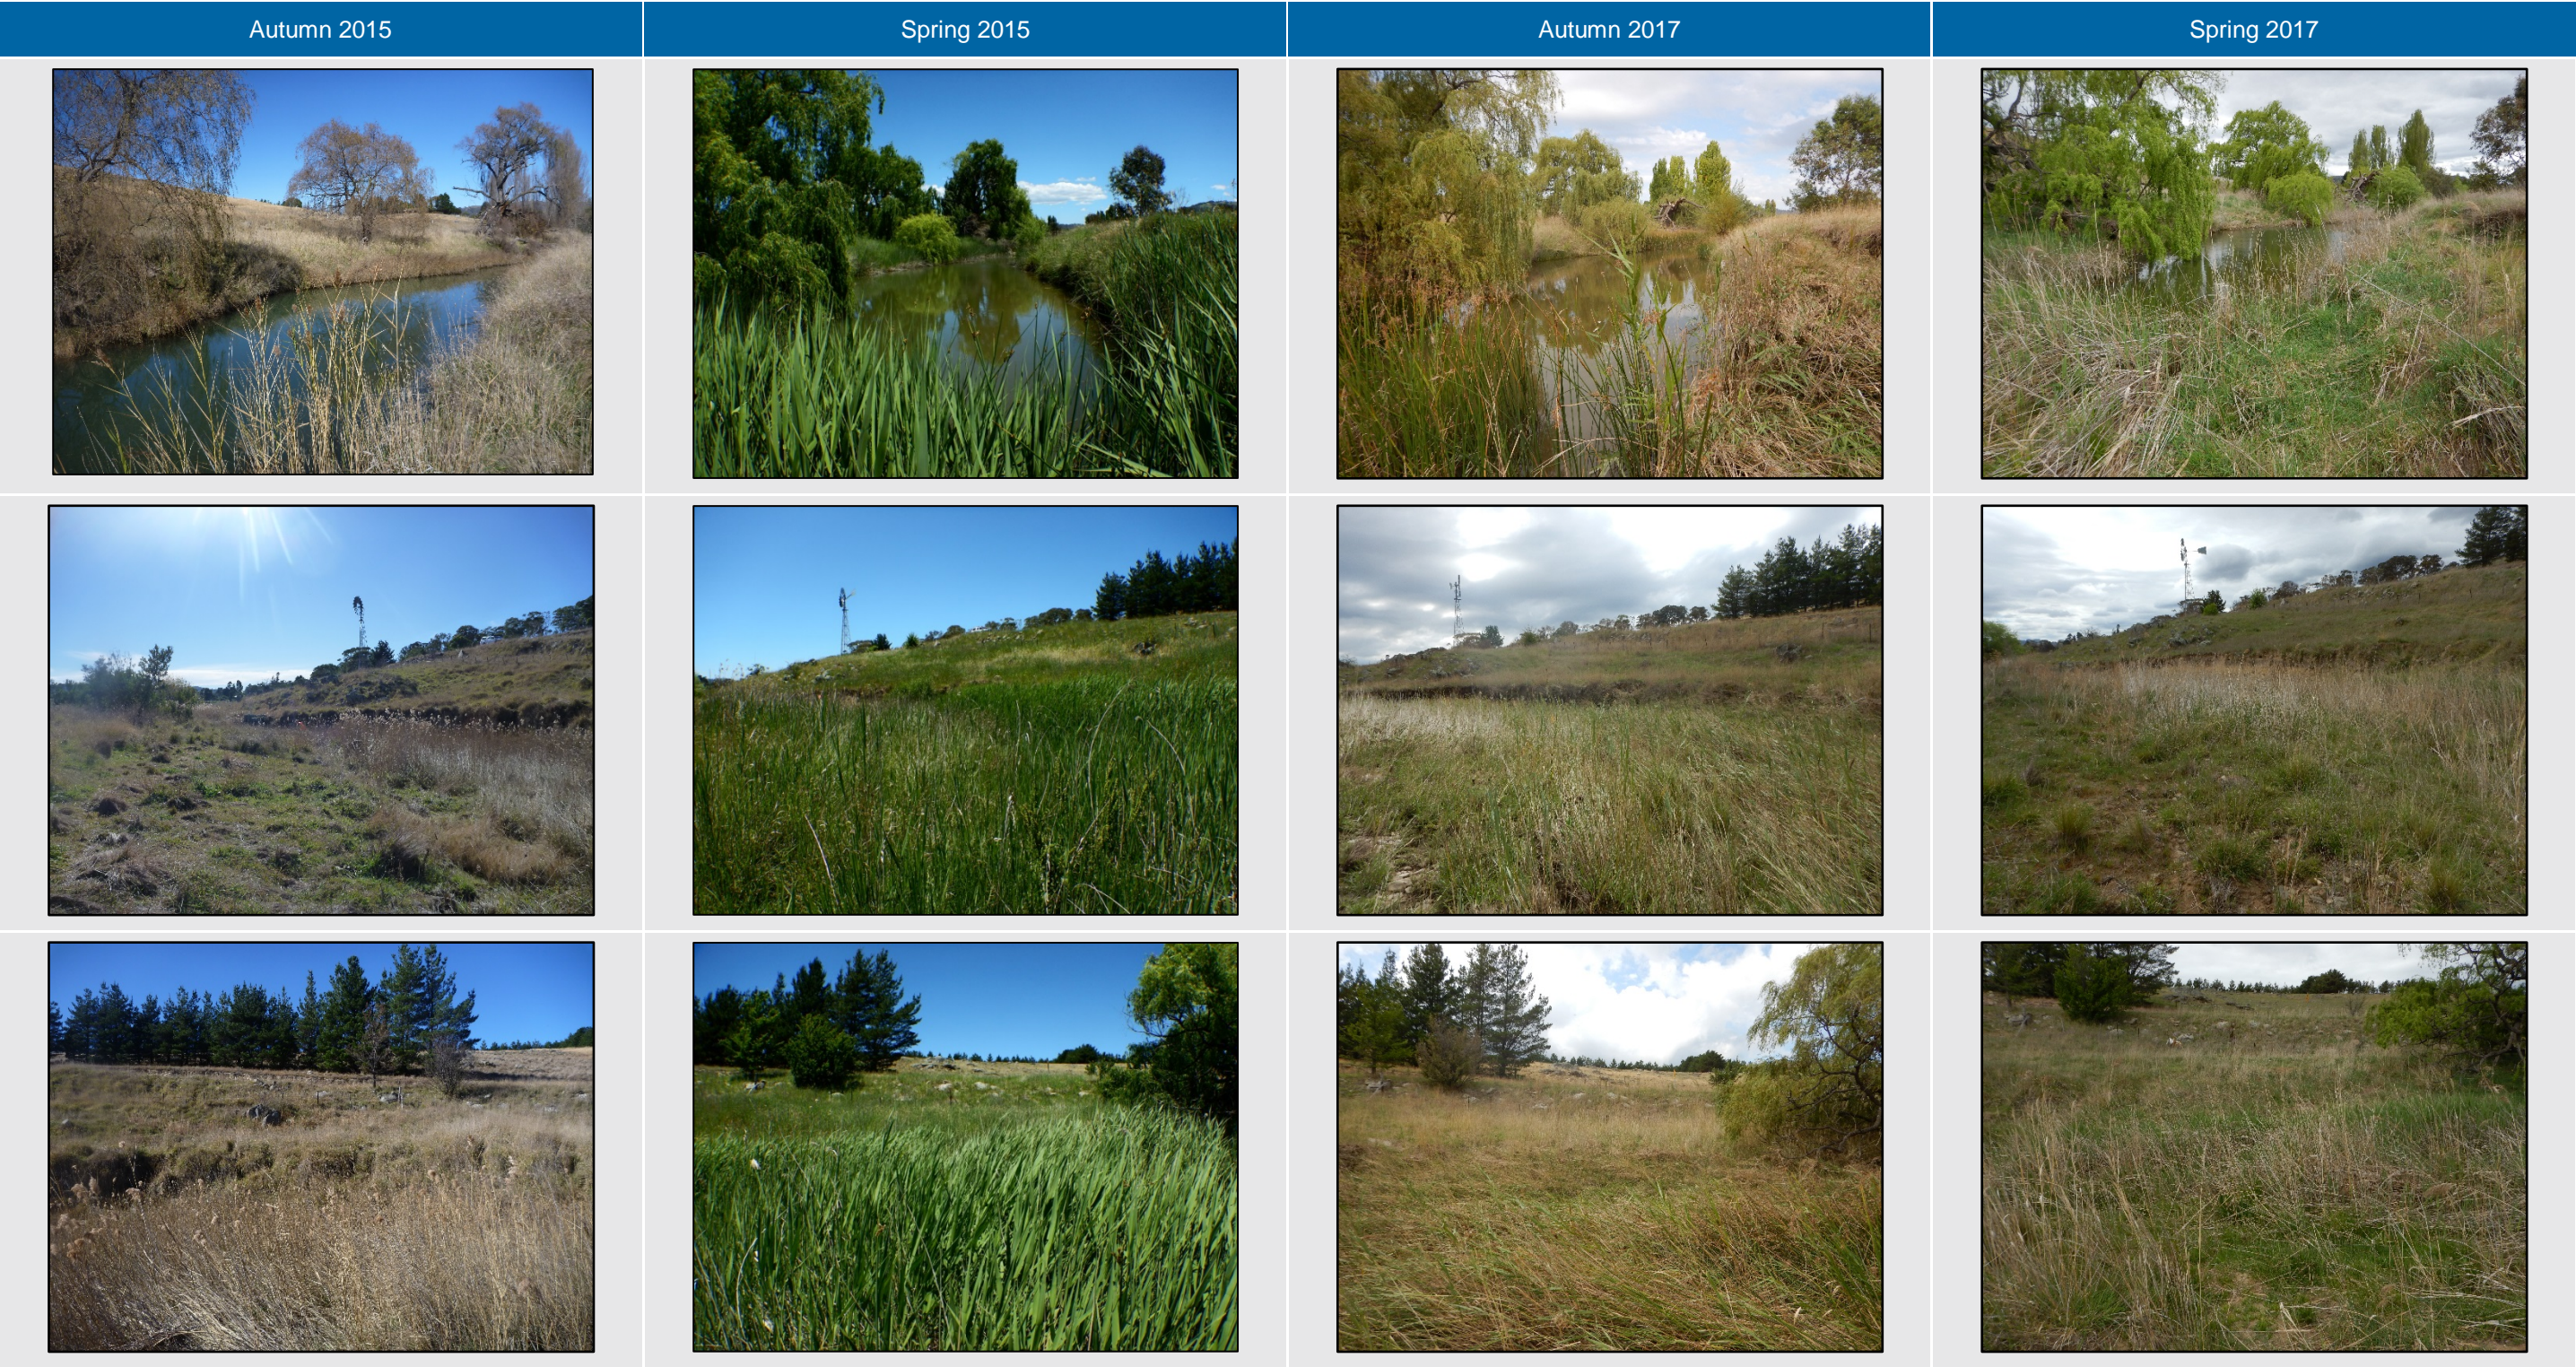
**Plate 4-23 Geomorphology photo point 1 at BUR2a showing upstream (a), downstream (b) and across the channel (c) from autumn 2015 (left) to spring 2017 (right)**

Like BUR1c, this reach is a depositional zone and there is blanketing silt across all habitats. Since the 2015 monitoring period, there have been no observable geomorphological changes at this site (Plate 4-23 and Plate 4-24).

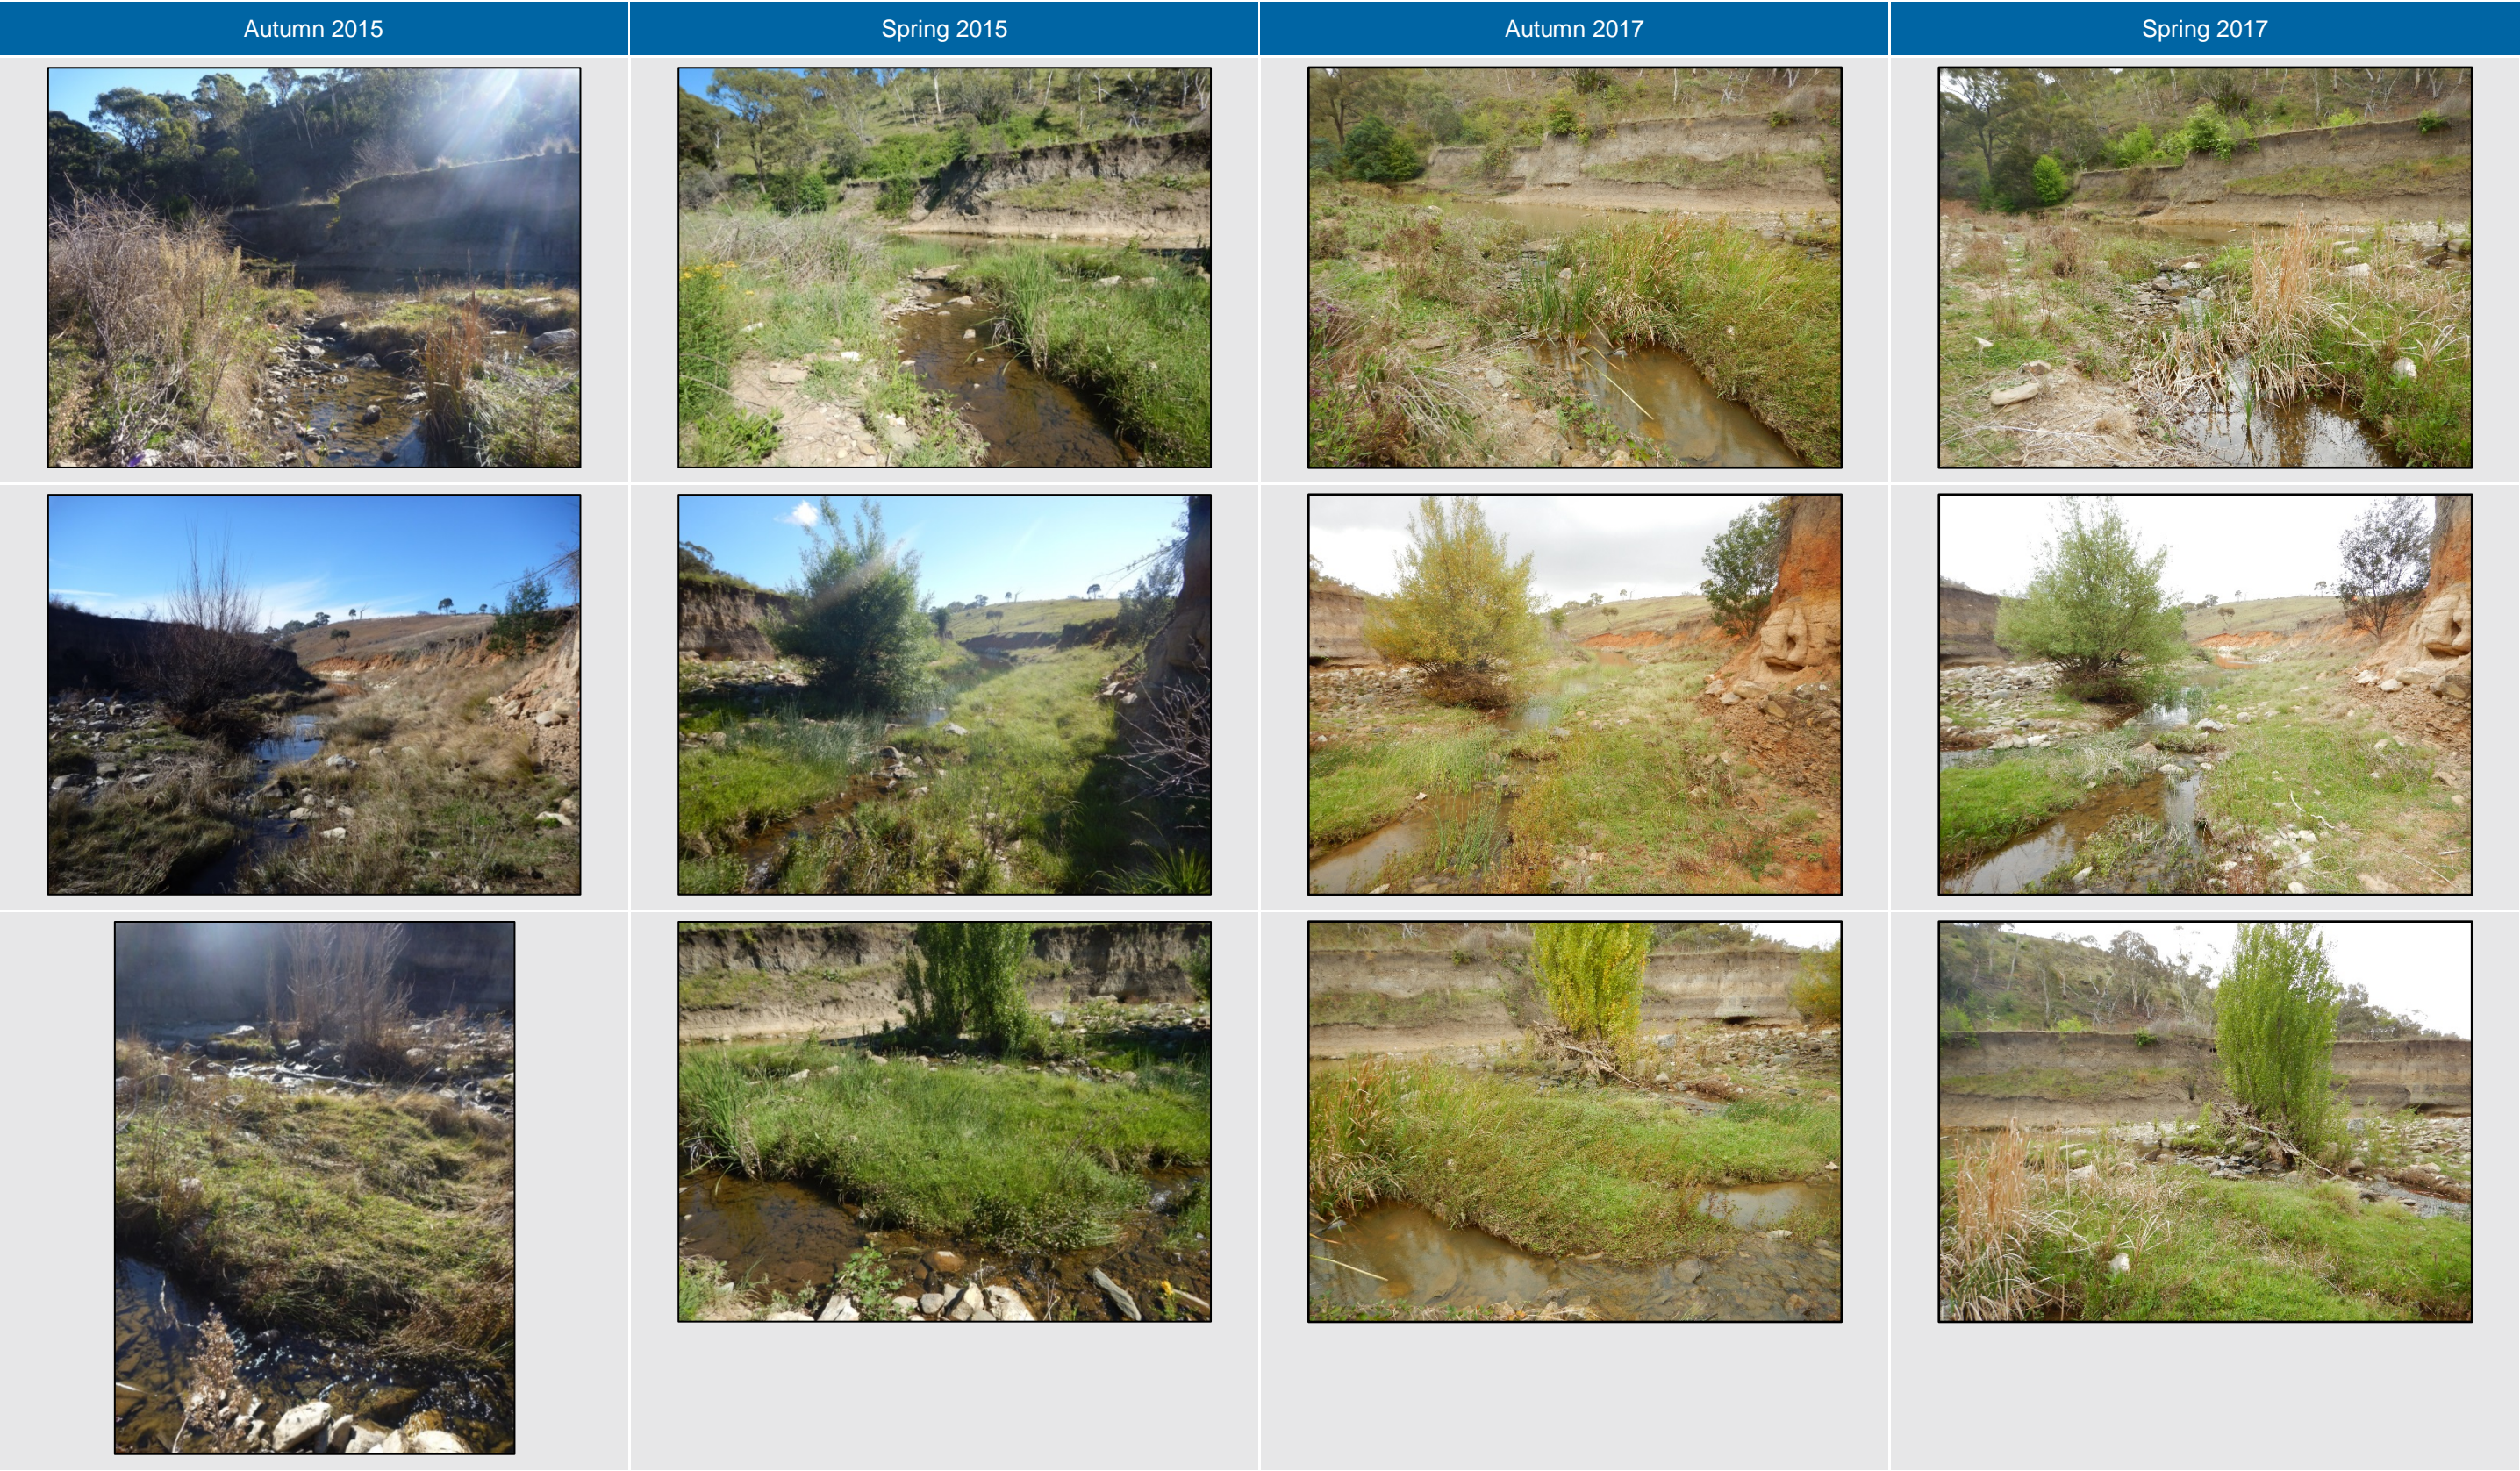
**Plate 4-25 Geomorphology photo point 1 downstream of pool 29 showing upstream (a), downstream (b) and across the channel (c) from autumn 2015 (left) to spring 2017 (right)**

Despite the moderate to heavy erosion potential in this reach, there has been little photographic evidence of slumping or movement from autumn 2015 to spring 2017 (Plate 4-25, Plate 4-26 and Plate 4-27). Both of the banks and the channel through this reach have not shown any major changes to their morphology. There were no major changes to the large macro channel morphology observed during the most recent visit in spring 2017. The formed vegetated island in the riffle habitat also appears stable.
