## **Icon Water**

# **Murrumbidgee Ecological Monitoring Program 2015-21 Sentinel Monitoring - Autumn 2018**

September 2018

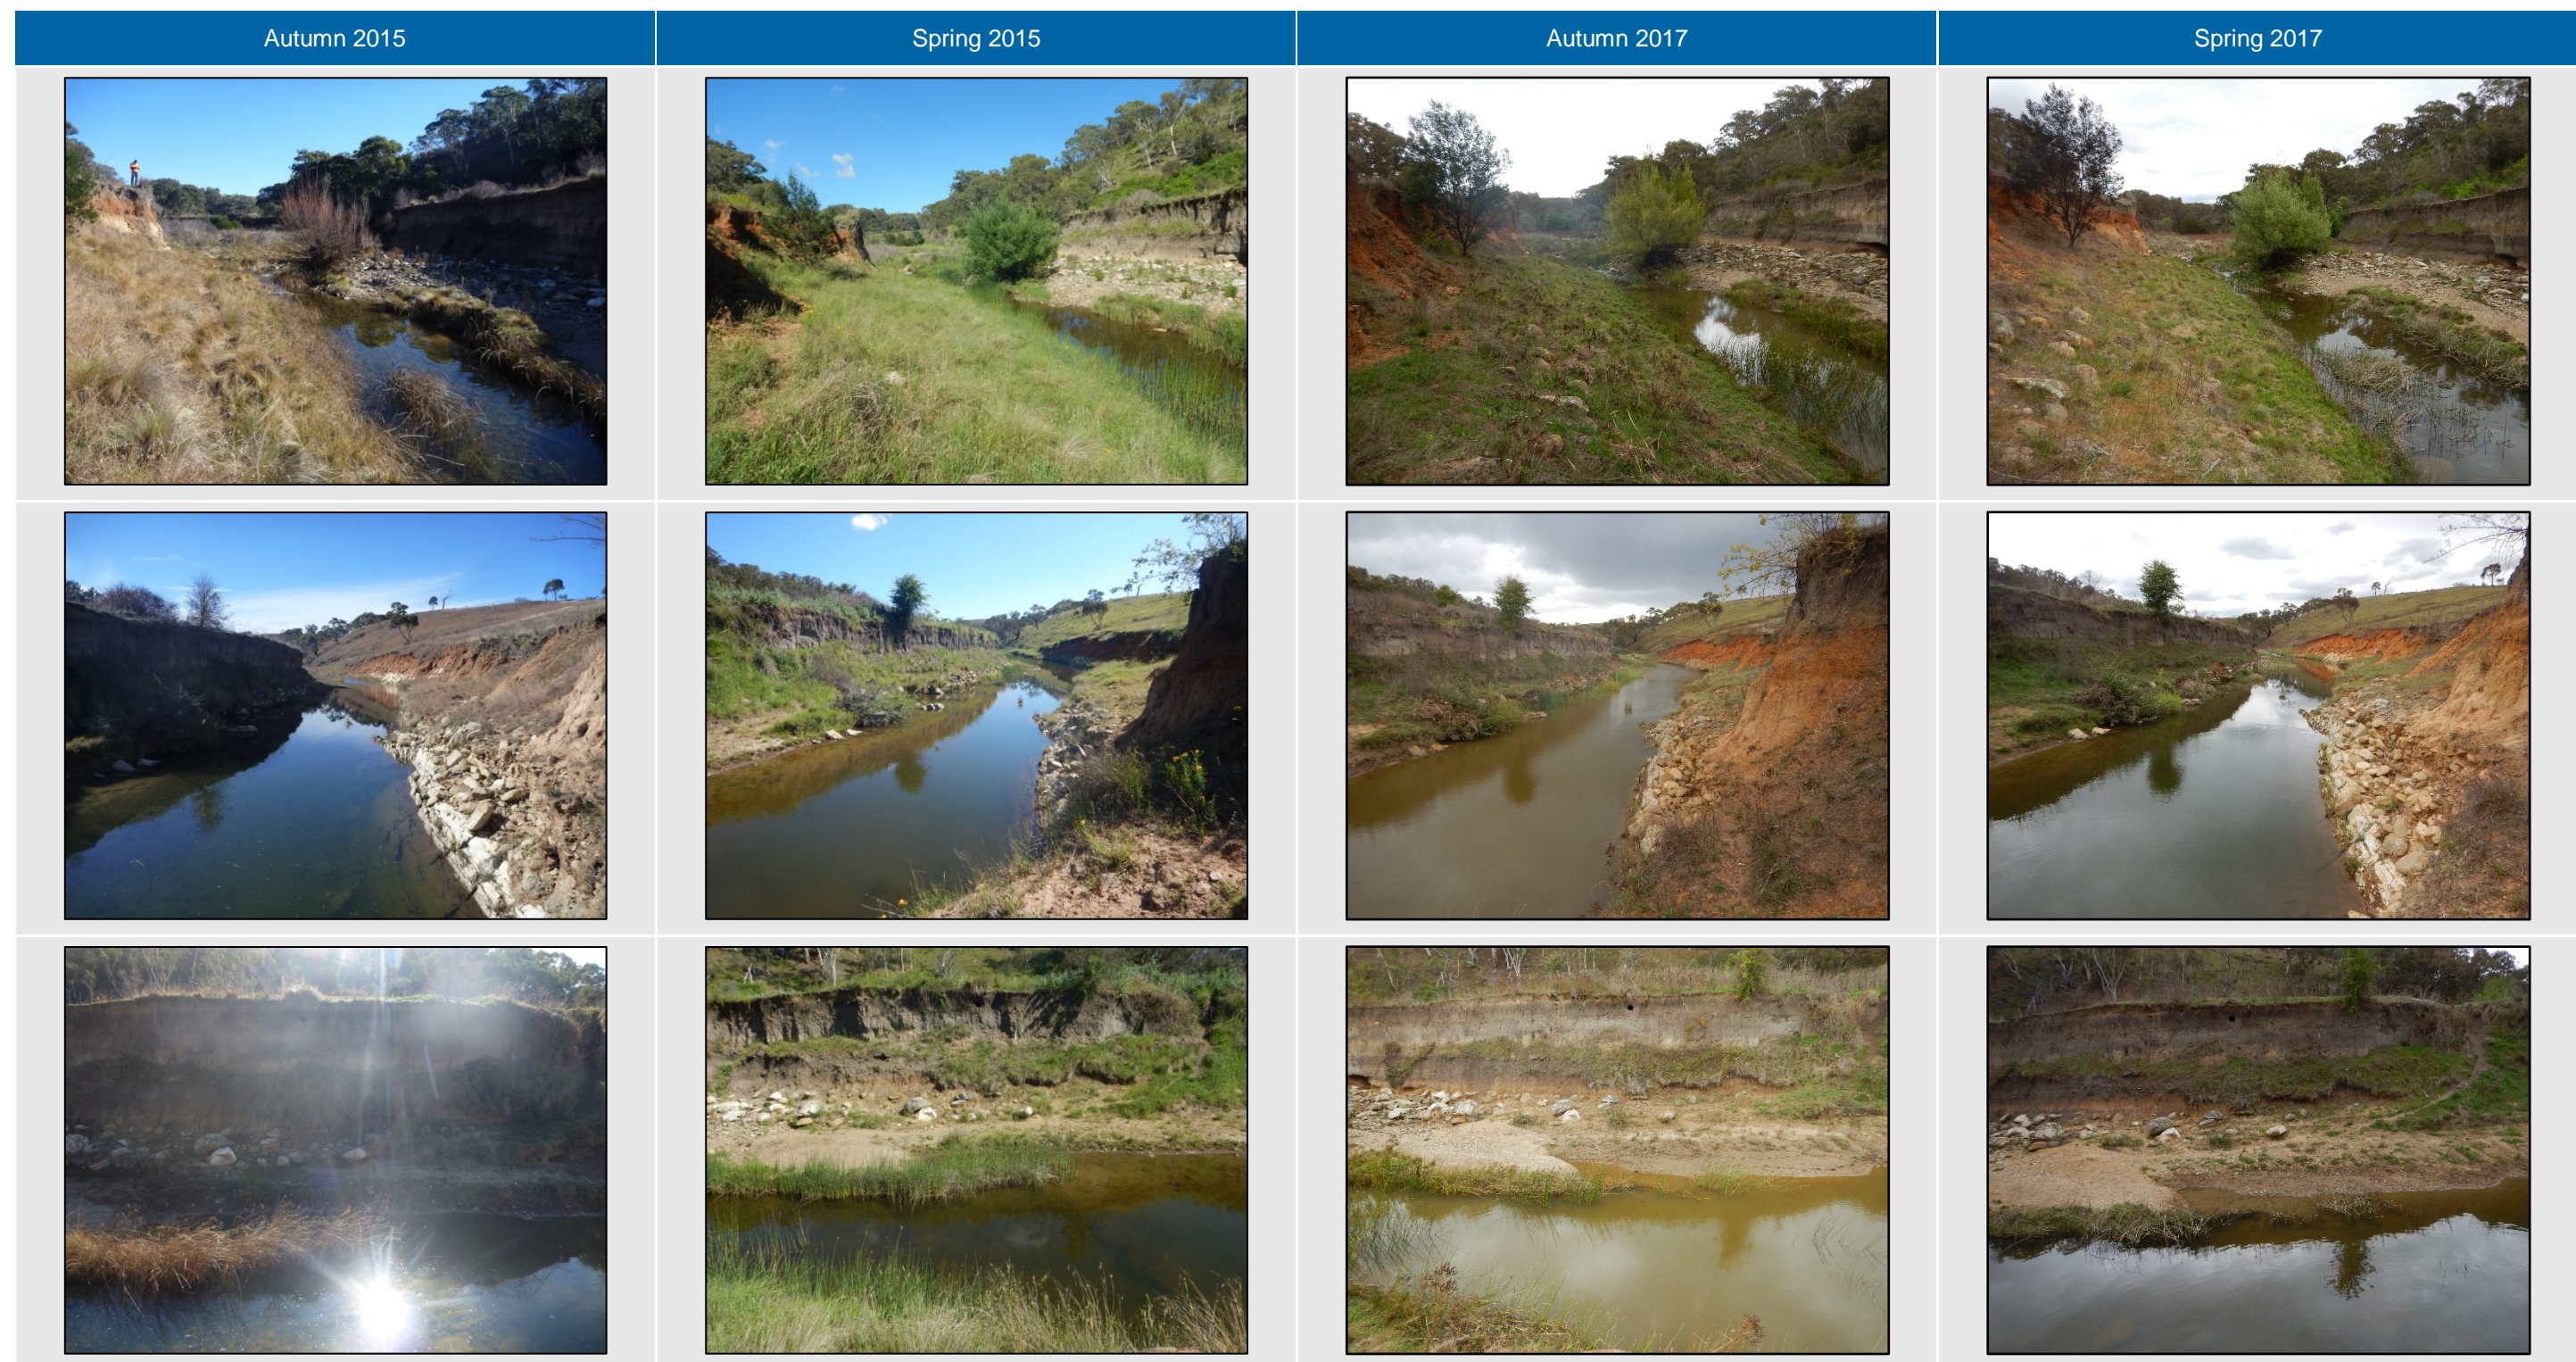
**Plate 4-26 Geomorphology photo point 2 downstream of pool 29 showing upstream (a), downstream (b) and across the channel (c) from autumn 2015 (left) to spring 2017 (right)**

Despite the moderate to heavy erosion potential in this reach, there has been little photographic evidence of slumping or movement from autumn 2015 to spring 2017 (Plate 4-25, Plate 4-26 and Plate 4-27). Both of the banks and the channel through this reach have not shown any major changes to their morphology. There were no major changes to the large macro channel morphology observed during the most recent visit in spring 2017. The formed vegetated island in the riffle habitat also appears stable.

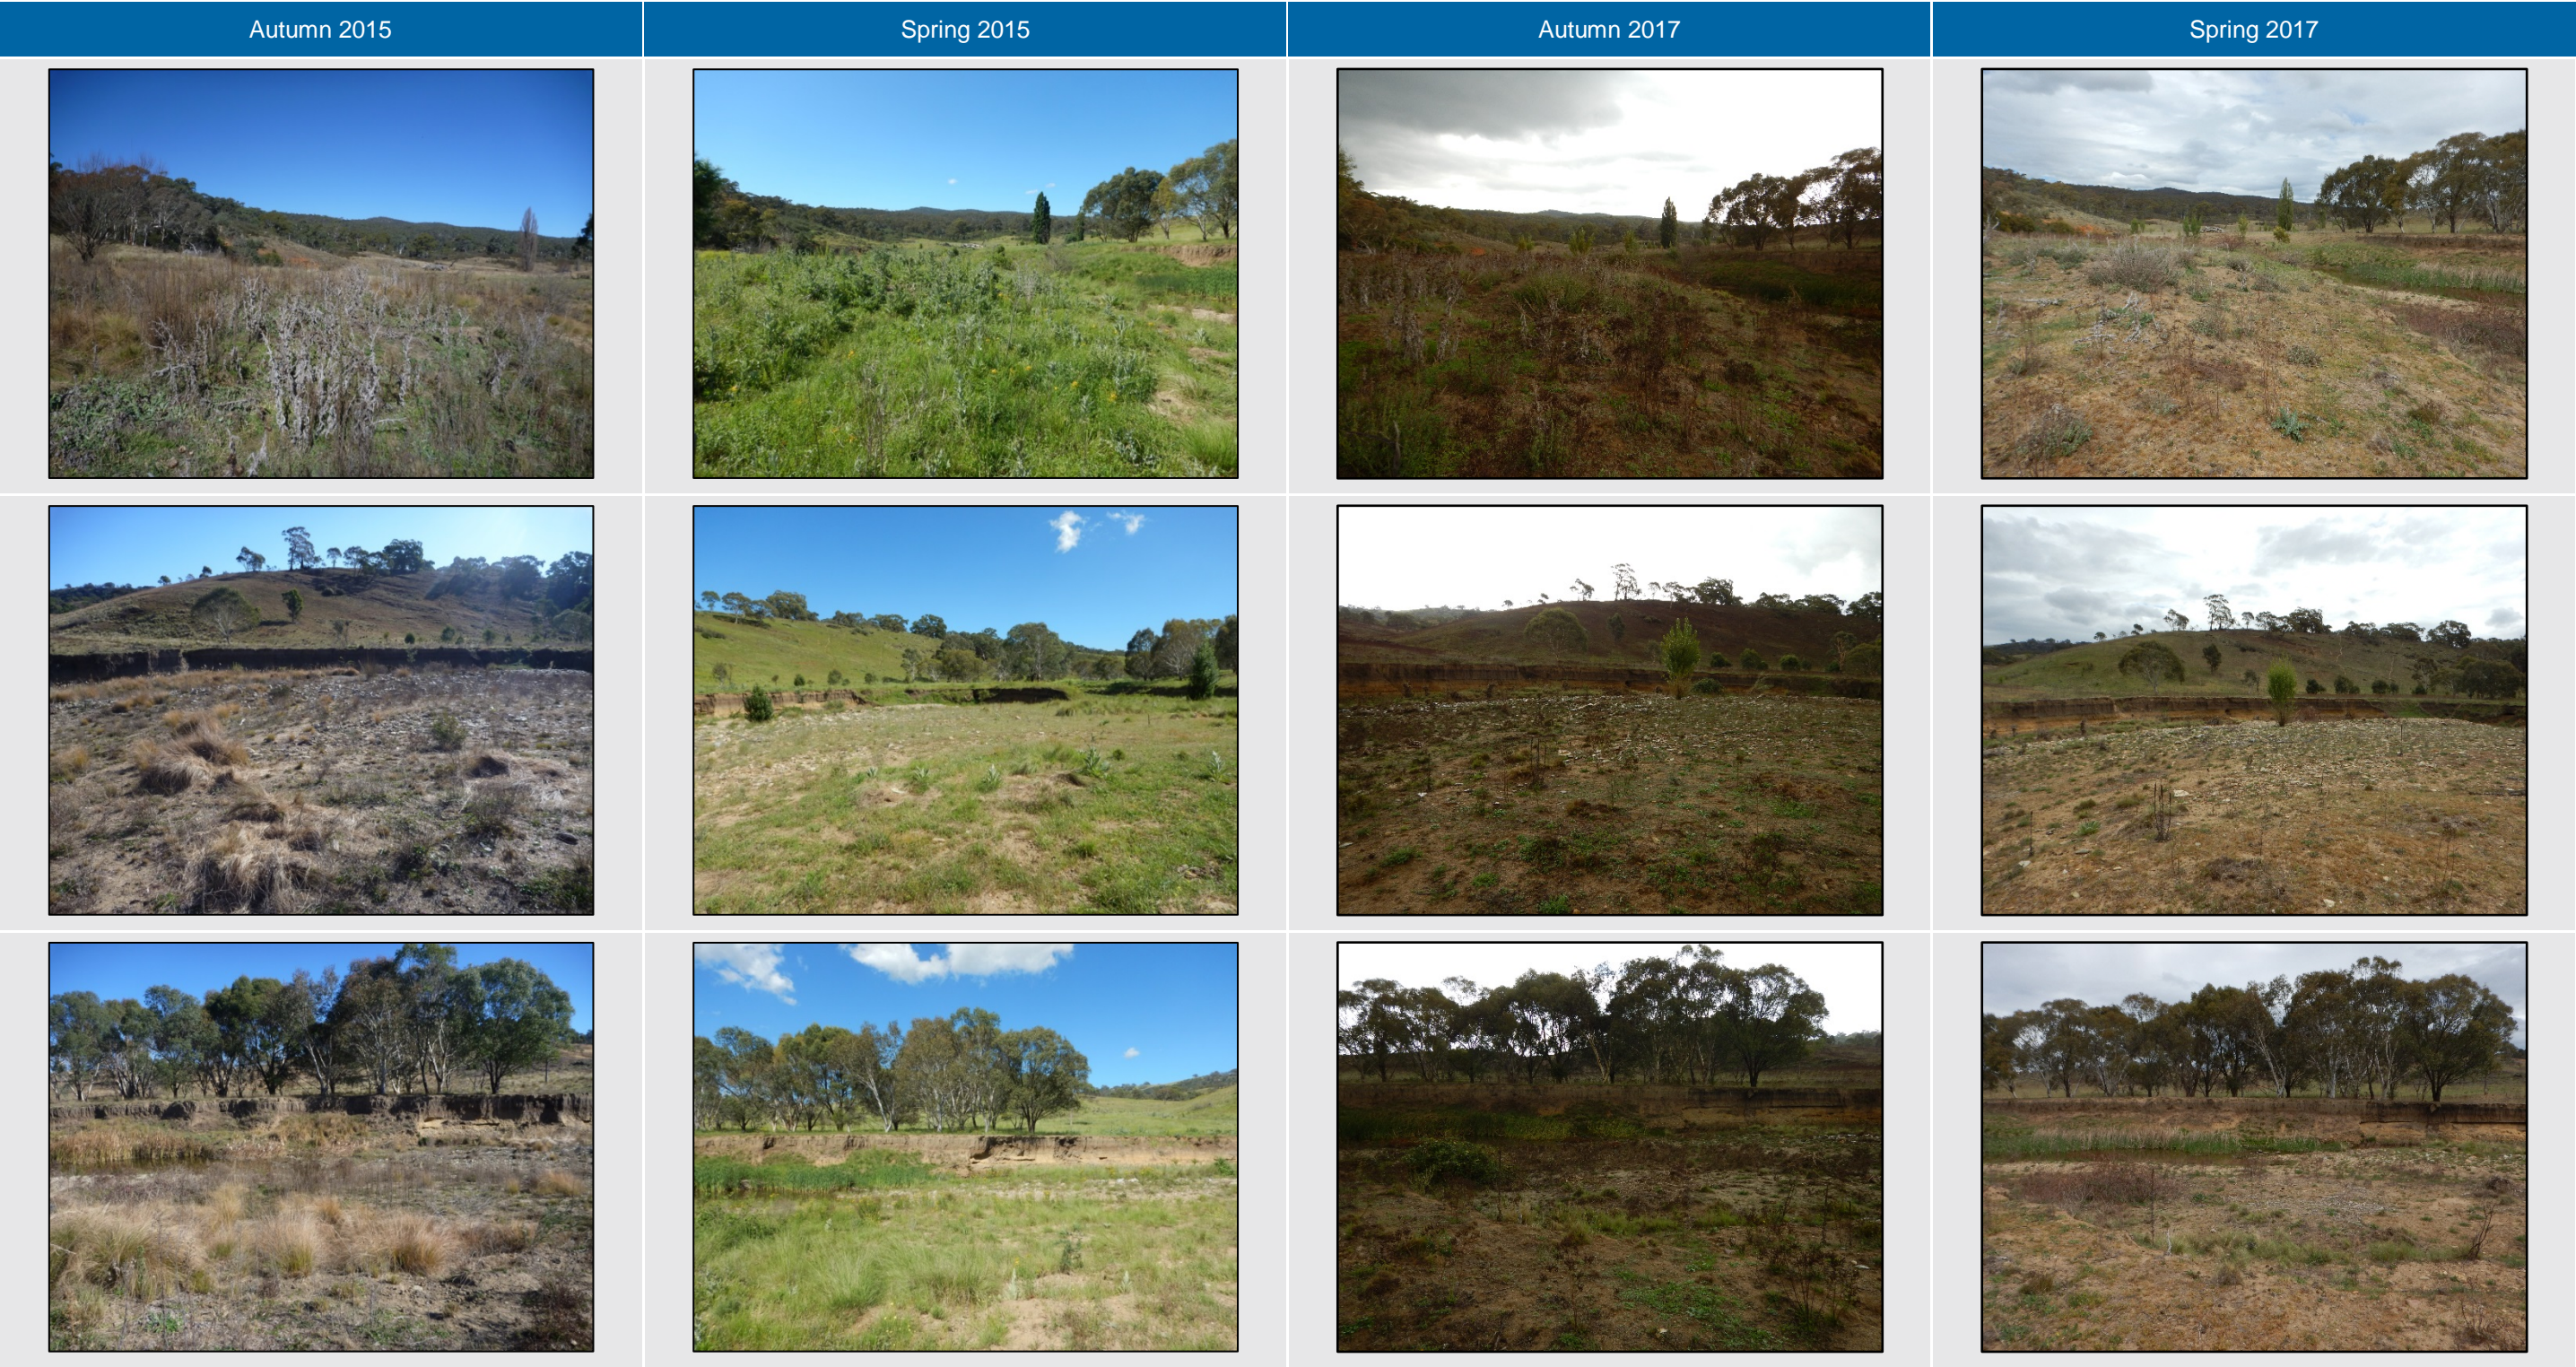
*In the MEMP **geomorphology** report it was pointed out that the area of greatest concern along Burra Creek is the downstream reach at BUR2c. There were no signs of any significant geomorphological changes at the photo monitoring locations in Burra Creek between spring 2015 and the current monitoring period. The creek channel appeared to be stable as did the creek banks, with no obvious slumping or collapse observed from the photographs – even at the most vulnerable sites (i.e. Pool 29 and BUR2c).*

**Plate 4-28 Geomorphology photo point 1 at BUR2c showing upstream (a), downstream (b) and across the channel (c) from autumn 2015 (left) to spring 2017 (right)**

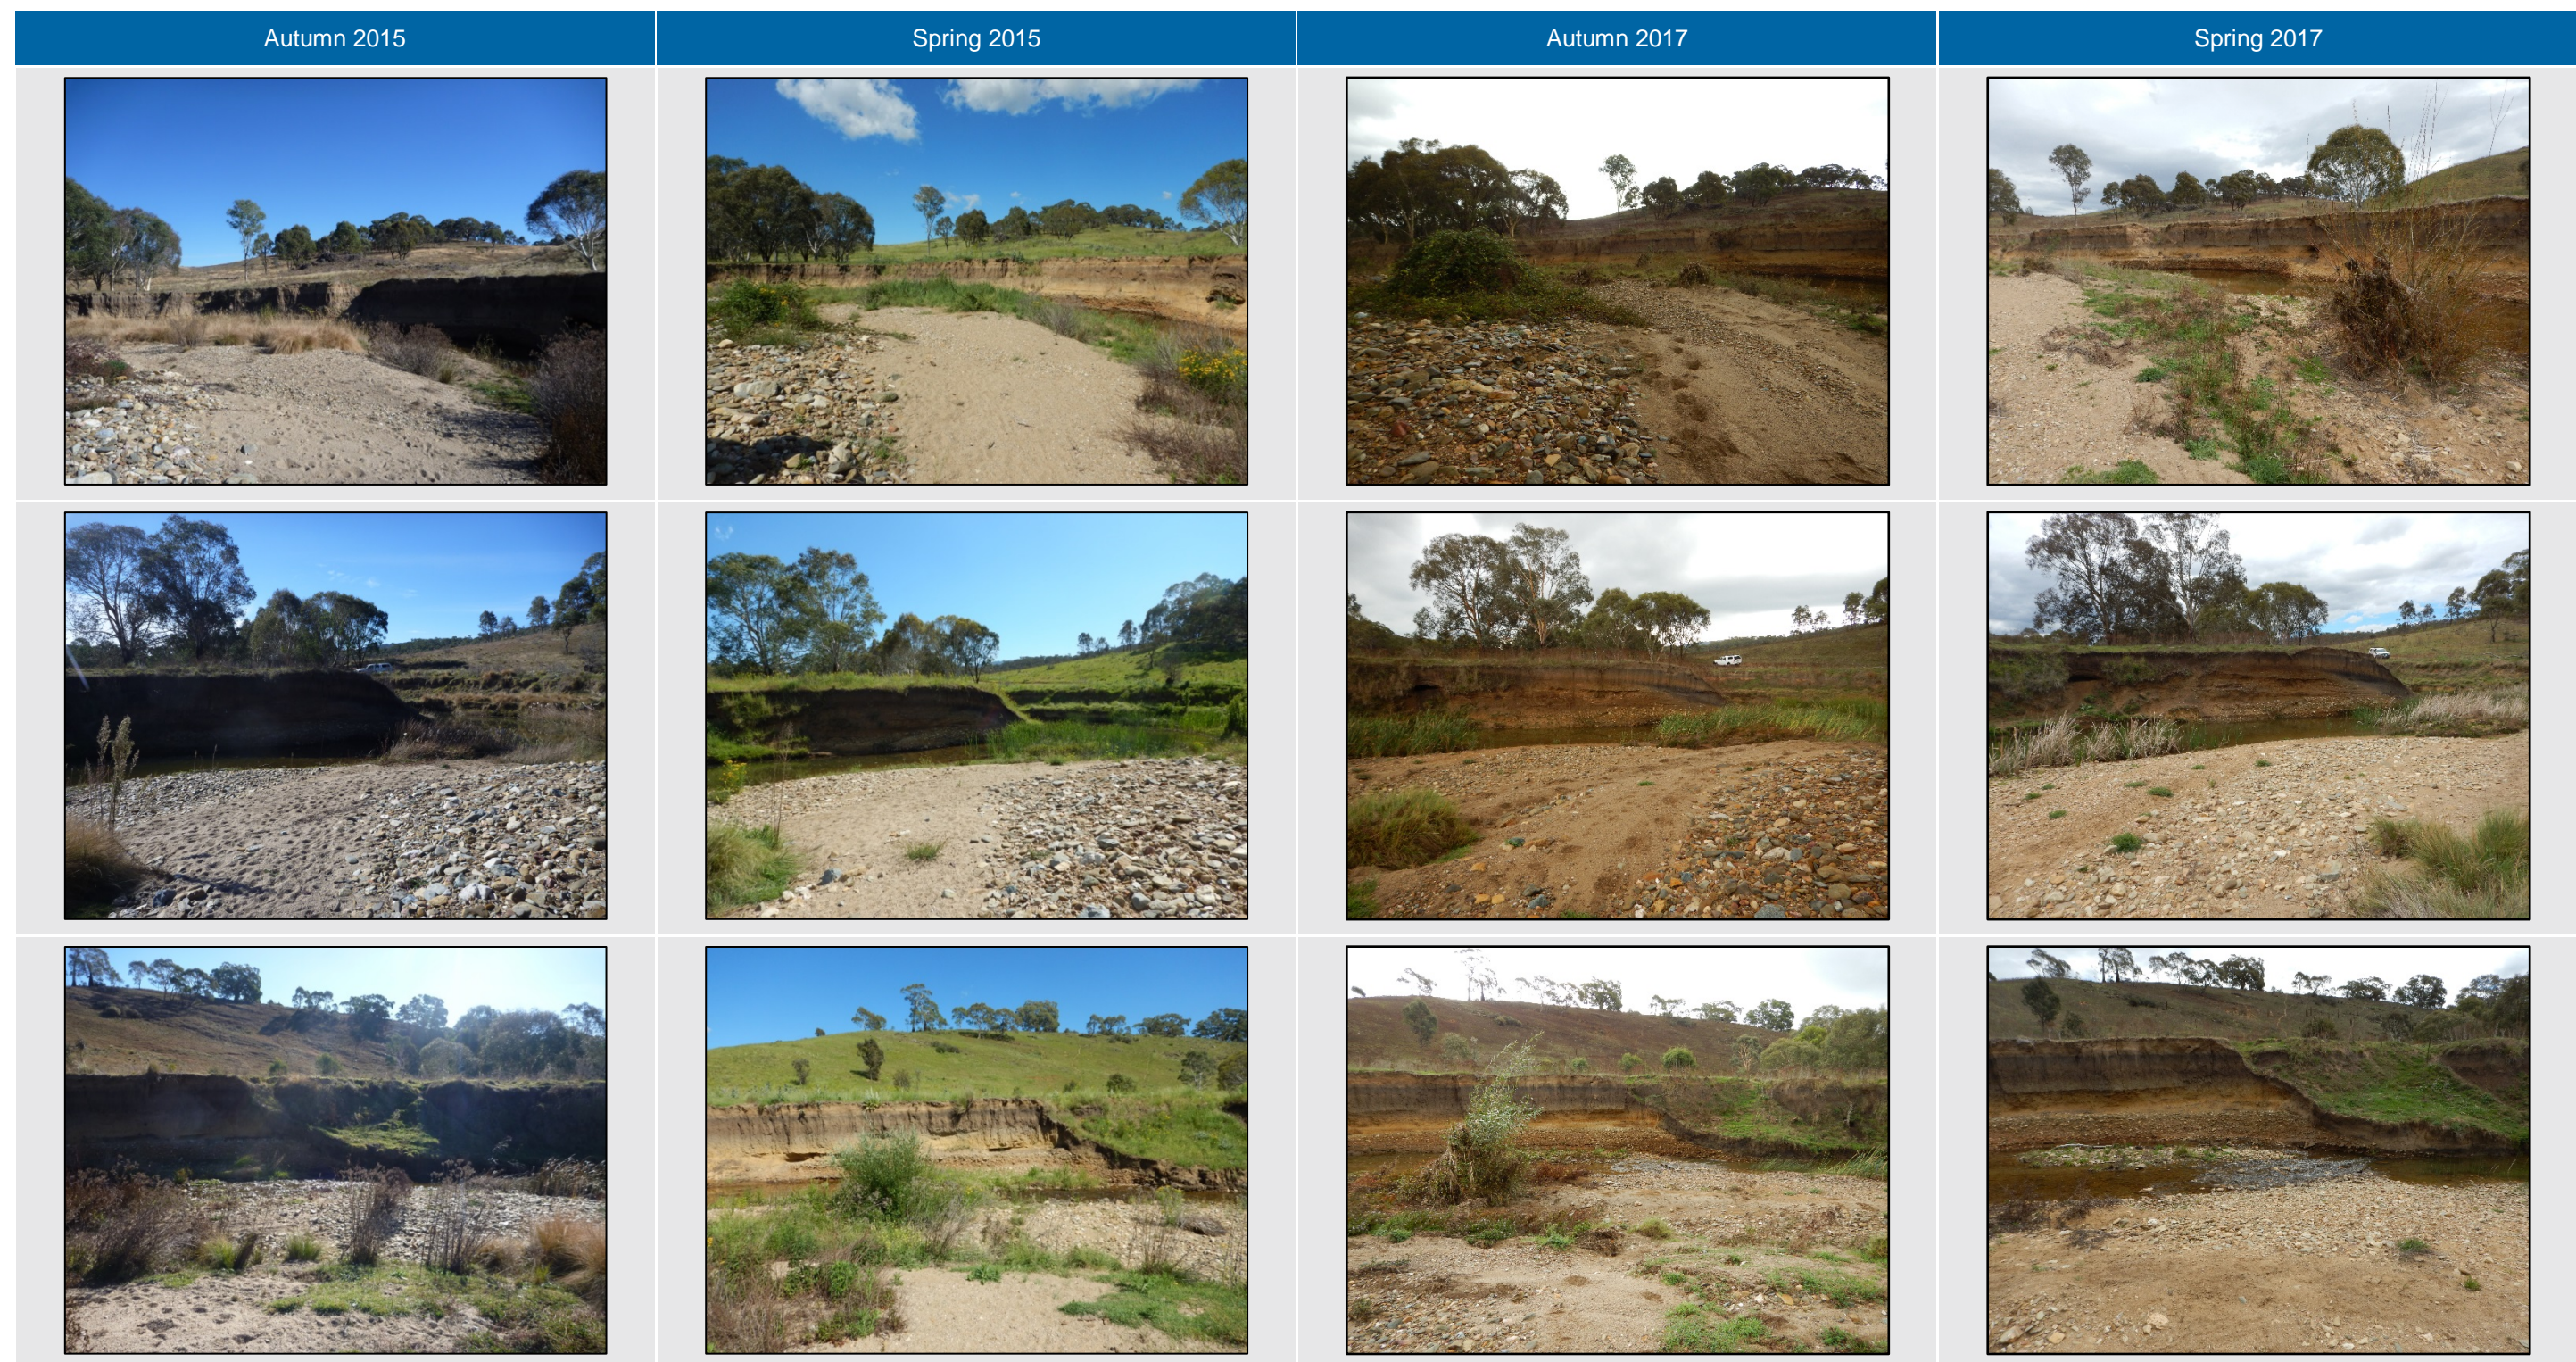
**Plate 4-29 Geomorphology photo point 2 at BUR2c showing upstream (a), downstream (b) and across the channel (c) from autumn 2015 (left) to spring 2017 (right)**

There was some slumping of the steep bank adjacent to the riffle habitat between the autumn 2015 and spring 2015 sampling periods. In the subsequent monitoring rounds (autumn 2017 and spring 2017) there has been little or no further slumping in this section of the bank (Plate 4-28; Plate 4-29), which may be related to the low rainfall and low flows over this period. Downstream of the main pool, the banks appear to be relatively stable due to the large areas of the face of the bank being vegetated by various grass species. There have been no obvious changes to the channel morphology since the last monitoring period.

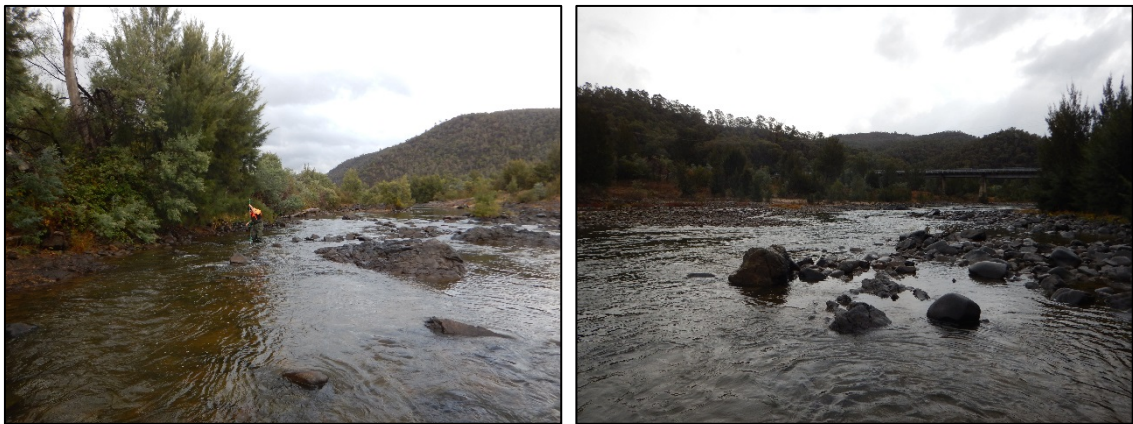
Both sites related to the Murrumbidgee Pump Station were sampled on 4 May 2018. Weather conditions were overcast in the morning, but cleared in the afternoon (Plate 5-1). The maximum temperature recorded at Canberra airport was 16.5°C (B.O.M, 2018).

**MUR28:** Looking upstream (left) and looking downstream (right)

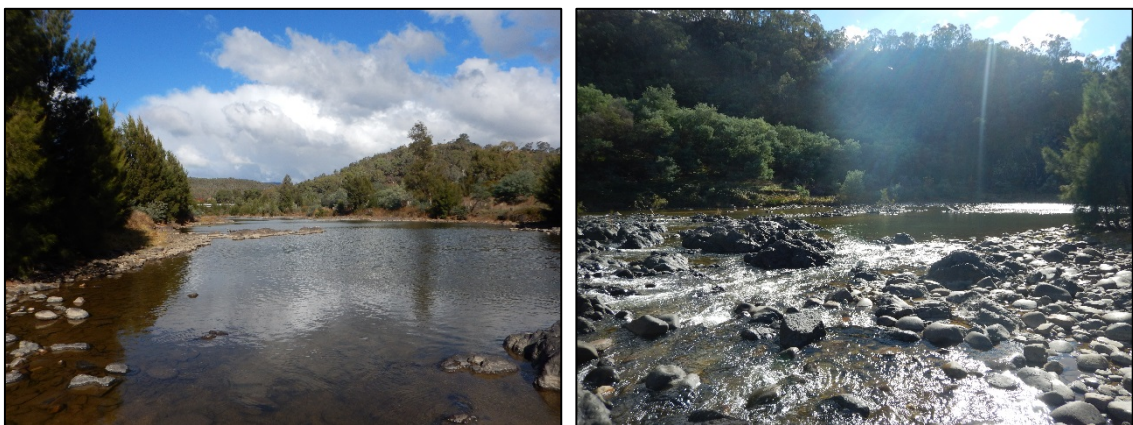
**MUR935:** Looking upstream (left) and looking downstream (right)

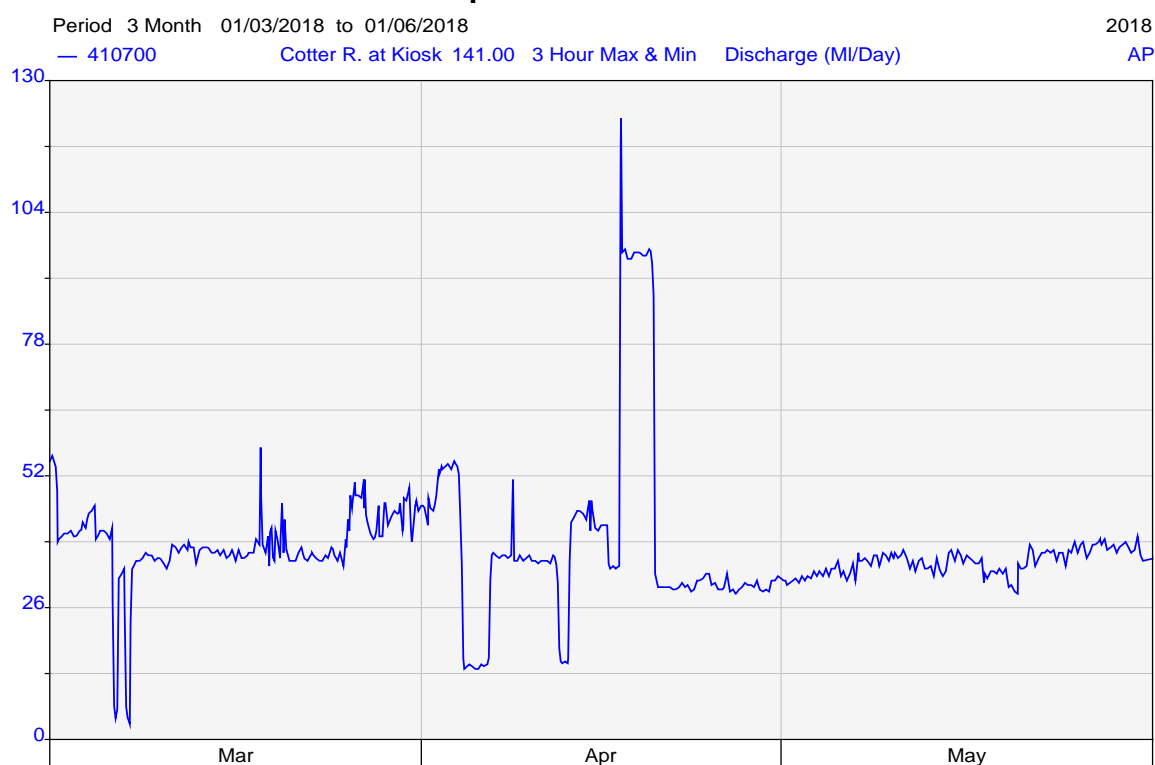
**Figure 5-2. Hydrograph for the Cotter River downstream of the Cotter Dam (410700) for autumn 2018**

At the time of sample collection, the Murrumbidgee River was flowing below the long term median flow of 507 ML/d: (calculated for the period 2008-2018) at Mount MacDonald. Flows on the day of sampling were receding following a small rainfall event in late April (Figure 5-1). A number of environmental flows were manipulated from the Cotter Dam in April, which would have influenced MUR935, but not MUR28. The hydrograph for this period is shown in Figure 5-2.

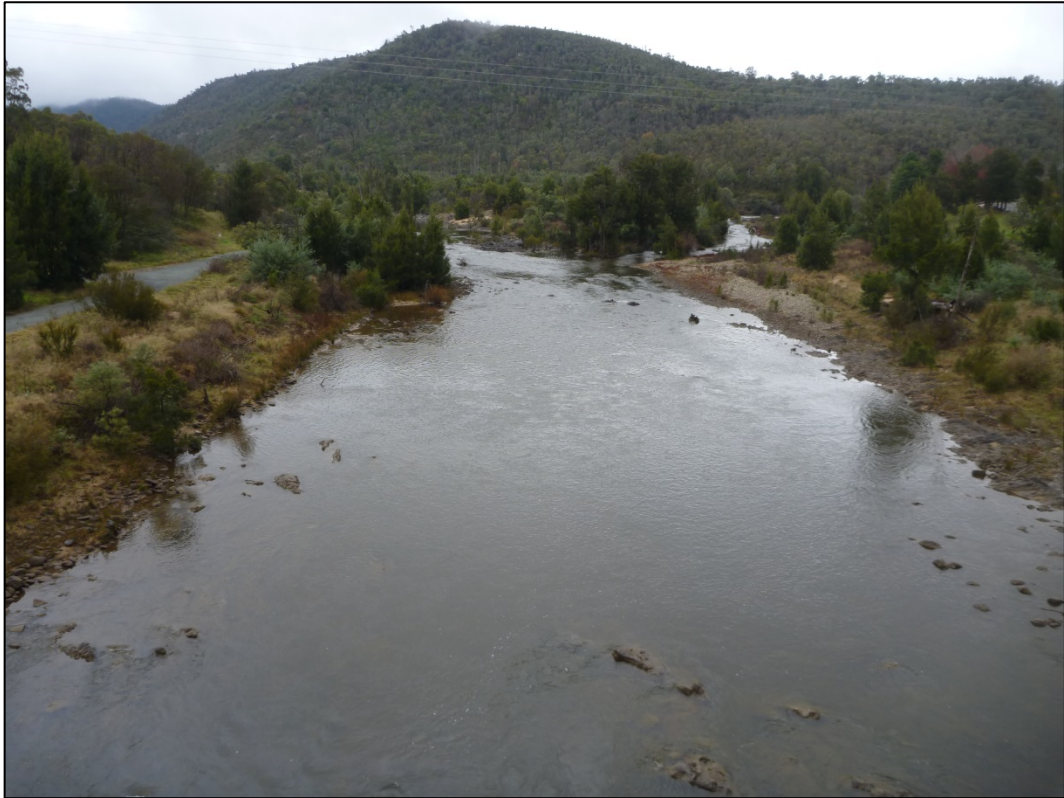
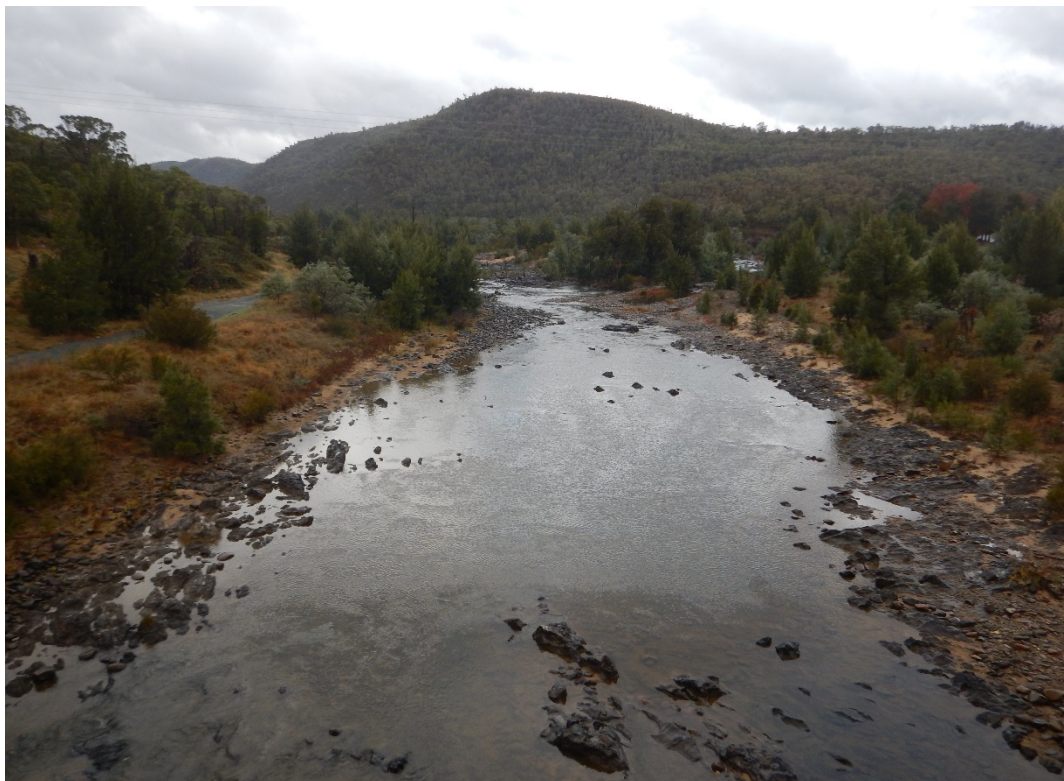
**Plate 5-2. The Murrumbidgee River upstream of the Cotter Road bridge and the MPS in autumn 2015 (top) and 2018 (bottom)**

**2015 - 510 ML/d (19/5/2015)**

**2018 - 108 ML/d (4/5/2015)**

Note: Flow is mean daily flow recorded at Mt. MacDonald (410738)

Mean daily flow on the day was recorded at 55 ML/d at the Lobb's Hole gauging station (410761) and 108 ML/d at the Mt. MacDonald gauging station (410738) (Plate 5-2 and Plate 5-3).

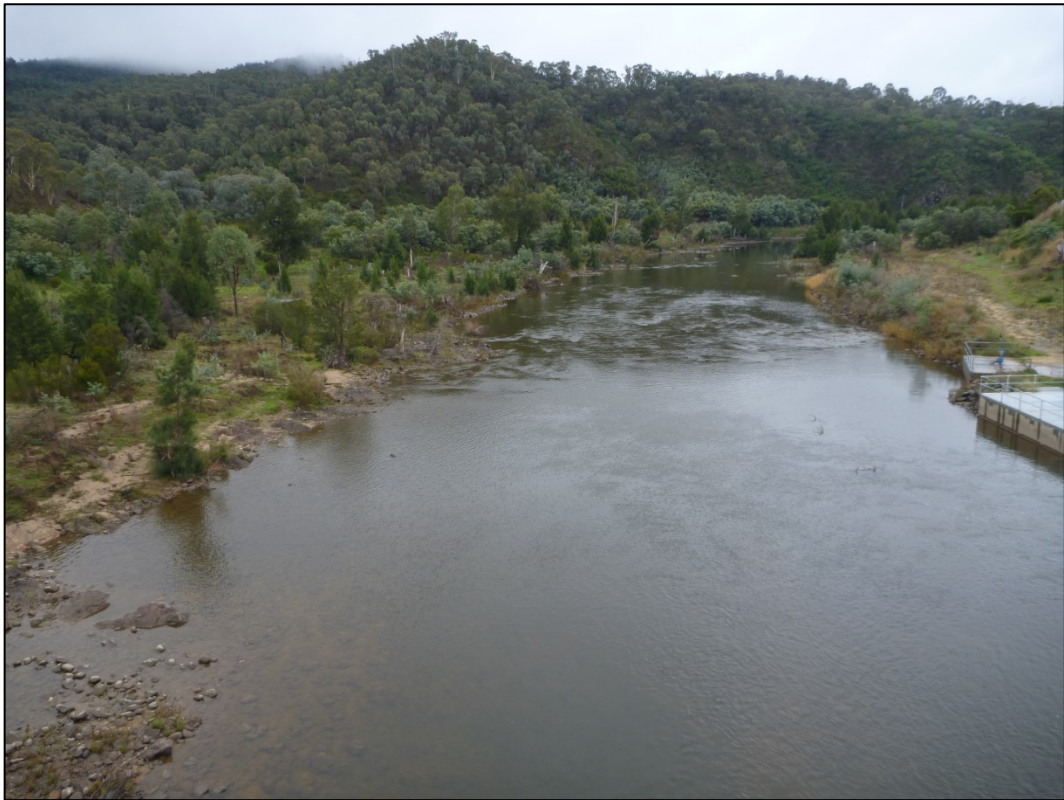
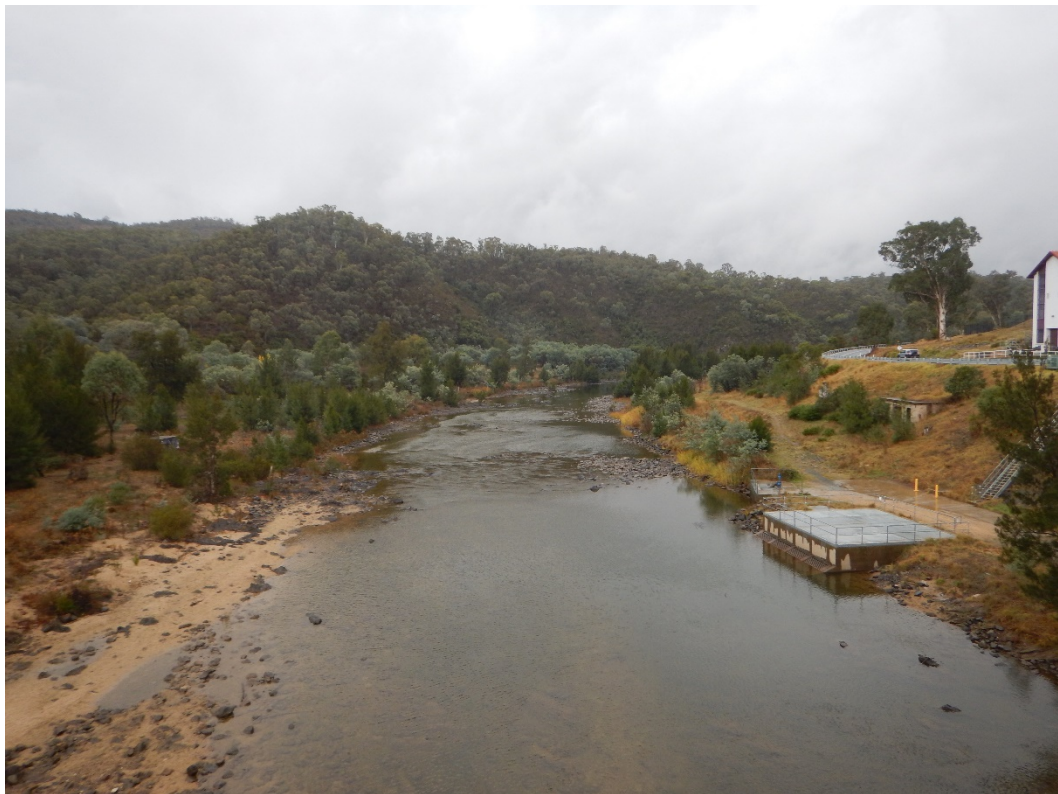
**Plate 5-3. The Murrumbidgee River downstream of the Cotter Road bridge, MPS on the right bank, in autumn 2015 (top) and 2018 (bottom)**

**2015 - 510 ML/d (19/5/2015)**

**2018 - 108 ML/d (4/5/2015)**

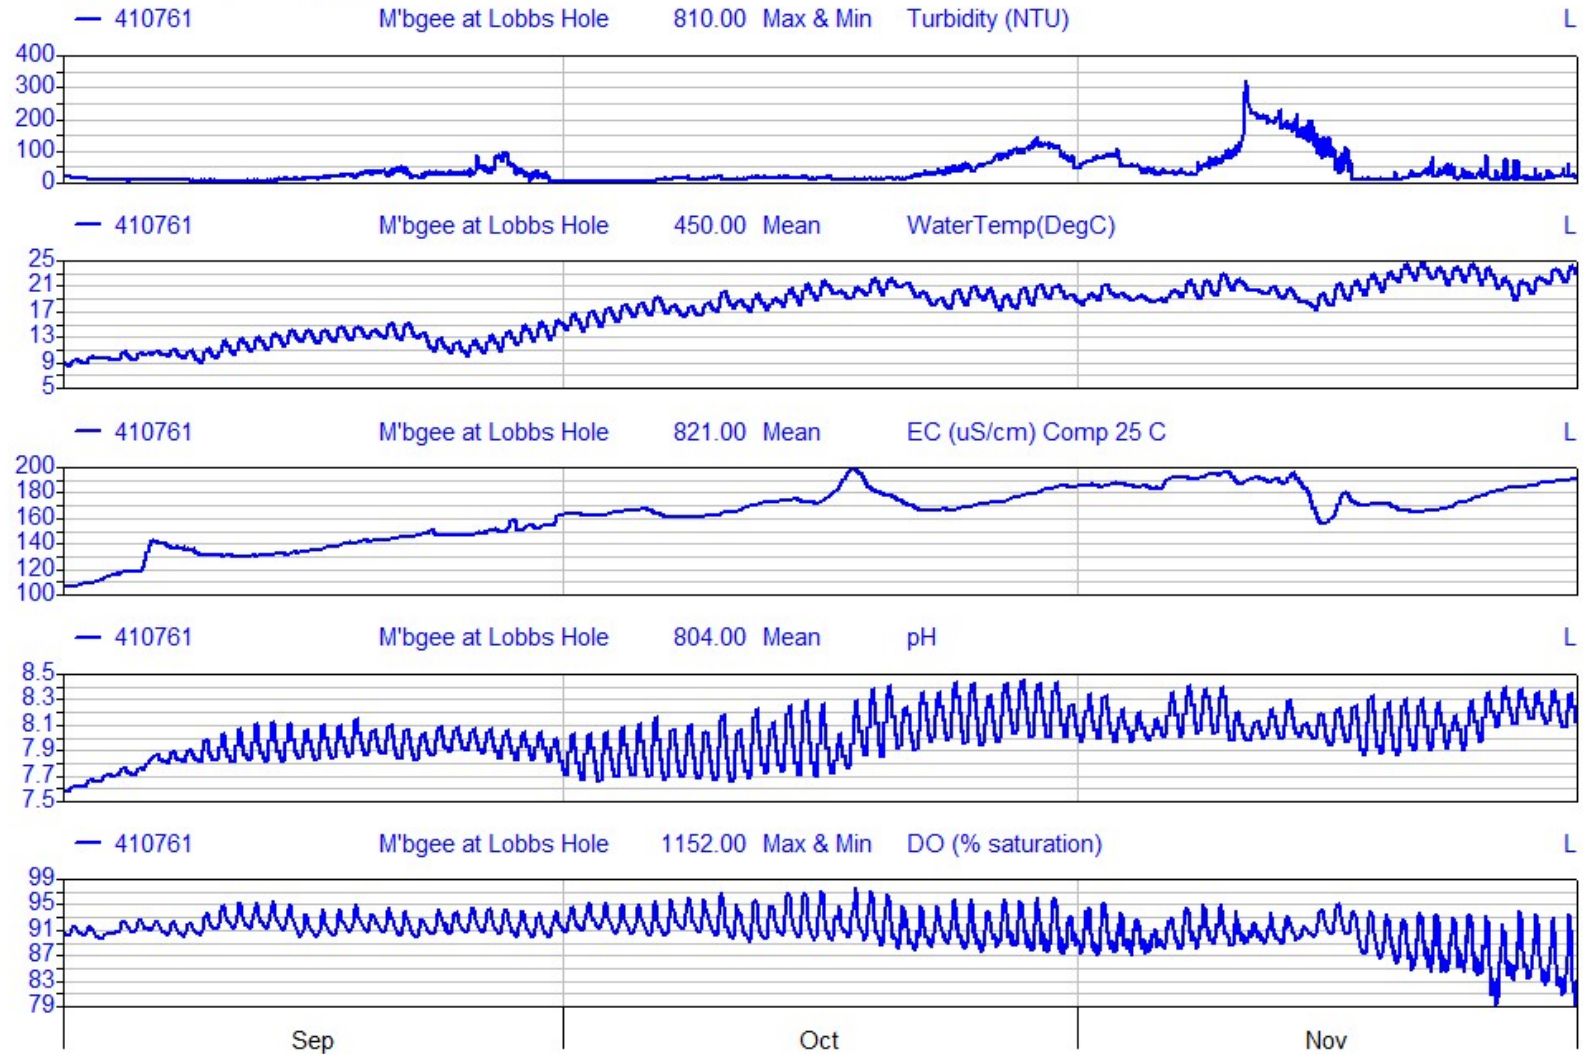
**Figure 5-3. Continuous water quality records from Lobb's Hole (410761) for autumn 2018**

The continuous water quality monitoring from Lobb's Hole (410761) are presented in Figure 5-3. Turbidity at Lobb's Hole and upstream of Angle Crossing were relatively consistent during autumn. There was a spike in early March at Lobb's Hole, which was in response to the small rainfall event. There were no exceedances in turbidity at either location during autumn. pH was typically above the upper ANZECC value of 8.0 during autumn, with 62% of the daily mean values in exceedance of pH 8.0. There were no exceedances in electrical conductivity at either location. Dissolved oxygen was below the 90 % saturation 50% of the time at the upstream site (based on daily means) and only 9% of the time 99 days) at Lobb's Hole, which may be due to the location of the probes at either site because there was nothing observed on site which may have caused these differences.

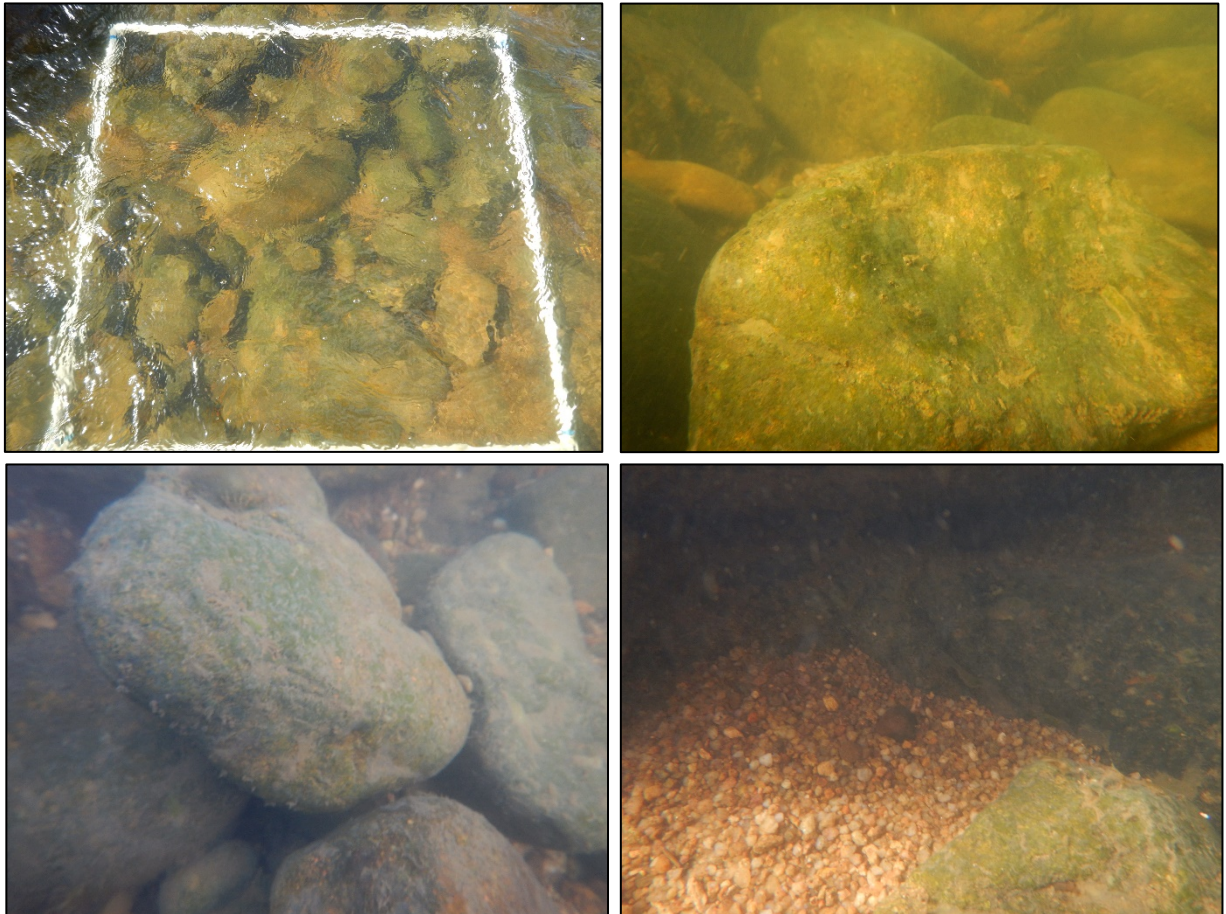
**Plate 5-4. Photos showing periphyton coverage in the riffle at MUR28**

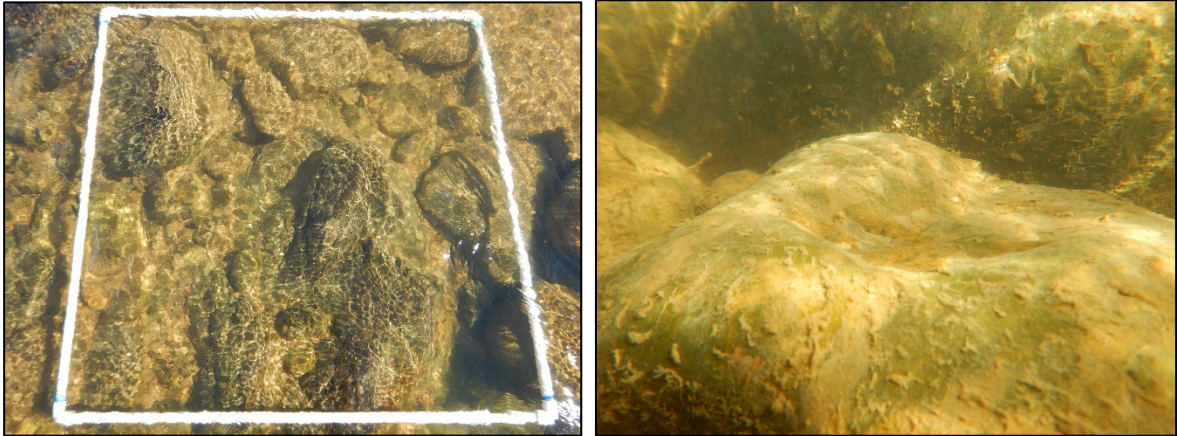
**Plate 5-5. Photos showing periphyton coverage in the riffle at MUR935**

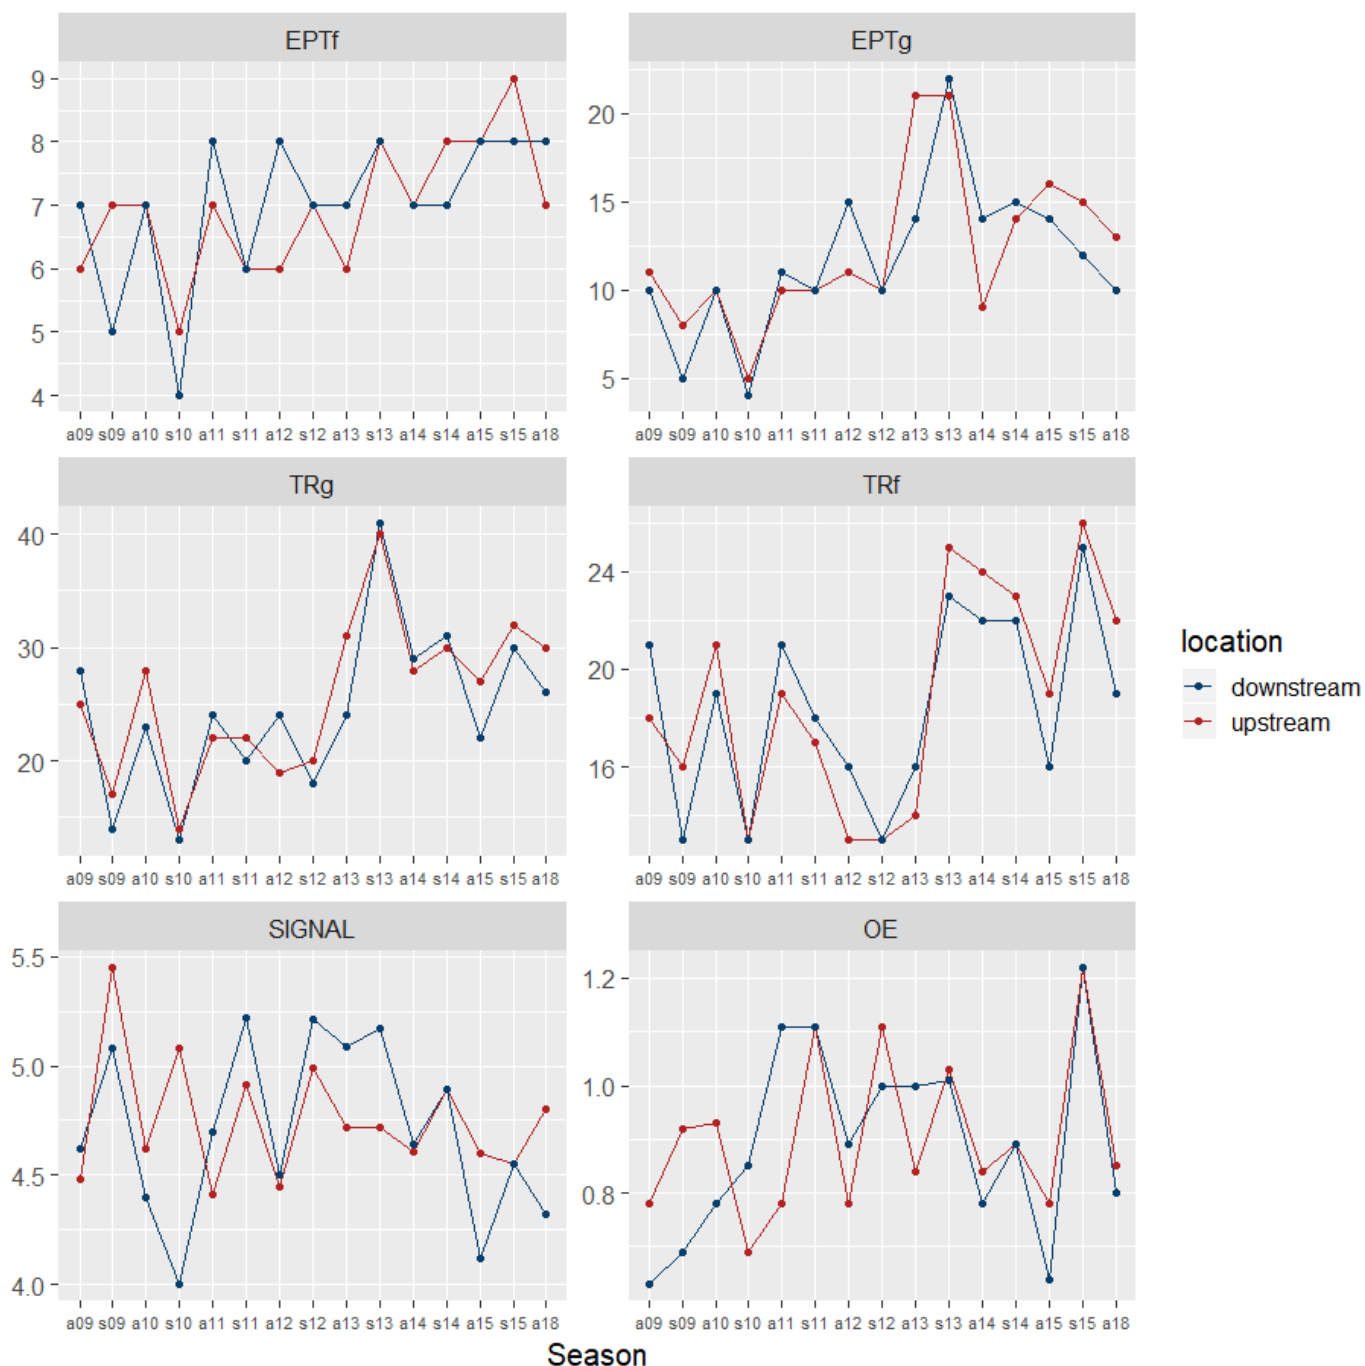
**Angle Crossing EDGE - Macroinvertebrate indices between autumn 2009 and autumn 2018**

NOTE - MPS is not included at this stage due to the large data gaps. Values are means for each location.
