**ACTEWAGL DISTRIBUTION  
MURRUMBIDGEE ECOLOGICAL MONITORING  
PROGRAM  
FIELD OBSERVATION REPORT: SPRING 2011**

**Client:** ActewAGL Distribution  
**Project Title:** Murrumbidgee Ecological Monitoring Program  
**Report Title:** Angle Crossing assessment autumn 2011  
**Document No:** 211063-11-R7-P1  
**Document Status:** **FINAL**  
**Date of Issue:** **16/08/2011**

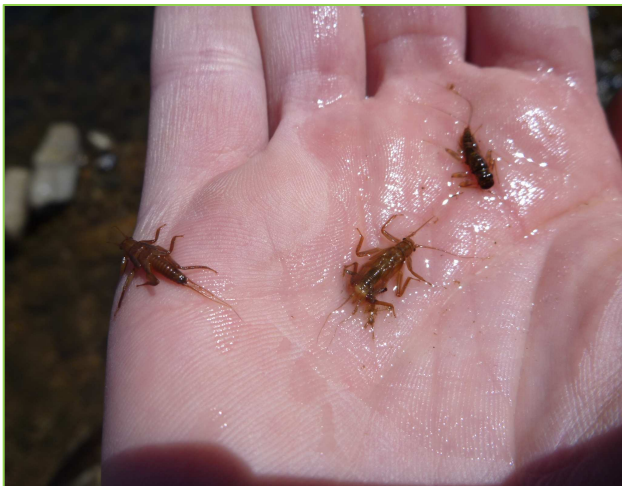
Stream-side scans of the macroinvertebrate samples in the field revealed several highly sensitive taxa both upstream and downstream of Williamsdale Bridge suggesting that; overall, Burra Creek appears to be in good condition (Plate 5) despite some areas of decreasing flows and reduced habitat availability as a result of these low flows.

**Plate 5.** Local sensitive taxa collected within Burra Creek: Plecoptera [Stonefly] (left and centre) and Ephemeroptera [Mayfly] (right).

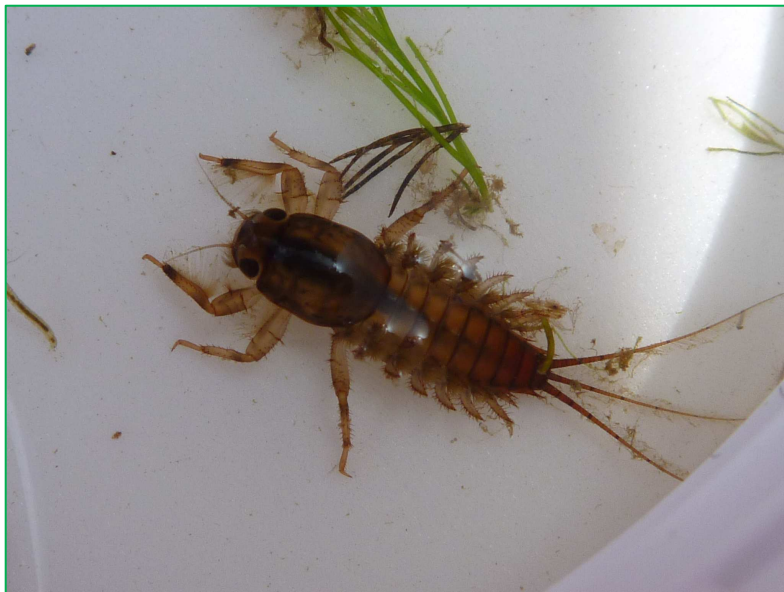
The macroinvertebrate scan at MUR 935 turned up a sensitive (SIGNAL=8) family of mayfly (Coloburiscidae: Plate 7) that has not been collected this far north, during the MEMP, prior to this sampling run. Whether this family is locally rare and has not been picked up before, or has been transported downstream from the high flow events is unclear at this stage, though it should be pointed out that at sites where they have previously been collected, they were more abundant than in previous sampling runs.

**Plate 7.** The mayfly-Coloburiscidae (stream horse)
