Balancing water security and environmental biodiversity

A win-win for regional water supply and fish conservation

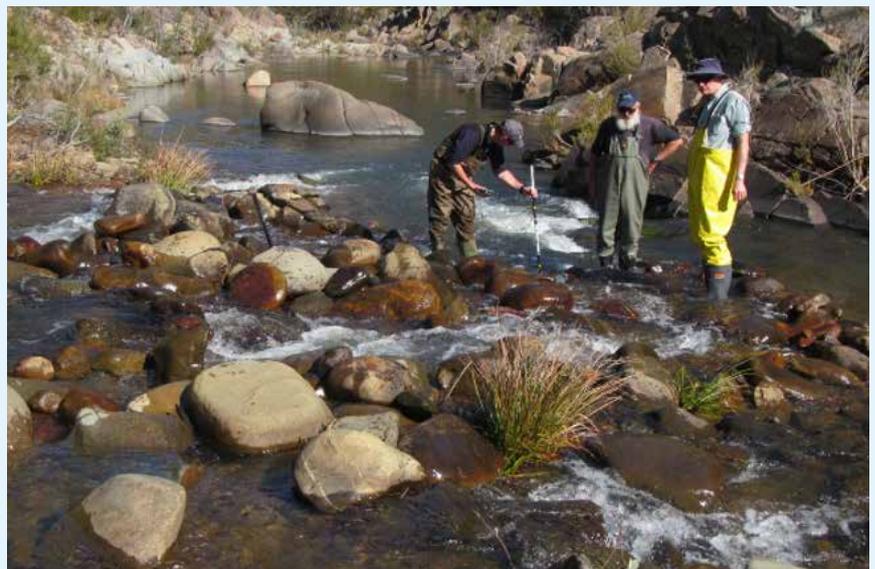
Icon Water and University of Canberra conducting fish passage assessments at differing dam levels

Before we filled the reservoir, we constructed fishways (also known as fish ladders) above the dam to open a substantial area in the Cotter River as spawning habitat for the Macquarie perch. We discovered that, although the swimming speed of Macquarie perch was faster than previously understood, the culverts at Pipeline Road Crossing were generating flow speeds even faster and beyond the capacity of the fish. To manage this, we designed the fishway at the crossing to slow the water velocity, allowing the fish to swim freely upstream.

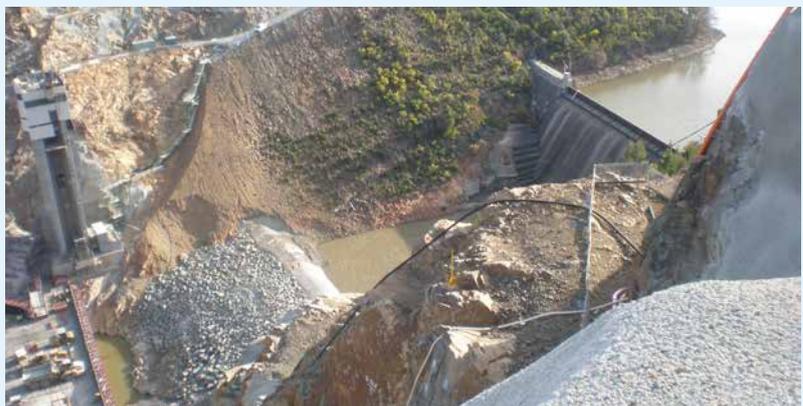
New Cotter Dam (under construction) and old Cotter Dam

This information informed measures to ensure the virus didn't enter the reservoir when constructing the new Cotter Dam wall (125 metres downstream of the original dam wall) – including relocating Macquarie perch trapped between the old and new walls and removing invasive fish. We also established strict requirements for all personnel working near or in the water to avoid contamination and disinfected the stream bed to kill the EHN virus and other potential pathogens. This sterilisation process was effective; no invasive fish were transferred above the wall and neither Redfin perch nor Carp have been found upstream.

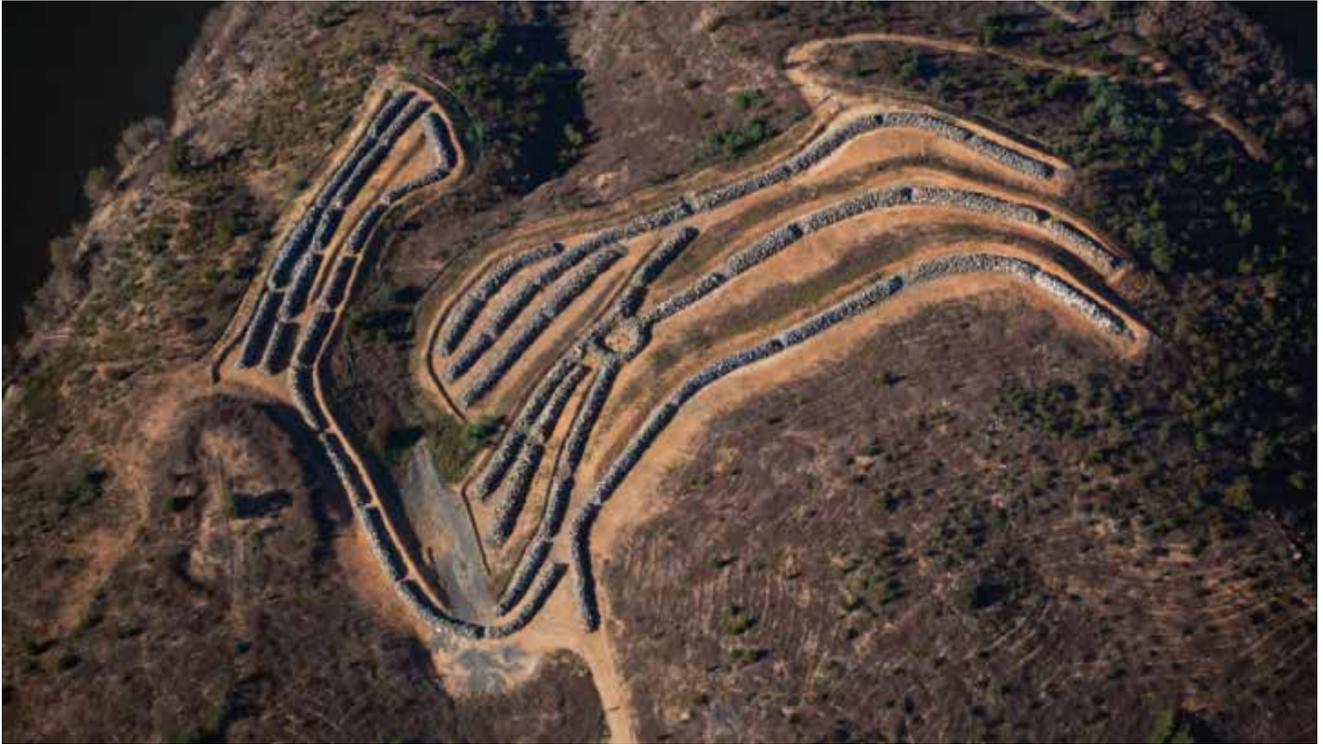
Satellite image of the rock reef artificial habitat constructed within the Enlarged Cotter Dam

We built a seven kilometre artificial freshwater rock reef in the inundation zone – the first of its kind – as a substitute for the fringing aquatic plants used by the Macquarie perch to shelter from cormorants.

The custom-designed habitat was made by positioning over 52,000 tonnes of rock close to the shoreline to provide shelter at a range of reservoir depths.
